運輸安全委員会
Japan Transport Safety Board

ANNUAL REPORT 2025

[March, 2025]

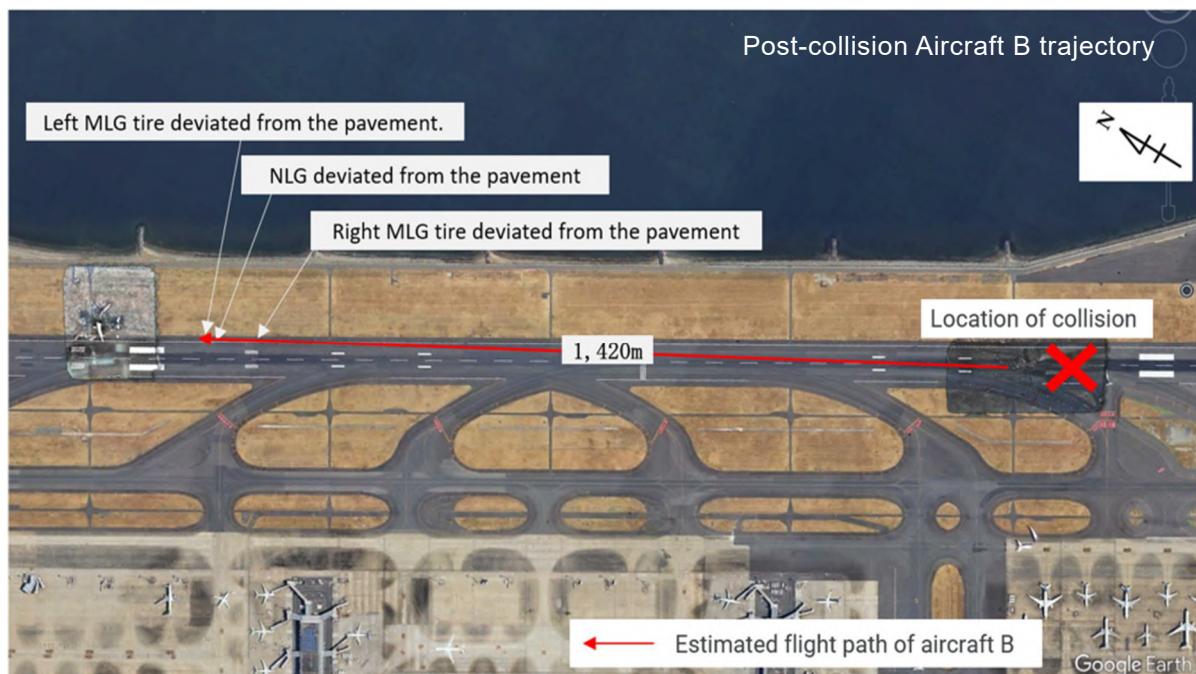
As a result of this collision, it is believed that most of the fuselage of Aircraft A was destroyed. Meanwhile, when Aircraft B collided with Aircraft A, equipment such as the electrical system and control system under the floor of the cockpit was severely damaged. As a result, the wheel brakes that slow down the aircraft did not function, and after taxiing without directional control, Aircraft B continued to roll down the runway and came to a stop in a grassy area.

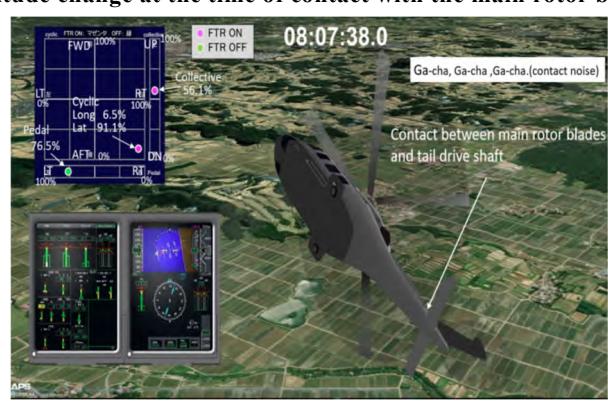
Attitude of helicopter at the time of contacting

It is presumed that the reason why the main rotor blades severed the tail drive shaft while the helicopter was in flight was that, while flying at high speed over a mountainous area in strong winds, the helicopter encountered a strong downdraft, which caused a rapid increase in airspeed, resulting in a right rolling motion exceeding 360°, during which the main rotor blades flapped significantly toward the fuselage.

Attitude change at the time of contact with the main rotor blades

attempt to maintain attitude, resulting in a right rolling motion exceeding 360°. The JTSB concluded that the main rotor blades most likely severed the tail drive shaft during this motion, making the helicopter difficult to control.

Based on the results of this investigation, the JTSB recommended, as safety actions, that when flying over mountainous regions in strong winds where mountain waves are expected to occur, pilots need to slow down in advance and select appropriate flight control modes to respond to sudden weather changes. The JTSB also recommended that to fully understand and properly use flight control modes during flight, pilots should carefully read the relevant documents and, whenever possible, conduct training using Full Flight Simulator and others corresponding to each aircraft type, including coordination between two pilots to enable quick and calm responses during emergency operations.

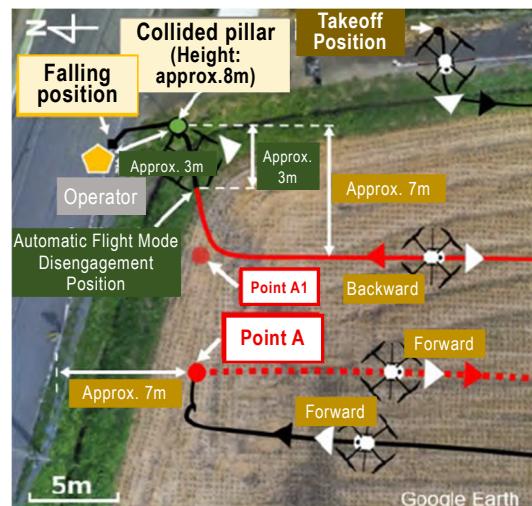
Fig. 2: Flight path at the time of the accident

In this investigation, to accurately grasp the shape of the rice field and the positional relationship between the utility pole that the small UA collided with and the flight path, photographs were taken from above using a small UA, and the flight path of the small UA near the accident site was depicted by combining the topographic data with the small UA's flight records (see Fig. 2).

Based on the results of this investigation, the JTSB indicated that, as one of the safety actions, it is important for those who use small UA for aerial application to assign an assistant to a position according to the flight path and to ensure a safe distance between the small UA and obstacles, the operator, and third parties.

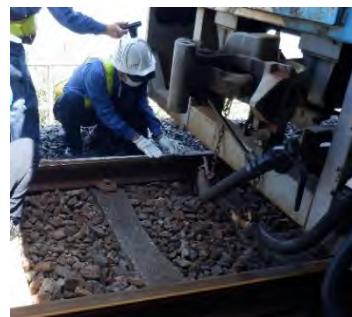
Fig. 2: Investigation status

In the investigation into this accident, the JTSB analyzed the handling of the train, which was allowed to run despite rainfall reaching the control value for the suspension of operations. As a result, the JTSB mainly found the following points:

Based on the above investigation results, the JTSB recommended that Tosa Kuroshio Tetsudo Co., Ltd. establish a system enabling dispatchers who constantly monitor driving conditions to promptly notify train drivers of speed restrictions when the control value for implementing speed restrictions is observed, in order to prevent recurrence of accidents. Additionally, the JTSB recommended the company re-examine its regulations for handling trains during rainfall by comparing them with those of other railway operators, make necessary reviews, and revise its regulations to ensure the safe transportation of trains.

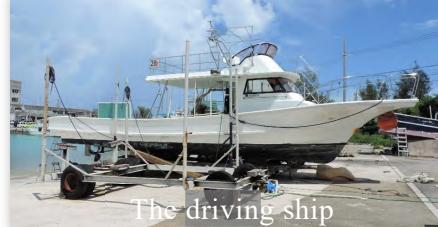
The driving ship

On August 16, 2023, the Diving Ship Crystal M (the ship), with the Master, 12 diving passengers and 7 instructors, was proceeding off the northwest coast of Shimojishima Island in Miyakojima City, Okinawa Prefecture, when it flooded and capsized.

This accident occurred when the ship experienced severe wind, rain, and high waves while passengers were diving. Since the ship continued to anchor by letting go anchor from the stern, waves crashed onto the upper deck, seawater and other substances flowed into the engine room from the stern storage, etc. Furthermore, as the Master continued to sail with more passengers on board and the stern lowered, it is probable that the crashing waves caused the ship to flood and capsize.

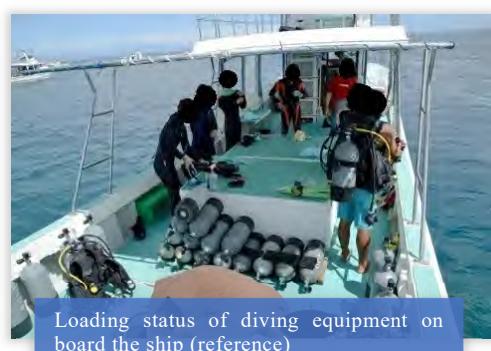
- By changing the stern shape (removal of the partition plate), the structure became more vulnerable to crashing waves.
- After repairing the hydraulic piping, the penetration was left open without being closed.
- The Master did not obtain information on weather and sea conditions after departure and could not make decisions such as evacuation.
- It was possible that the stern part of the ship sank easily, which affected the deterioration of stability, as approximately 1,000 kg of diving equipment was loaded mainly on the stern deck.

Loading status of diving equipment on board the ship (reference)

Additionally, the following items were found in the investigation of this accident, and it is recommended that multi-layered guidance and enlightenment regarding the operation of diving ships be provided in the future:

- The change in the stern shape was subject to temporary inspections, but it was overlooked due to the lack of suggestions from shipowners and indications during inspections. There was a need to increase the effectiveness of ship inspections, etc.
- The operators did not receive direct guidance and enlightenment from relevant organizations, and the initiatives of relevant administrative agencies regarding diving ships were insufficient.

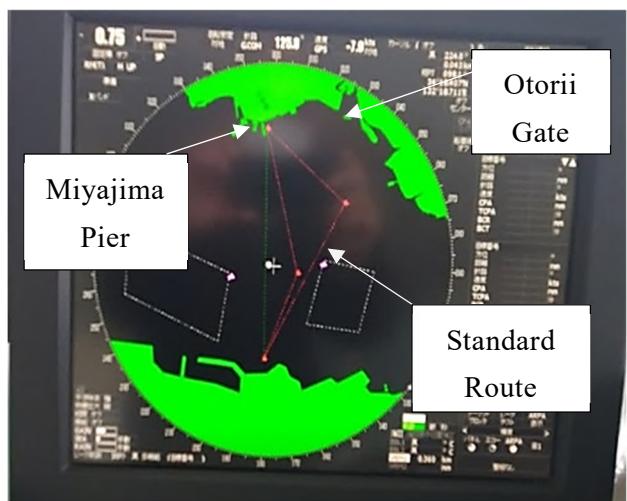
Additionally, after the ship was stranded in February 2020, the passenger ferry operation company displayed the standard route on the passenger ferry's radar and instructed passenger ferries not to navigate in the waters near the Otorii Gate of the standard route when visibility was restricted, such as during fog, but allowed them to drift in the same area. However, the operation company had not considered the precautions to take when drifting in the area.

factors, a Master must not be optimistic based on his/her experience or other factors, thinking that the ship will not be swept away, but must check the ship's position visually and by radar, etc. Furthermore, to improve navigation safety, passenger ship operators are required to investigate the risks of grounding and other hazards in the waters they navigate, consider safety measures, including prohibiting entry, and have crew members implement these safety measures.

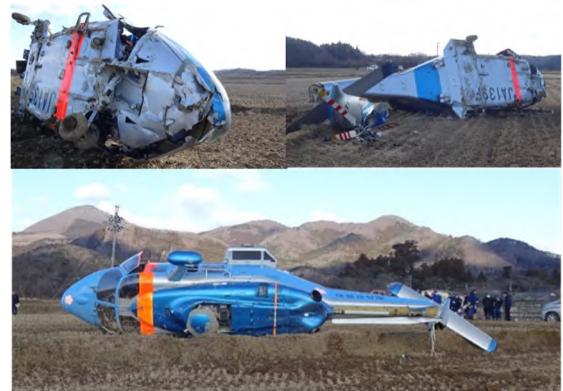
Rollover of the Accident Helicopter

Agusta AW139 of the Fukushima Prefectural Police Aviation Unit

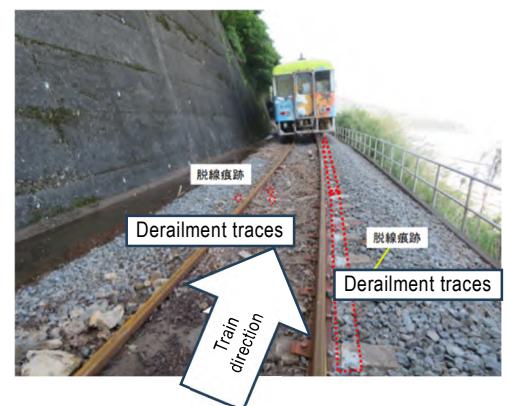
Train derailment accident of Tosa Kuroshio Tetsudo Railway

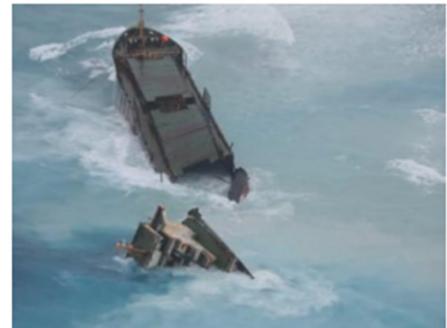
Grounding of a cargo ship XIN HAI ZHOU 2

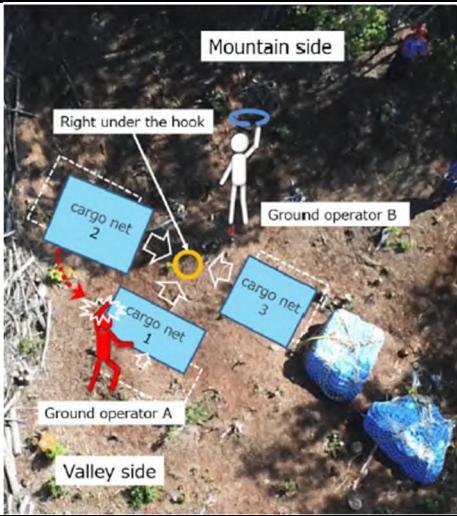
<p>Summary</p> <p>*1“Cargo net” refers to a tool used to wrap and suspend loads by attaching suspension straps to the four corners of the rope woven nets.</p>	<p>When the helicopter lifted the Cargo covered in cargo net^{*1} (hereinafter referred to as “Cargo net”), it came into contact with a ground operator in the mountains in Nantan City, Kyoto Prefecture, and the ground operator was seriously injured.</p>

Probable Causes	<p>The JTSB concludes that in this accident, it is certain that the signal person was injured because while the helicopter was unloading, the Cargo net swung and hit the left leg of the signal person who had moved to the side of the wooden path thinking that assistance work might be required.</p> <p>It is highly probable that the Cargo net hit the signal person because during unloading, the signal person was in the range where the Cargo net could swing and reach. Distracted by the assistant moving between the Cargo net and other cargo, the signal person took the eyes off from the Cargo net, which also more likely contributed to.</p>

<p>Safety Actions</p>	<p>It is necessary for the external cargo sling operators to ensure thoroughly that the ground operators shall never approach cargoes without sending a sign to the onboard mechanic, and that when finding the ground operator has not moved to a safe position during the monitoring of ground work, the onboard mechanic shall secure the safety for the ground work in cooperation with the captain. (See “3. ANALYSIS” on the Investigation Report.)</p>		
	<p>Report</p>	<p>https://jtsb.mlit.go.jp/aircraft/rep-acci/AA2024-3-2-JA9678.pdf (Japanese) https://jtsb.mlit.go.jp/eng-air_report/JA9678(3).pdf (English)</p>

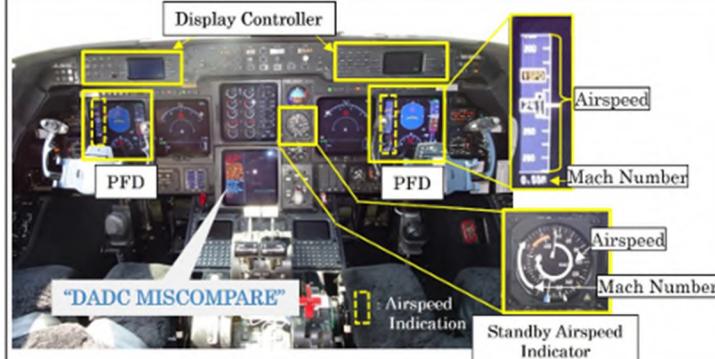
5	<p>Date of publication</p> <p>August 29, 2024</p>	<p>Date and location</p> <p>May 22, 2020 At an altitude of about 13,200m, about 300km southwest of Tokyo International Airport</p>	<p>Operator</p> <p>Prime Jet, LLC</p> <p>Aircraft registration number and aircraft type</p> <p>N146BG GULFSTREAM AEROSPACE G-IV (Large aeroplane)</p>
	Summary	<p>The aircraft operated as a positioning flight by Prime Jet, LLC became the airspeed indications unreliable on both primary flight displays *¹ (PFDs) receiving the air-data from a remaining Digital Air Data Computer *² (DADC) when commencing the descent for landing while the flight crew members had deactivated one of the two DADCs, which the flight crew members decided that it had failure during the cruise for the</p>

<p>Tokyo International Airport after the take-off to position the Aircraft from Phnom Penh International Airport. After that, the Aircraft landed at Tokyo International Airport. There were three people on board, including two crew members other than the captain in the Aircraft, no one was injured, and the aircraft had no damage.</p> <p>*¹ “Primary Flight Display” is an integrated instrument that displays information necessary for flight, such as attitude, altitude, and speed.</p> <p>*² “Digital Air Data Computer” is a device that processes outside air information and digitally outputs such as altitude, speed, temperature, and others.</p>		
	Probable Causes	<p>The JTSB concludes that the probable cause of this serious incident is certainly to be determined as falling under the category of multiple malfunctions in one or more systems installed on aircraft impeding the safe flight of aircraft because both airspeed indications became unreliable when the aircraft began the descent in the situation where the flight crew members deactivated No. 2 DADC determined to be faulty as the action for the DADC MISCOMPARE message and the PFDs for both seats use the data from No. 1 DADC.</p> <p>It is possible that the reason that the airspeed indications on the PFDs for both seats, which had been using the data from No. 1 DADC became unreliable was because the aircraft was flying through airspace where ice crystals existed and the No. 1 pitot line was blocked. Regarding the operating status of No. 2 DADC determined to be faulty by the flight crew members, it could not be determined with almost no records on the DFDR except the one during the descent and few objective factual information.</p>

Safety Actions	<p>The design and manufacturing company probably needs to reorganize the descriptions in the QRHs^{*3} related to DADC MISCOMPARE message. (See “3. ANALYSIS” on the Investigation Report.)</p> <p>*³ “QRH” stands for Quick Reference Handbook, which describes the contents of the Airplane Flight Manual regarding emergency operations and performance for quick retrieval and viewing in actual flight operations.</p>		
	Report	<p>(Japanese) (English)</p>

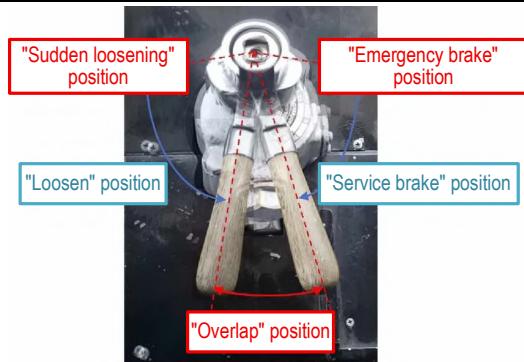
3	Date of publication	Date and incident type	Railway operator	Line section (location)
	November 28, 2024	January 5, 2024 Dangerous trouble in vehicle	Kumamoto City Transportation Bureau	Between Kotsukyoku-mae Tram Stop and Misotenjin-mae Tram Stop on the Suizenji Line (Kumamoto Prefecture)
Summary		<p>The driver of this tram received a report from a passenger that the door was open immediately after departing from the Kotsukyoku-mae Tram Stop on the Suizenji Line, subsequently, the driver promptly applied the brakes to stop the vehicle.</p> <p>The vehicle's dashcam footage recorded the vehicle departing from Kotsukyoku-mae Tram Stop with the passenger boarding and alighting door (hereinafter referred to as "the middle door") located near the center of the vehicle on the left side (front, back, left, and right are based on the train's direction) remaining open.</p> <p>There were 11 passengers and 1 driver on board, but no one was injured.</p>

<p>^{*1} The term "overcoat" here refers to the cold-weather clothing provided to the driver by the Public Corporation.</p>		
	Safety actions	<p>(1) Safety Actions considered necessary for the Public Corporation</p> <ol style="list-style-type: none"> ① It is necessary to establish handling procedures for when the driver leaves the vehicle. ② It is necessary to thoroughly instruct the drivers to handle operations as specified. ③ Regarding the means of communication between the drivers and the operations control room, it is desirable to establish the priority of the equipment to be used. <p>(2) Safety Actions considered necessary for Sapporo City Transportation Bureau^{*2}</p> <p>It is desirable to install devices on all vehicles owned that automatically activate the brakes when the driver leaves the driver's seat.</p>		
		<p>^{*2} "Sapporo City Transportation Bureau" was separated into upper and lower sections in April 2020, with the Bureau owning the vehicles and facilities, and the Public Corporation managing the operation of trams and the maintenance of vehicles and facilities.</p>
