# JTSTB Digests

JTSTB (Japan Transport Safety Board)

(Issued in April, 2014)

## Digest of Aircraft Accident Analyses For Prevention of Helicopter Accidents

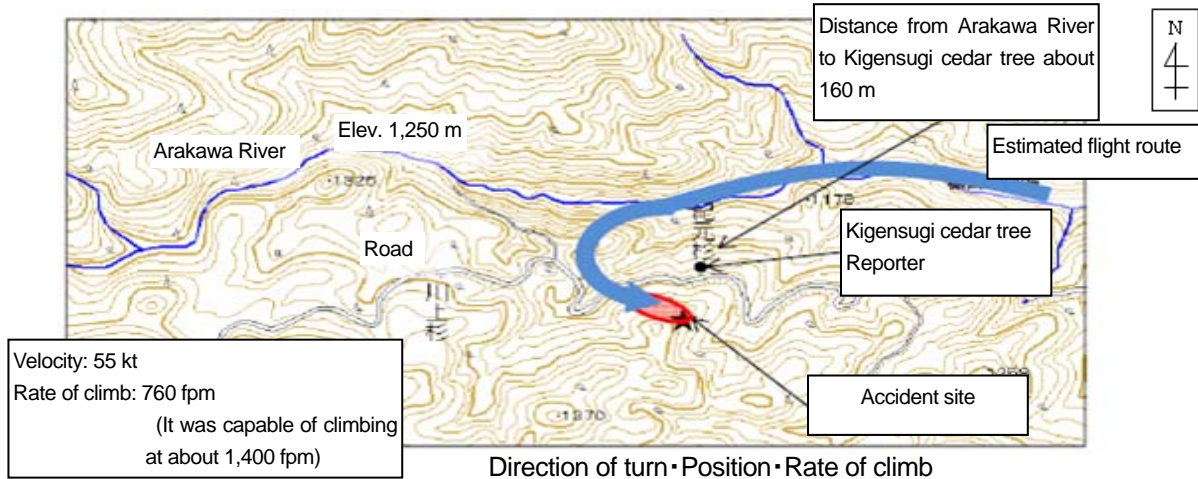
## Reasons for Unavoidable Collision with the Trees

It is probable that the pilot selected the easier maneuver of the left turn than OGE hovering (\*1) above the Arakawa River, although the latter was possible if he accepted a large control input. His selection resulted in the proximity to the slope in the valley causing the underslung cargo being caught in the branches of Tree B or Rock A. Reason for his selection are as follows:

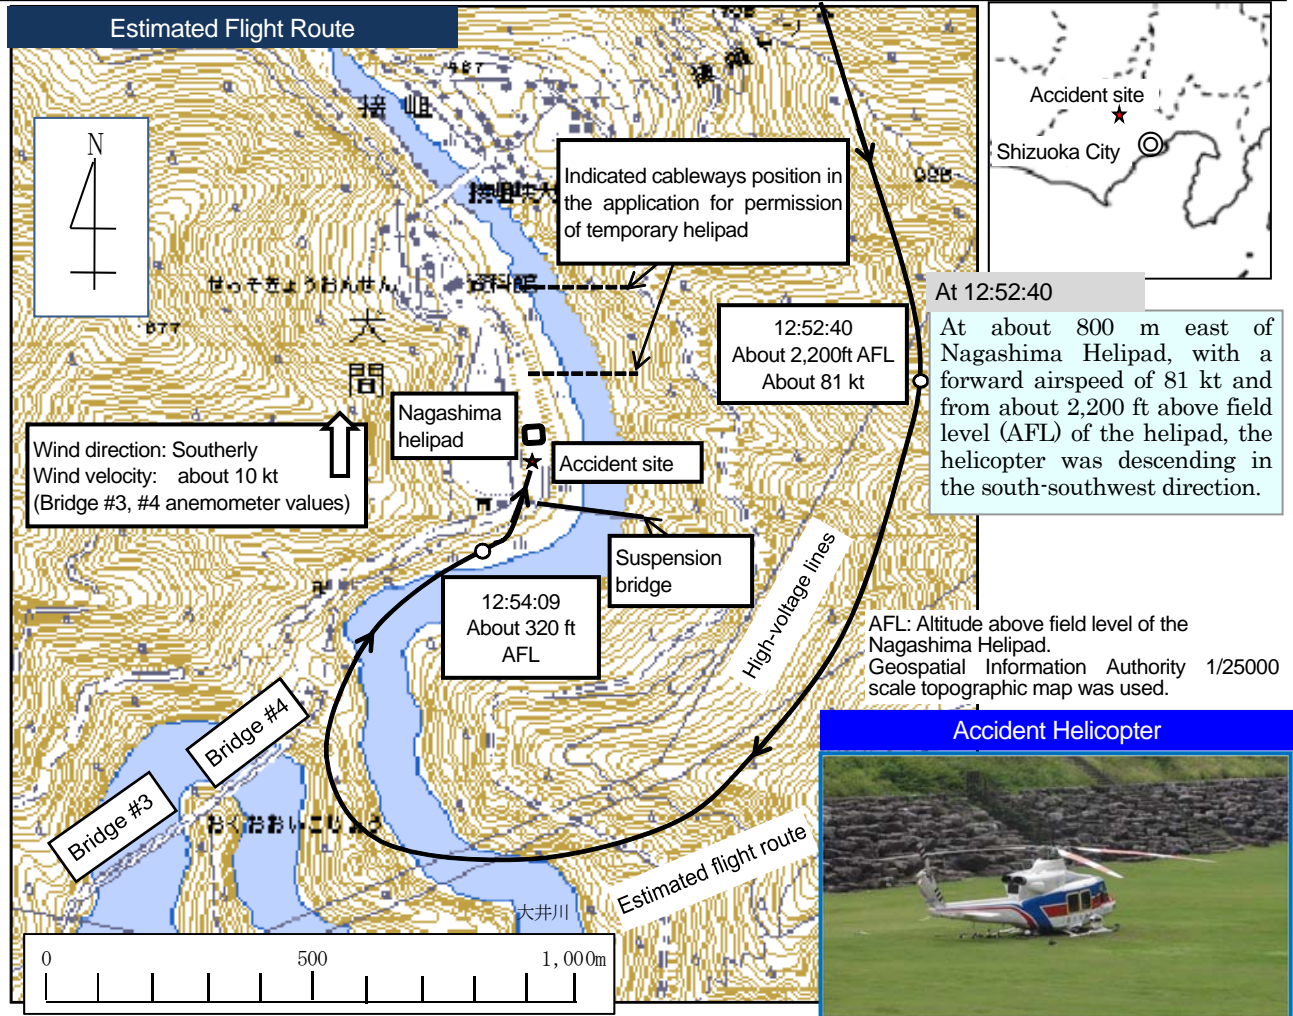
**Persons on board were injured as a result of hard landing during a high descent rate**

Summary: On Friday June 29, 2012 at 12:54 local time (UTC+9 hours), a Bell 412EP, owned by Chubu Regional Bureau, Ministry of Land, Infrastructure, Transport and Tourism (operated by contracted Company A) experienced a hard landing when attempting to land at upstream of Nagashima Dam temporary helipad, Kawanehon-cho, Haibara-Gun, Shizuoka Prefecture. The pilot suffered serious injuries, and one of the passengers suffered minor injuries. There were eight persons on board, consisting of the pilot, two crews and five passengers. The helicopter was slightly damaged, but there were no outbreak of fire.

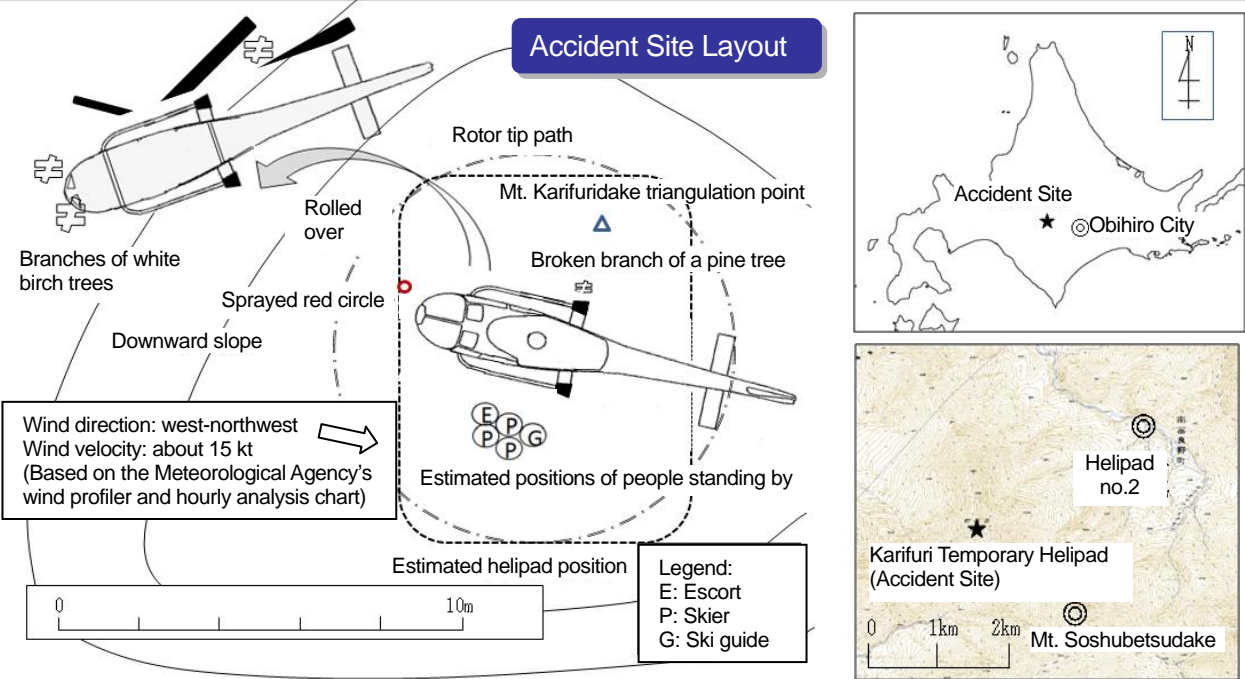
**The continued lift-off sequence while being caught by ground obstacles led to a dynamic roll over**

Summary: On Sunday February 19, 2012, at around 13:25 local time (UTC+9 hours), Eurocopter EC120B, operated by Company A, rolled over during takeoff from Karifuridake temporary helipad in Minami-Furano Town, Sorachi-Gun, Hokkaido, and sustained substantial damage. On board the helicopter was a pilot, but he suffered no injury. The helicopter sustained substantial damage, but there was no outbreak of fire.

It is highly probable that obstacles, possibly branches of creeping pines (\*1) covered with snow, restrained the right and left skids, and it continued the lift-off sequence with the right skid sill restrained. As a result, abrupt right roll started and the roll angle exceeded the critical roll-over angle. The aircraft rolled over to the right in a state of dynamic roll-over, and sustained damaged.
