3. Case of close call incidents, aircraft accidents, etc. (related to wake turbulence and wrong approach to a runway, etc.)

Case 1 of wake turbulence (aircraft accident)

The aircraft encountered strong wake turbulence from the preceding aircraft when descending, and two cabin attendants who were in the aft galley fell over

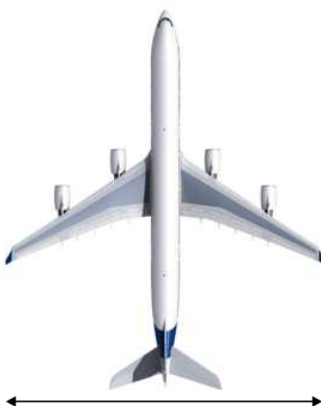
Approximately 368 tons

Wake turbulence classification: Heavy aircraft

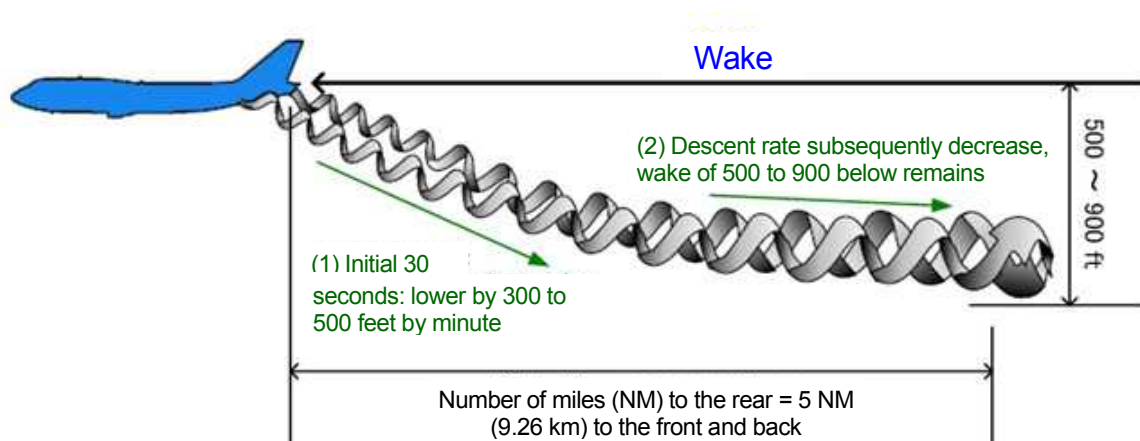
Mini explanation About wake turbulence

Wake turbulence from aircraft is the spiraling flow of air that occurs from the difference in air pressure above and below the wings. Wake turbulence is said to exist in a belt that generally has a length of 9.3km (5nm) from front to back in the case of large aircraft, and air traffic control conducts control so that aircraft do not enter a minimum interval that is stipulated based on the size of the preceding aircraft and the aircraft that follows it.
