# JTSTB Digests

JTSTB (Japan Transport Safety Board) DIGESTS

(Issued in May,2016)

### Close call incidents in the field of aviation

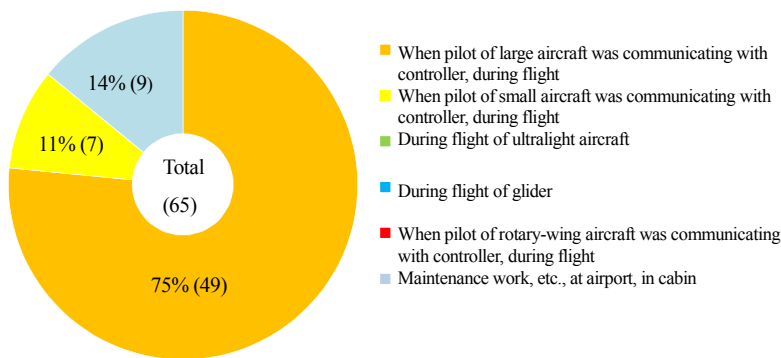
When comparing the conditions during which close call incidents and accidents, etc. occur by type of aircraft, reports on the close call incidents were most common for “when pilot of large aircraft was communicating with controller, during flight,” which accounted for 75% overall (see Figure 1).

Fig.1 Conditions when close call incidents occurred

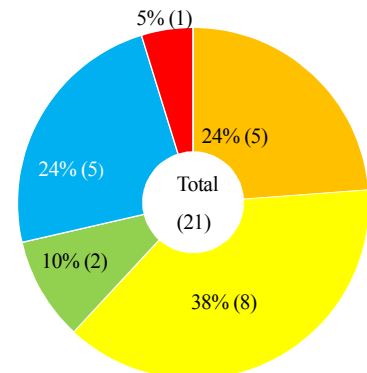
Looking at accidents, etc. in contrast to close call incidents, reports were most common for “when pilot of small aircraft was communicating with controller, during flight,” which accounted for 38% overall (see Figure 2).

Fig.2 Conditions when accidents, etc. occurred

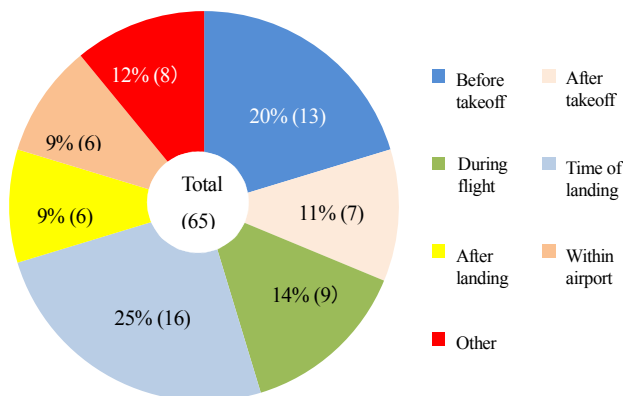
When comparing the flight phases during which close call incidents and accidents, etc. occurred, we see that close call incidents occurred in all types of phases (see Figure 3).

Fig.3 Flight phase when close call incidents occurred

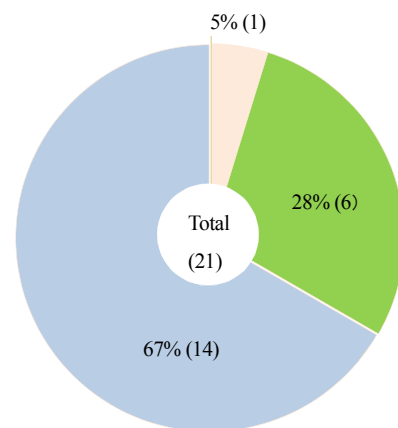
Looking at accidents, etc. in contrast to close call incidents, occurrence was most common when landing, accounting for 67% overall. (See Figure 4).

Fig.4 Flight phase when accidents, etc. occurred
