Serious Accident : Case 3

While hoisting cargo with a deck crane, the wire rope broke and the cargo fell into the hold of the barge

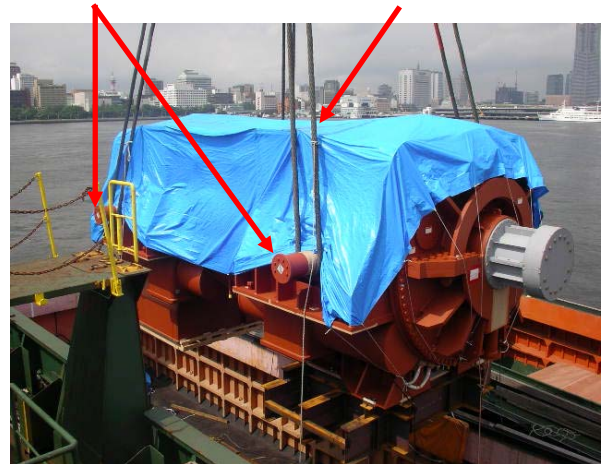
Hoisting attachment Grommet (hoisting wire ropes)

According to the cargo planning prepared by the Contract Company and the technical data sheet prepared by the Electrical Manufacturer for the cargo submitted by the ship management company of Vessel A, the Cargo was a steam turbine driven generator for a power plant made by the Electrical Manufacturer, with dimensions of approximately 11.4 m long, 5.5 m wide and 4.6 m high, and with the weight of 314 t.
