JTSB Digests

JTSB (Japan Transport Safety Board)

Digest of Marine Accident Analyses

For prevention of “Fatal and Injury Accidents Related to On-Board Works”

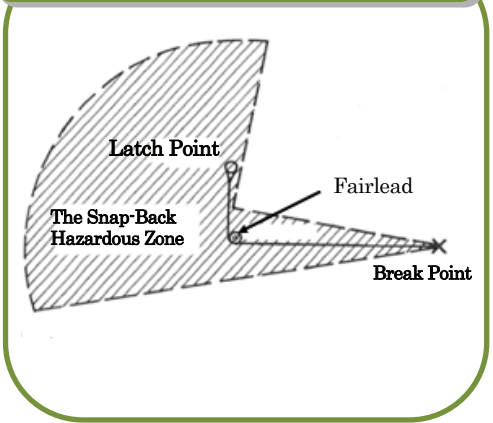
< reference chart >
In case of Break of a Mooring Line bent at a Fairlead

* The chart for the situation of the accident shows a snap-back hazardous zone when a break point is between a latch point and a fairlead.
In the case of the Ship, as in the reference chart, the mooring line was bent at the fairlead, although a snap-back hazardous zone will extend further if a break point is between a fairlead and a latch point.

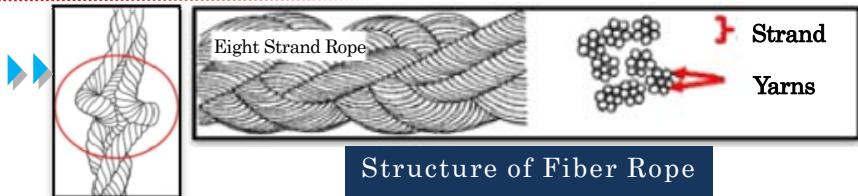
📌 A "hockling" is a word referring to a deformation found only in twisted ropes

- Synthetic lines should be checked for obvious signs of deterioration before each use and undergo a thorough inspection at least once each year.
- Some signs of damage such as hockling, cuts, surface abrasion and fusion are readily visible. Others are not as evident. While it is not possible to prescribe definitive retirement criteria, the following sections discuss the types of damage and wear experienced by ropes and providing general guidelines.

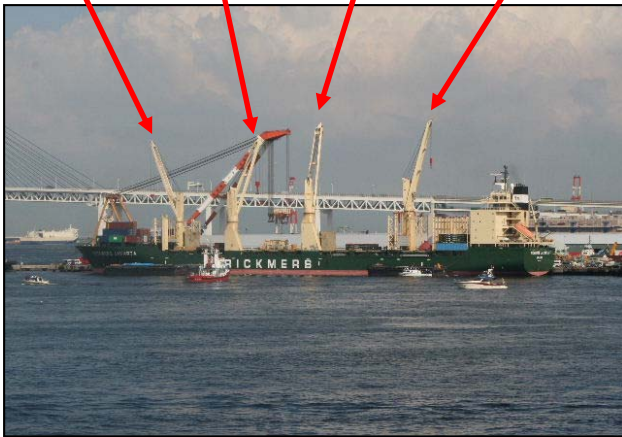
Full View of Vessel A (after the accident)

Vessel A underwent a special survey on its four deck Cranes on August 13, 2008, at a dockyard in Shanghai, the People's Republic of China. This survey was carried out by the classification society (*3), Germanischer Lloyd (GL), wherein Crane No.2 and No.3 went through a load test of hoisting a 352-ton load that was 1.1 times as heavy as the Safe Working Load (*4) stipulated by GL rule. Both Cranes successfully passed this test.

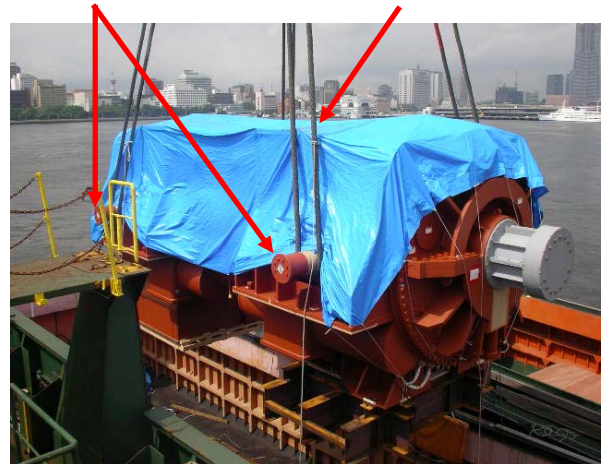
The Cargo immediately before the accident

According to the cargo planning prepared by the Contract Company and the technical data sheet prepared by the Electrical Manufacturer for the cargo submitted by the ship management company of Vessel A, the Cargo was a steam turbine driven generator for a power plant made by the Electrical Manufacturer, with dimensions of approximately 11.4 m long, 5.5 m wide and 4.6 m high, and with the weight of 314 t.

Hoisting attachment Grommet (hoisting wire ropes)
