2. Situations where accidents occurred due to pitching, etc.

2.1 Sea conditions and navigational conditions at the time of accident

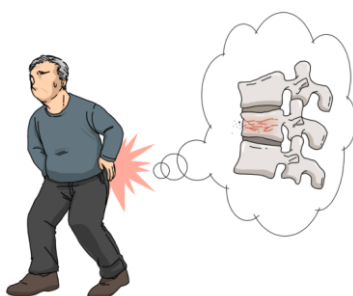
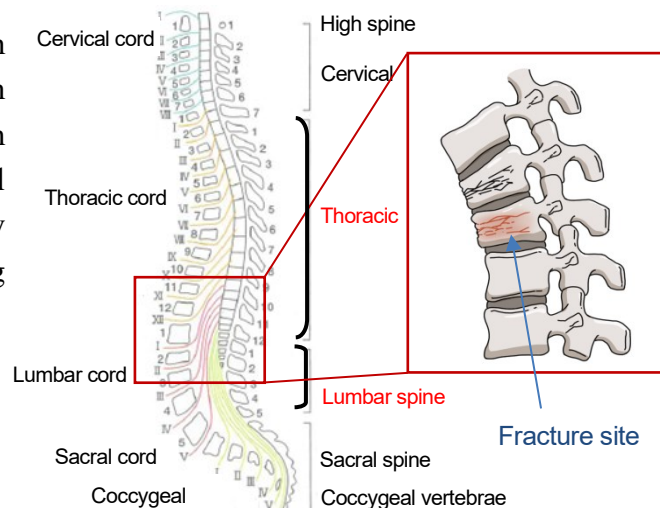
Vertebral fracture refers to compression fracture in which the spine suffers from hyperflexion injury and burst fracture in which the spine is damaged due to vertical axial compression. The spine may be damaged by shocks or external forces due to fall and falling on one's bottom.
