Railway Accident Analysis Report

Preventing railway accidents caused by snow

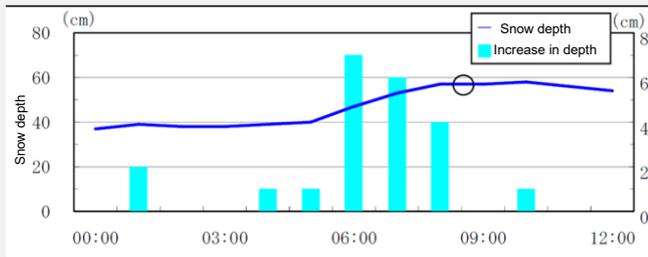
Figure 11: Snow depth and increase near the accident site (the circle indicates the time when the accident occurred.)

As for the occurrence of the accident, it is possible that the rapid formation of compacted snow due to a combination of the following factors was involved: strong winds from the direction unobstructed near the accident site caused a snowdrift to grow quickly at the level crossing, which, together with snowfall earlier in the period before the accident, led to snow accumulating enough to bury the rails at the crossing; and many heavy vehicles passed over the crossing and compacted the accumulated snow in a short time.

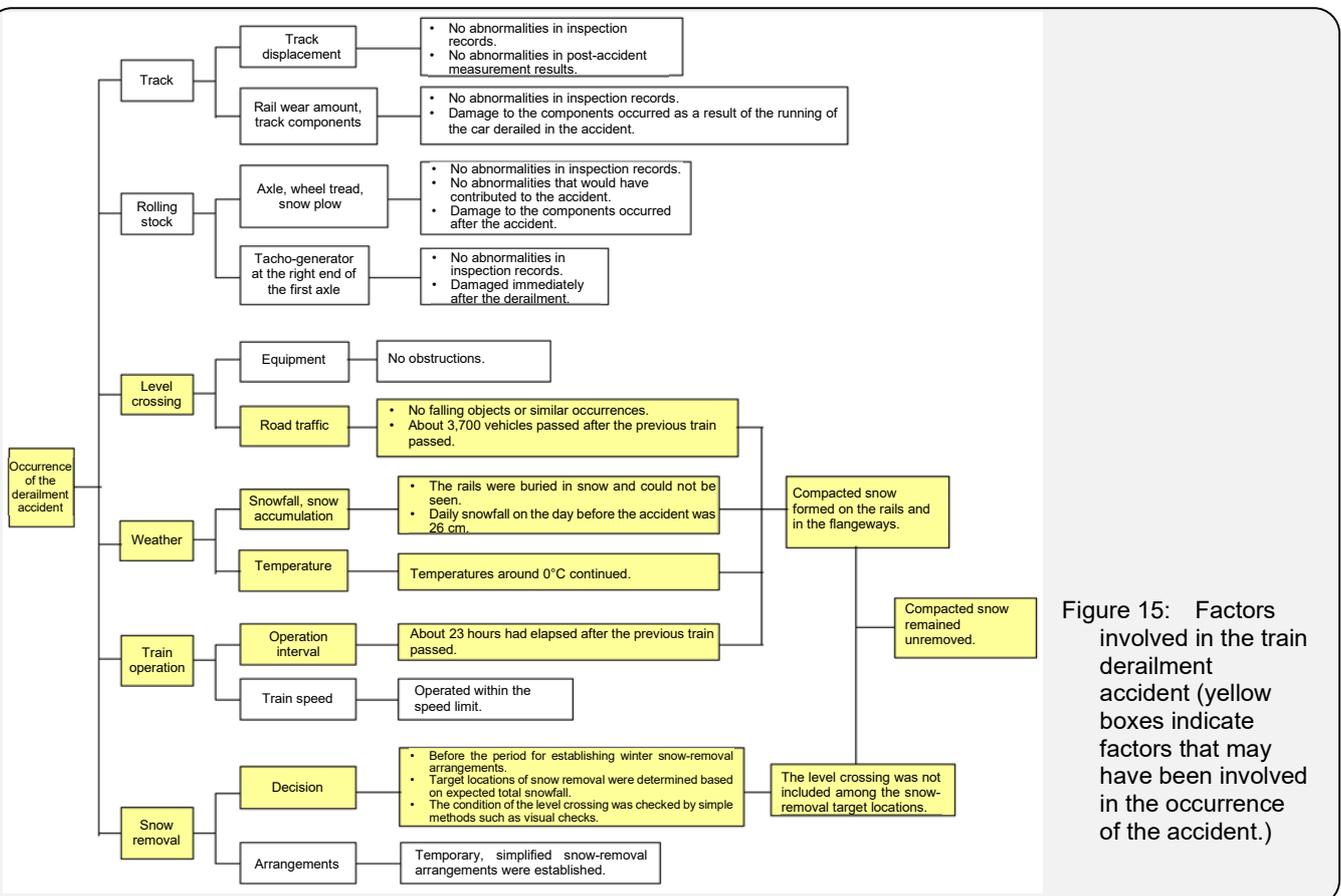
Figure 15: Factors involved in the train derailment accident (yellow boxes indicate factors that may have been involved in the occurrence of the accident.)

Probable causes: The JTSB concludes that the probable cause of the accident was, when the train was passing the level crossing located on the right-hand curve of the siding for inbound and outbound lines, which had not been used frequently, on the station premises, the left wheel of the first axle of the leading car's bogie climbed up onto the left rail (outer rail), resulting in a derailment to the left.

As for the presence of compacted snow at the level crossing, it is possible that heavy snowfall on the day before the accident, under the condition where temperatures around 0°C continued, and the continued compaction of snow by vehicles passing over the crossing during the long interval after the previous train contributed to its presence. In addition, it is possible that the compacted snow formed on the rails and in the flangeways remained unremoved, because no snow removal was performed up to when the train passed the crossing. As for the lack of snow removal, it is possible that the following factors were involved: it was before the period for establishing winter snow-removal arrangements; the condition of the level crossing was checked by simple methods such as visual checks; and the operation interval was not sufficiently considered in on-site checks and decisions about snow removal.

- (1) Appropriate snow-removal arrangements and designation of snow-removal target locations according to the situation
In the cases where a day with heavy snowfall, the passage of strong cold air at night, or other weather conditions requiring caution are expected, it is desirable to flexibly increase snow-removal personnel according to the situation even outside the planned period for the winter snow-removal arrangements. Furthermore, it is desirable to further enhance snow removal at level crossings depending on snowfall and accumulation conditions by, for example, appropriately designating snow-removal target locations taking into account the conditions of compacted snow ascertained through on-site checks and environment of the level crossings, such as train operation intervals and vehicular traffic volumes.

- (3) Identification of locations requiring attention, bringing forward the winter snow-removal arrangements, review of work schedules, etc.
Thirteen level crossings on station premises (11 stations) with conditions similar to track E at D Station, such as tracks with two or fewer trains per day and level crossings with high vehicular (particularly truck) traffic, were newly designated as locations requiring attention. At the stations with such crossings, the winter snow-removal arrangements were brought forward, and the review of work schedules, etc., were implemented so that the crossings could be inspected before the entry of the first train.
In view of the driver having resumed the operation of the train without noticing damage to its snow plow, the operator instructed crew members on points of caution when checking cars that re-railed after a derailment and cars that experienced abnormal impact, in order to further enhance initial response measures.

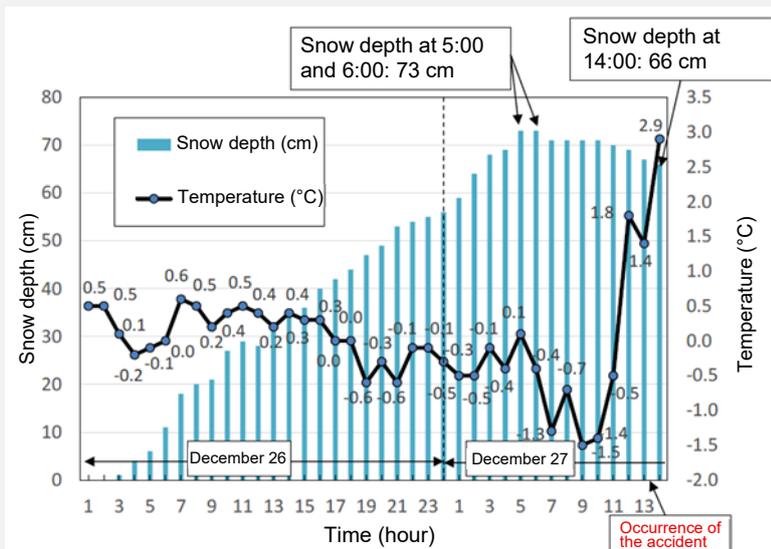
Figure 19: Trends in snow depth and temperature near the accident site

Probable causes: The JTSB concludes that it is possible that the accident occurred because the wheel load of the front bogie of the leading car decreased, and while the train was running with that bogie turned to the left, the first axle of the bogie climbed up onto compacted snow that was on the rails and in the flangeways at the level crossing, causing a derailment.
