**AIRCRAFT SERIOUS INCIDENT
INVESTIGATION REPORT**

**Privately owned
B – 3 2 0 3**

MULTIPLE MALFUNCTIONS IMPEDING

EMBRAER ERJ190-100ECJ, B-3203

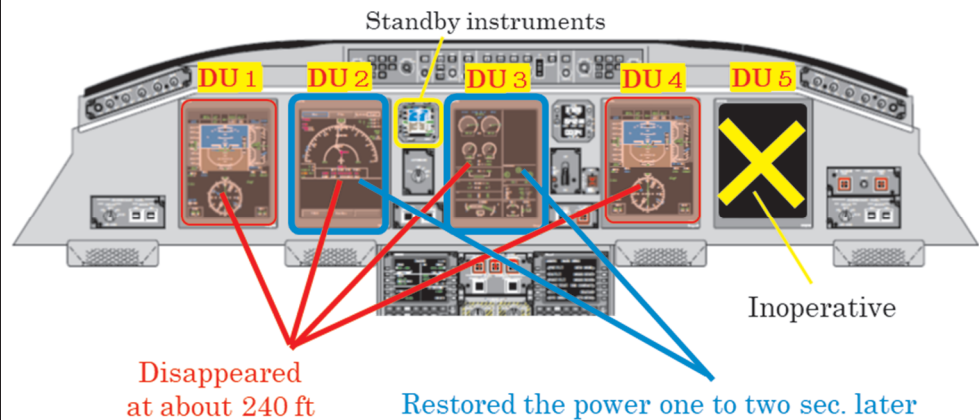
Figure 2: DU (Display Unit) location (As for the indications, see 2.7.(2))

During a normal inspection for the Aircraft on December 12, 2019, a failure in DU5 was found, but it was confirmed to be a failure of a DU5 itself, therefore the Aircraft was allowed to make three days flight until the repair was completed by applying the MEL. When the DU5 fails and the “MFD MODE Switch” is set to “AUTO”, the DU4 will function as PFD (Figure 2).
