AIRCRAFT ACCIDENT INVESTIGATION REPORT

China Airlines
Airbus Industrie A300B4-622R, B1816
Nagoya Airport
April 26, 1994

July 19, 1996

Aircraft Accident Investigation Commission
Ministry of Transport

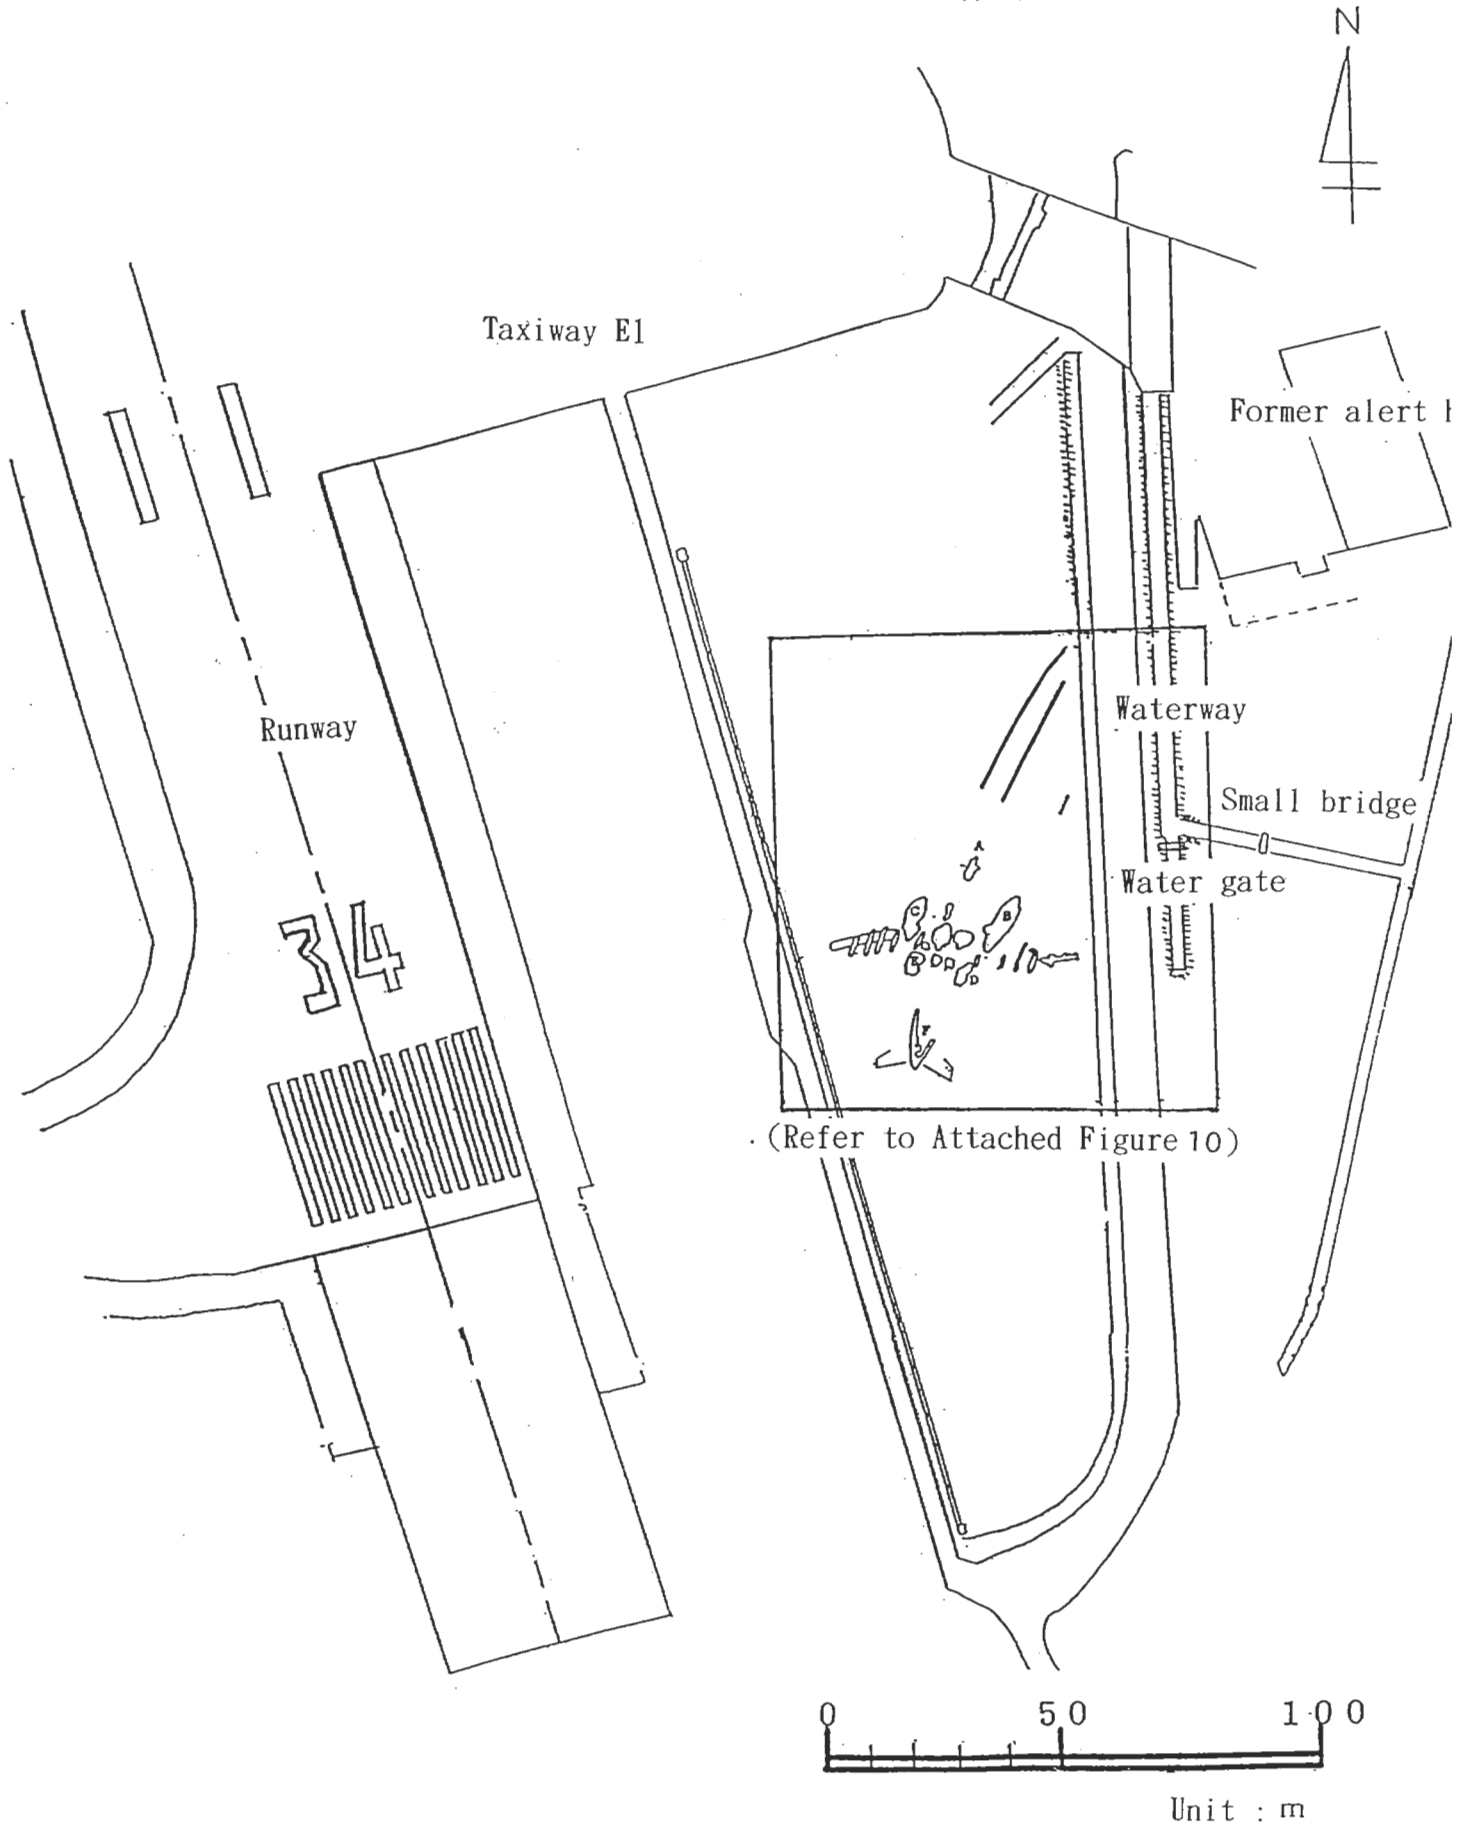
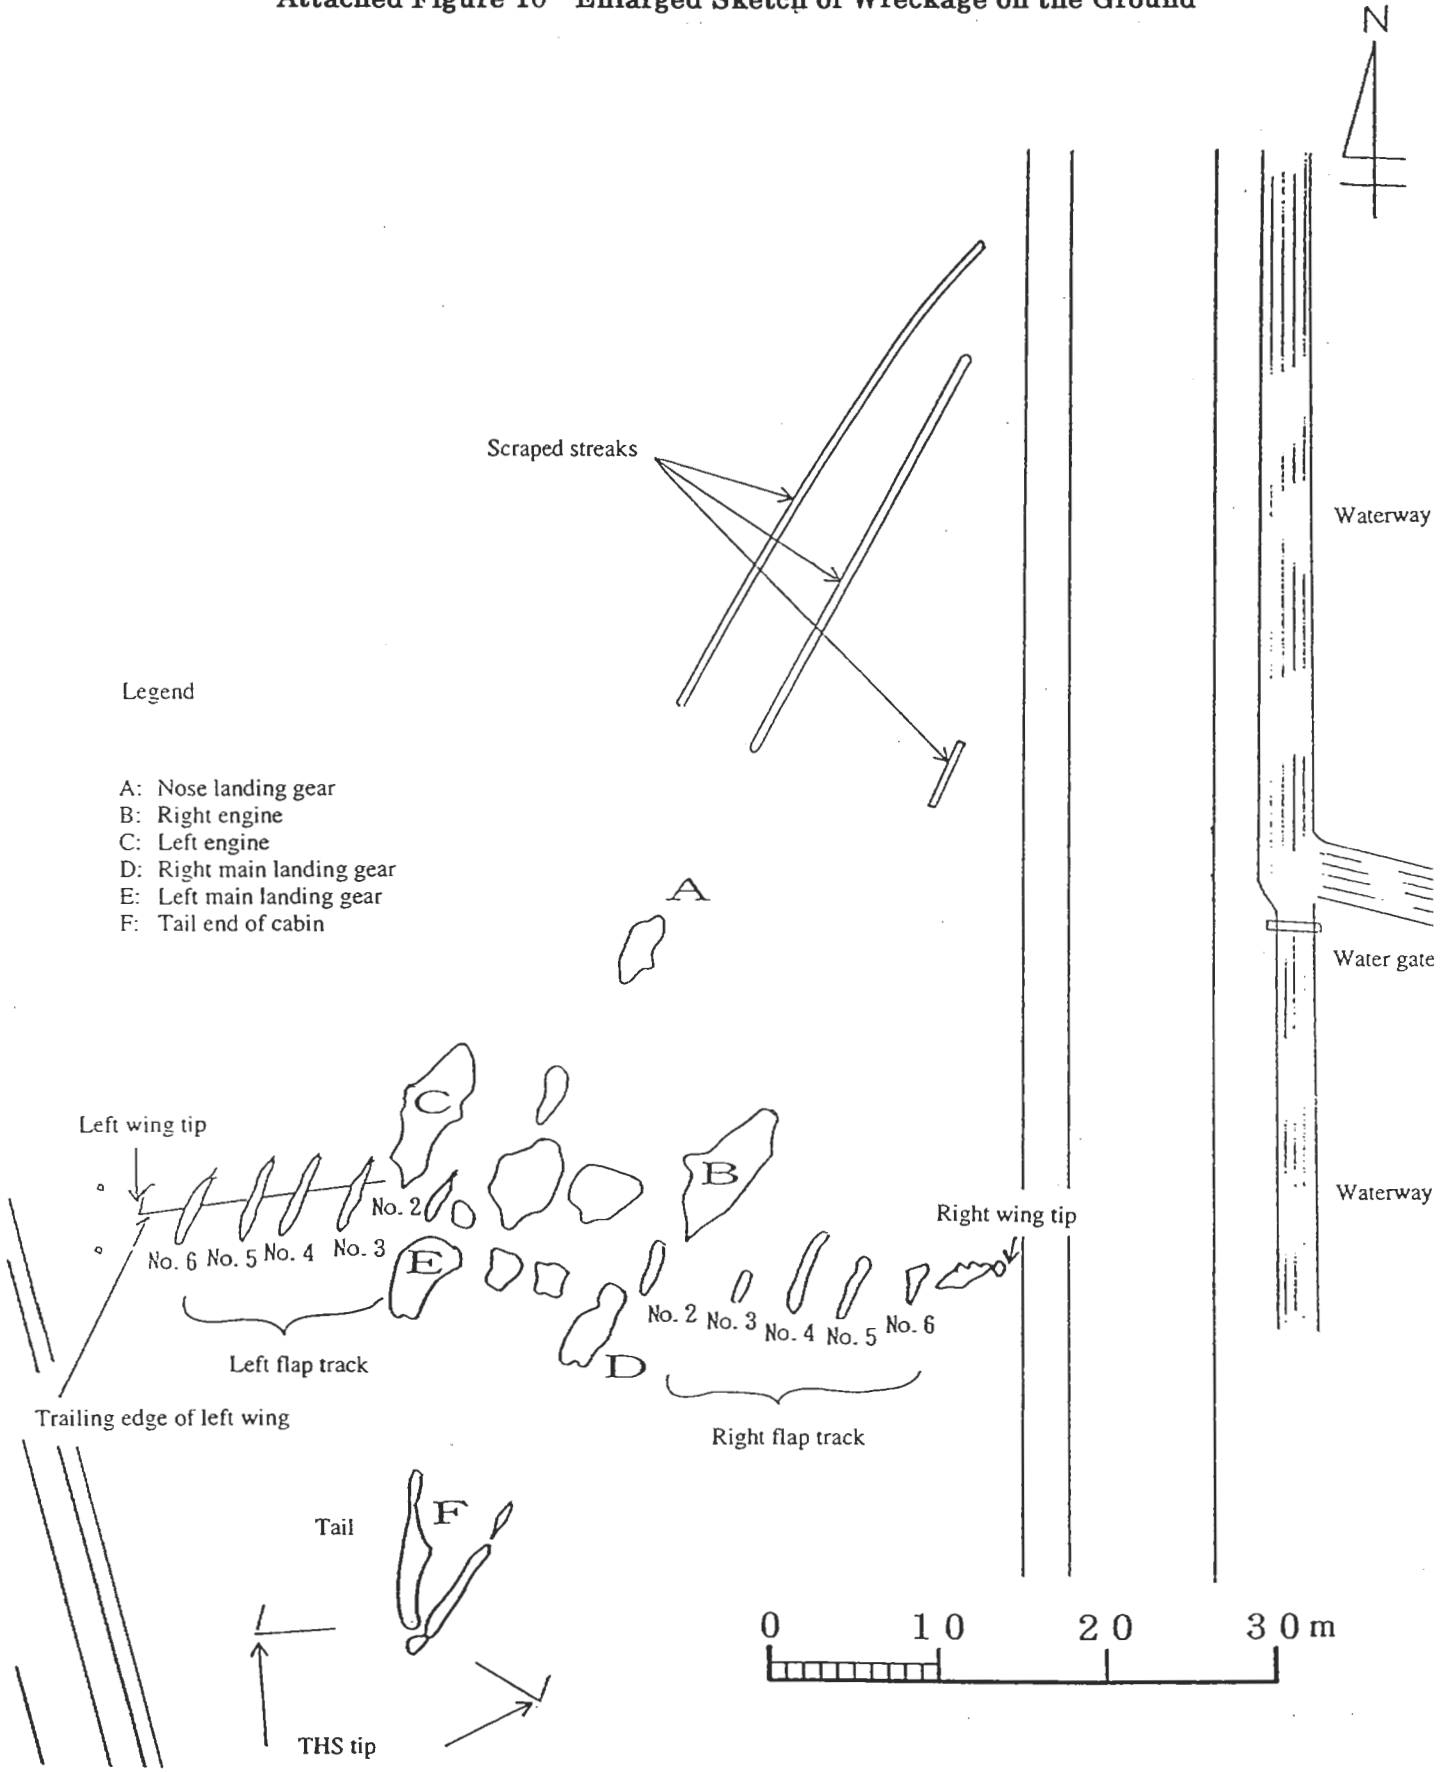
Attached Figure 9 Sketch of Wreckage on the Ground after the Crash

The direction of the linear marks which are made when the center section of the fuselage scratched the ground, coincided with magnetic bearing of about 22°. (See attached Figures 9, 10, and Photographs 49 and 50.)

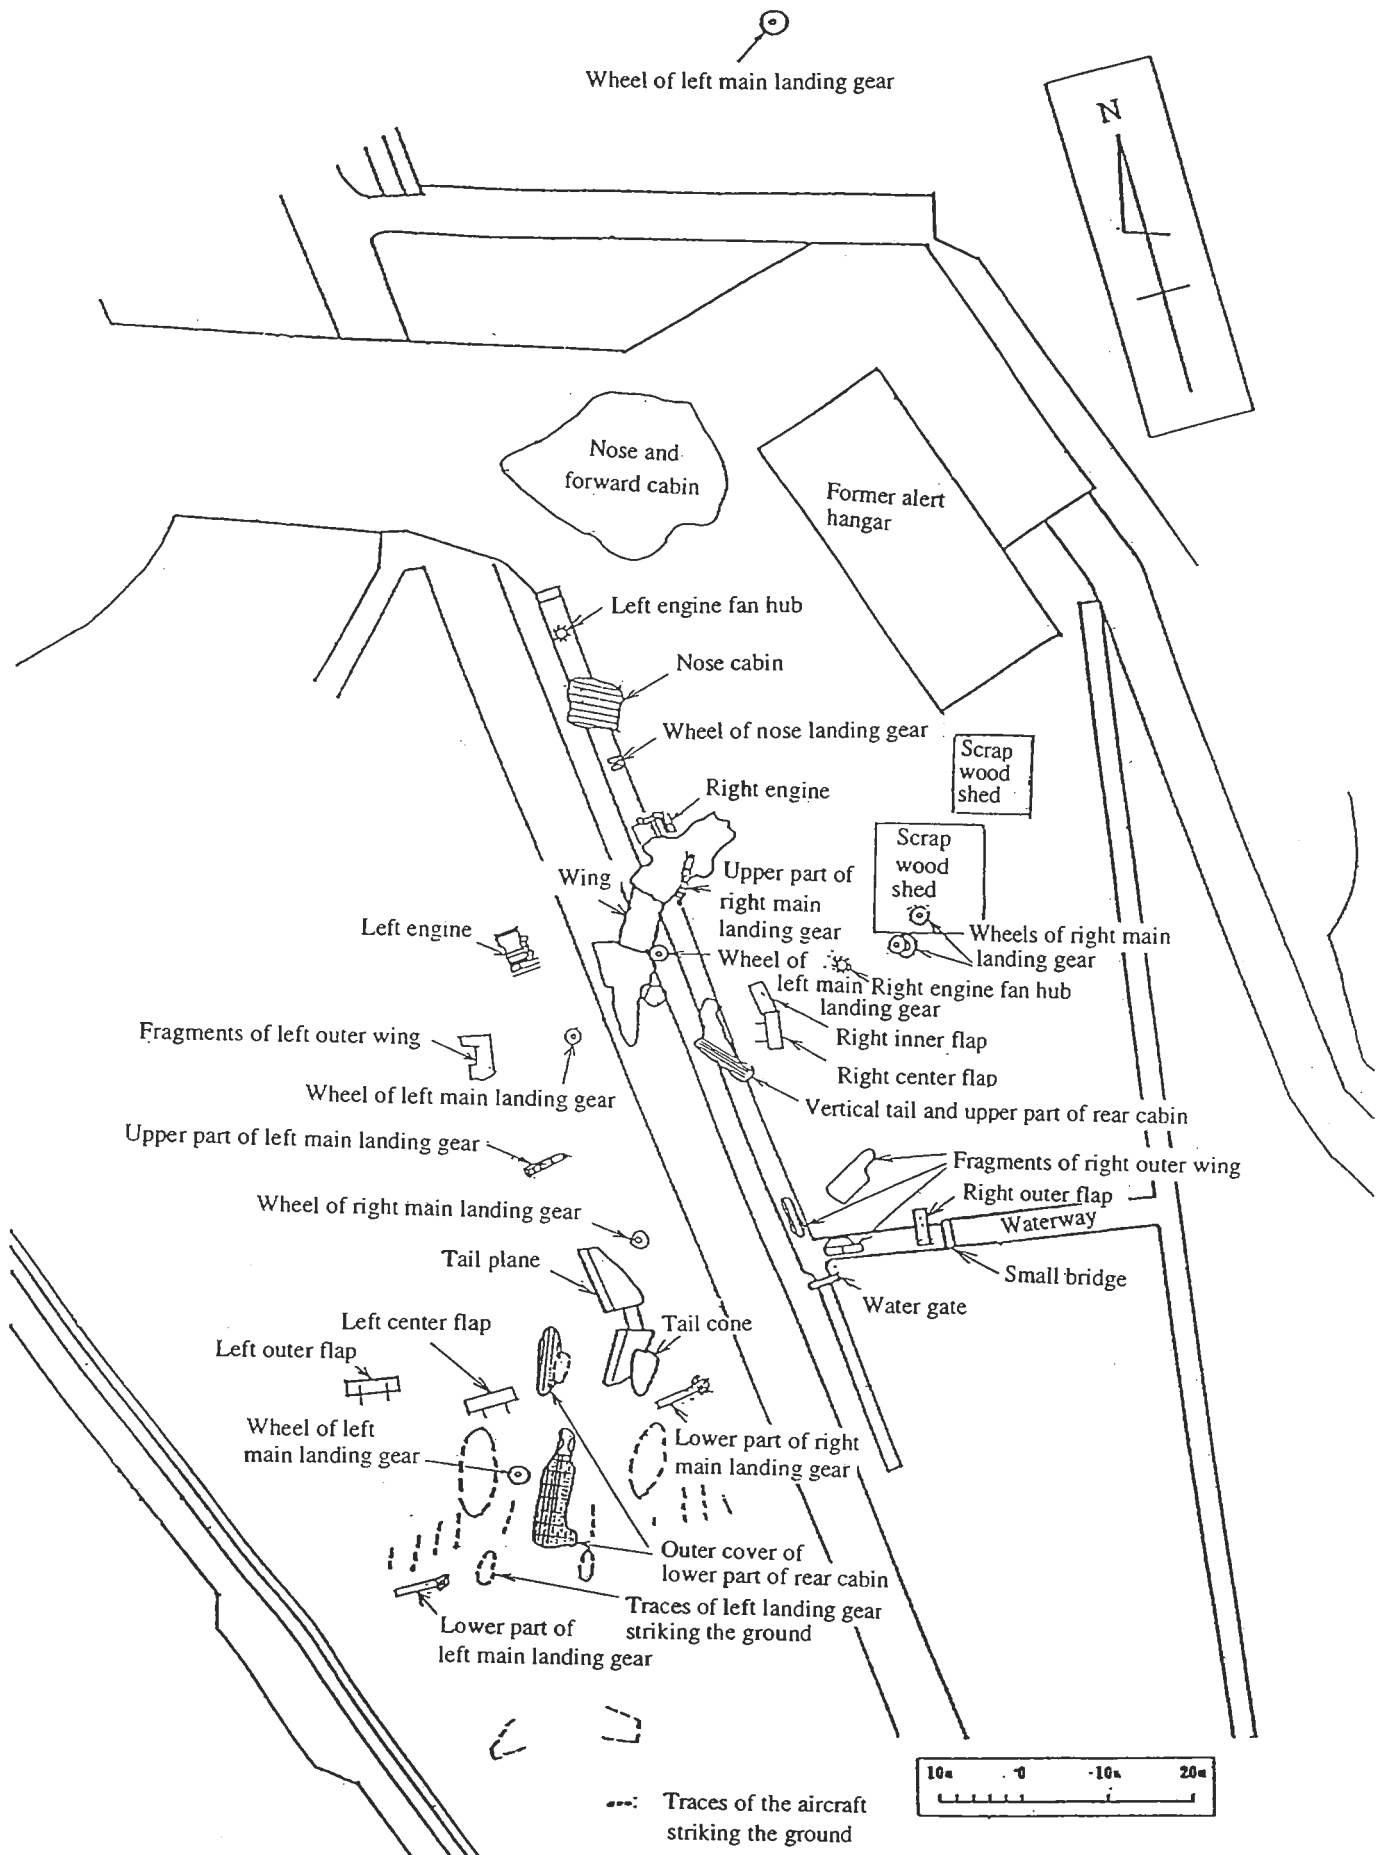
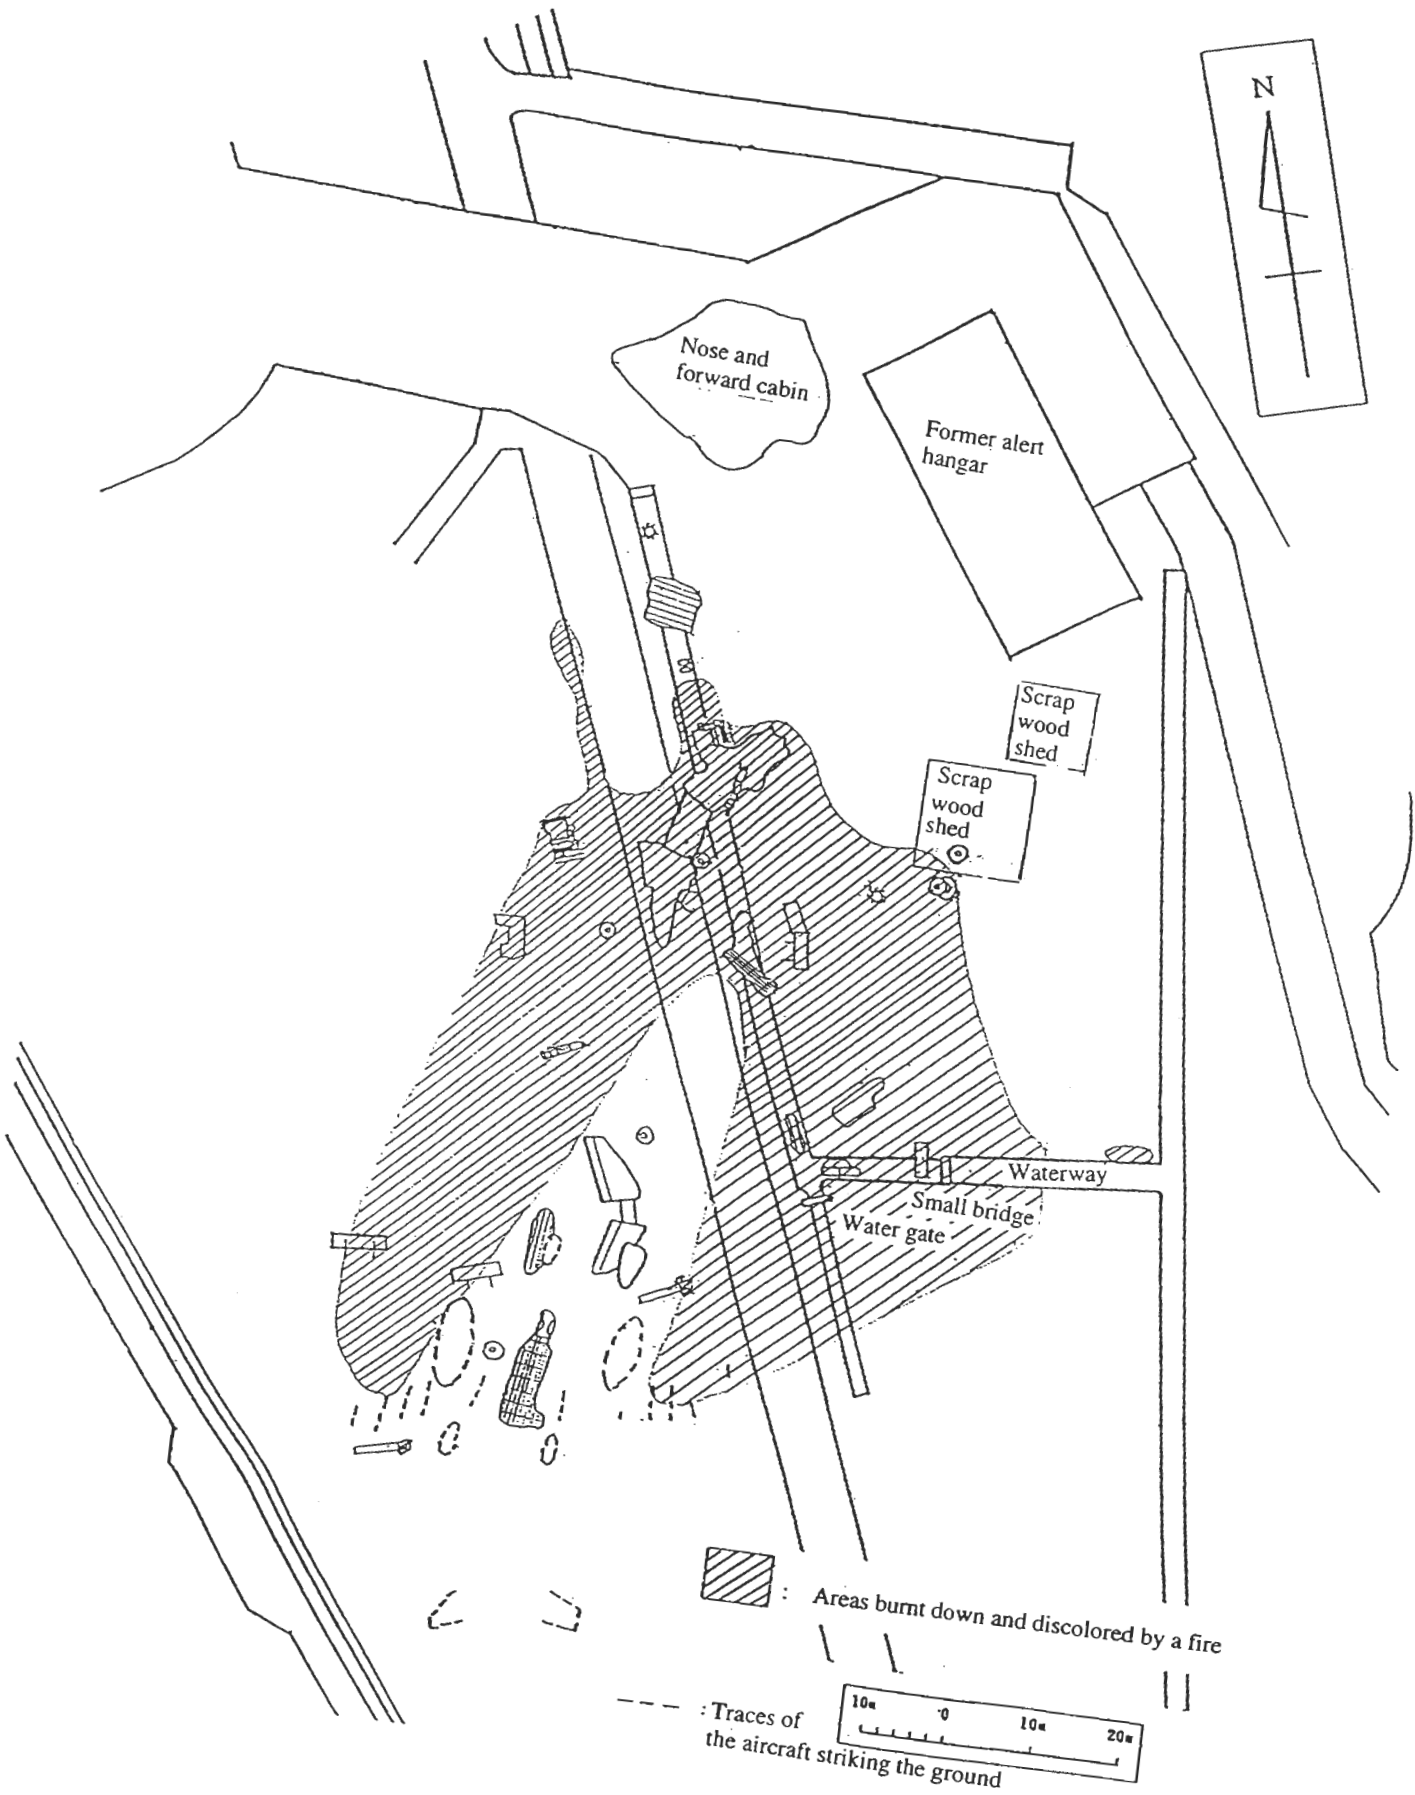
Attached Figure 12 Traces of Fire

An approximately 50 meters long and 20 meters wide scorch mark of fire were detected on the ground, each extending to the east-northeast from the vicinities of the ground scars of the LH and RH wing flap tracks, and the trees near the water gate were burnt. Signs of fire were also detected on the ground near where the wings were found (see attached Figures 11 ,12 and Photographs 2 and 3).

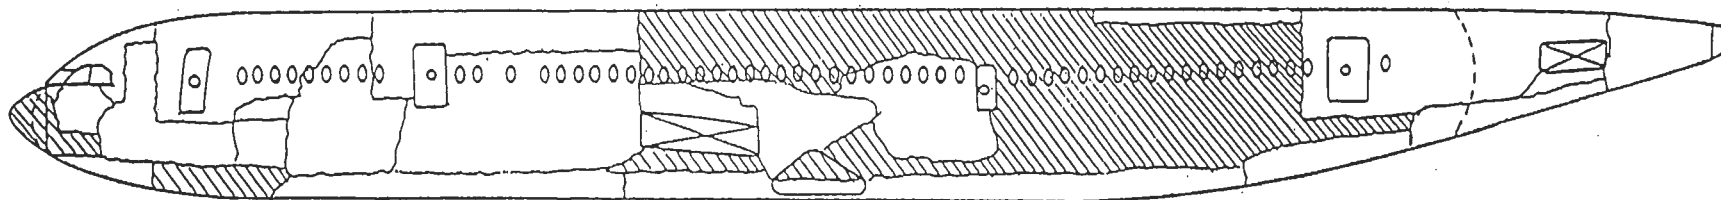
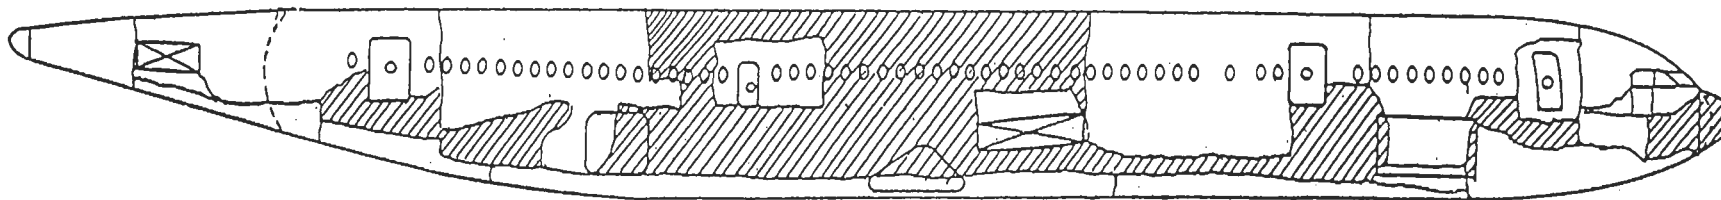
Attached Figure 13 State of Damage to Fuselage Skin

State of Breakage in Left Fuselage

State of Breakage in Right Fuselage

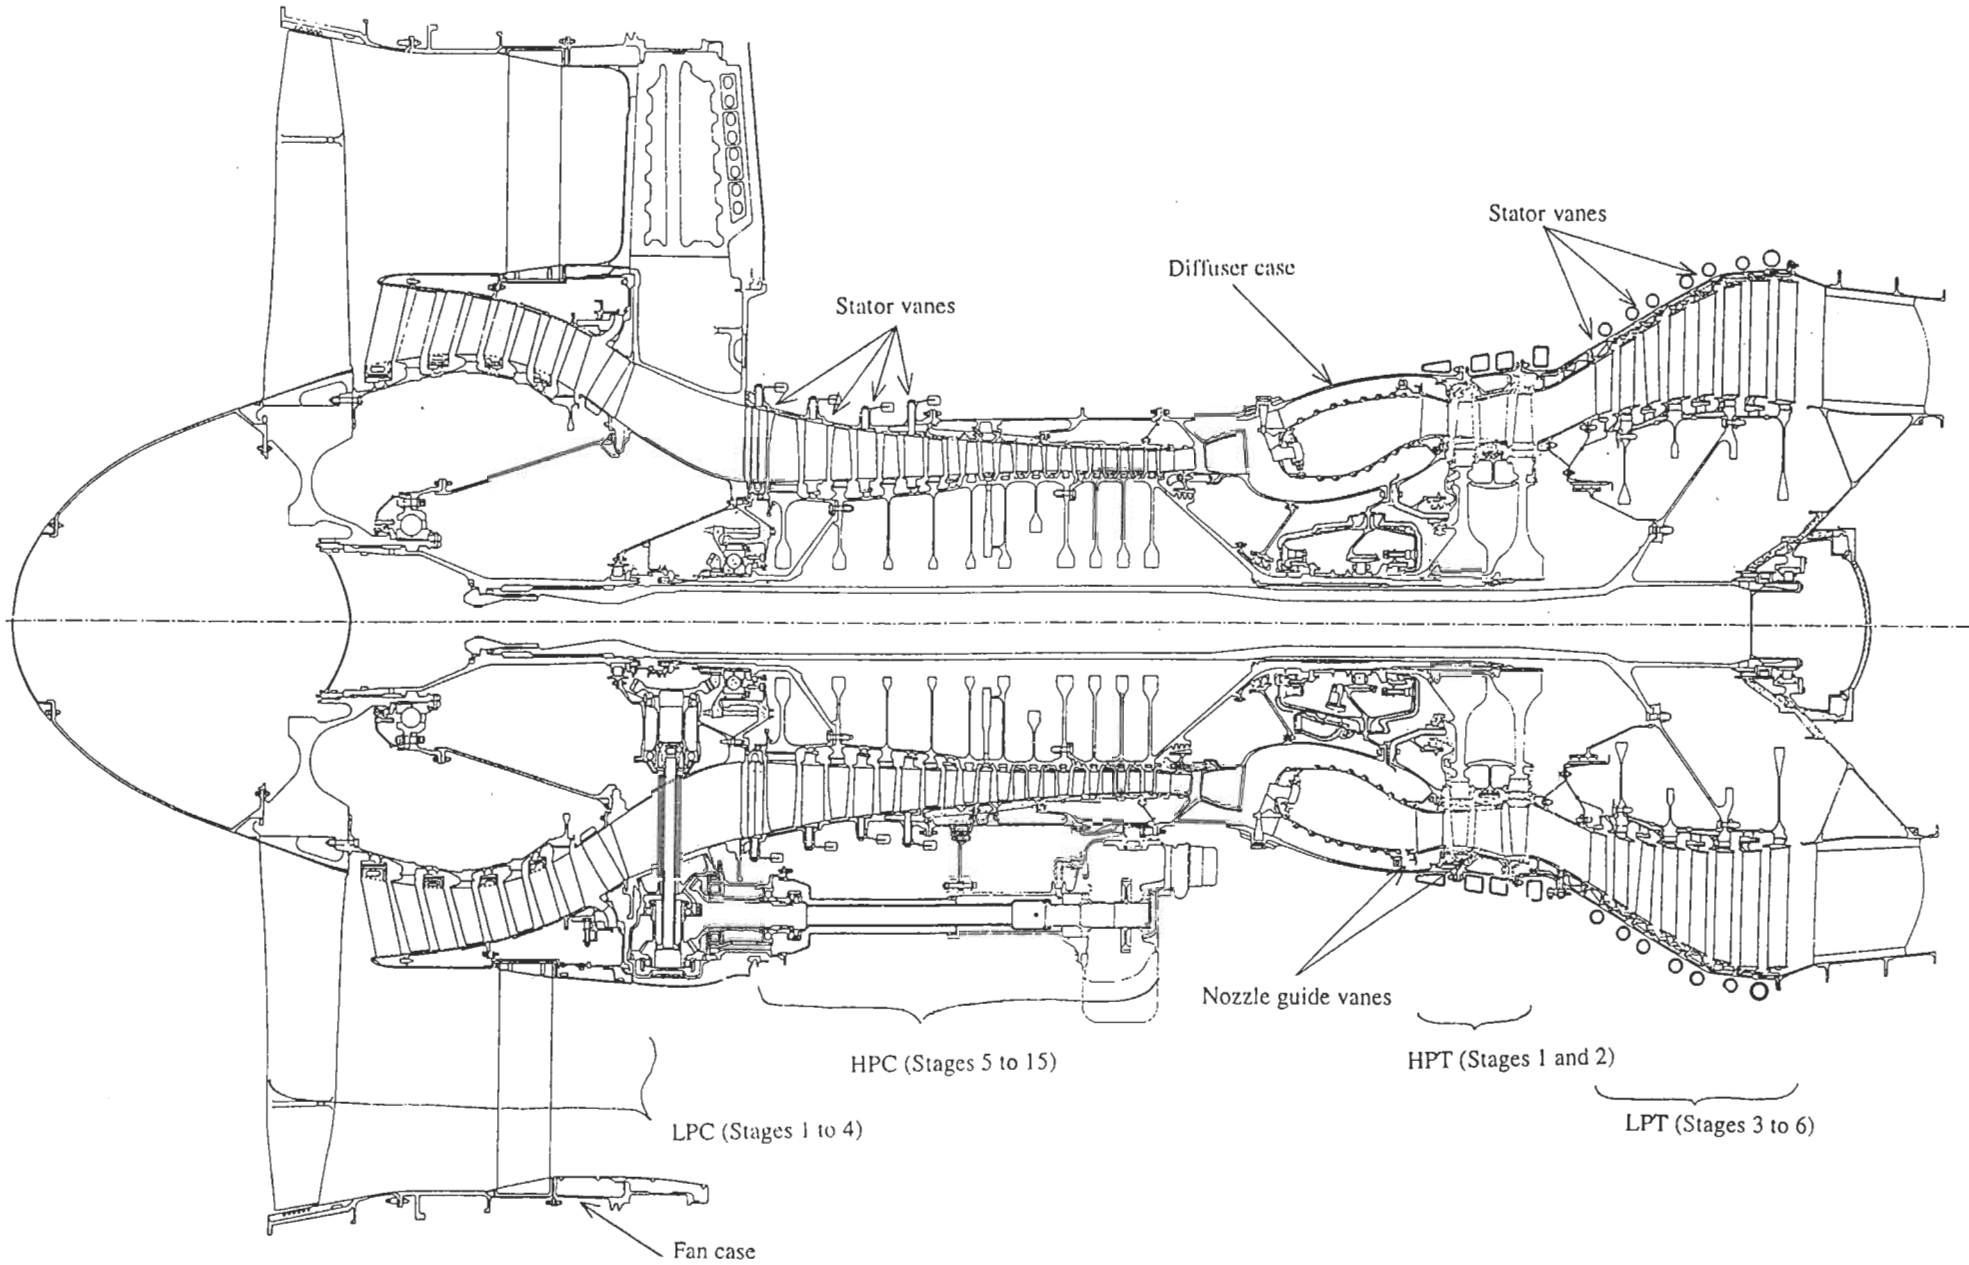
Attached Figure 20 Engine Sectional View (Pratt & Whitney model PW 4158)

- (5) All oils collected at the crash site (fuel, engine oil, and hydraulic fluid) contained a great deal of foreign matter such as water, mud, grains of sand, and other fiber-like objects, and they were found polluted and deteriorated, making it difficult to determine the conditions they had been in before the crash. (See Attached Figure 20 and 21.)

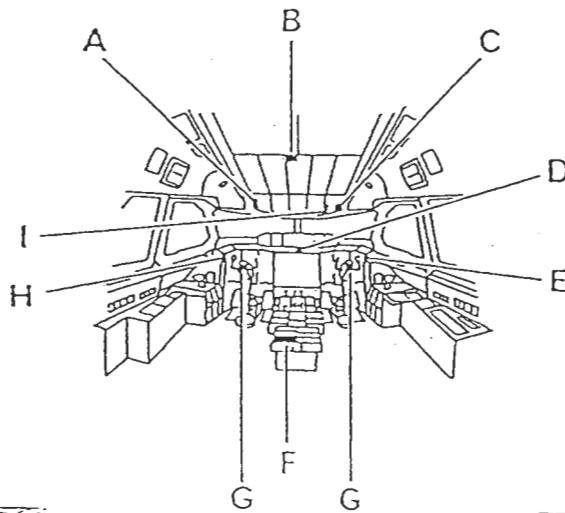
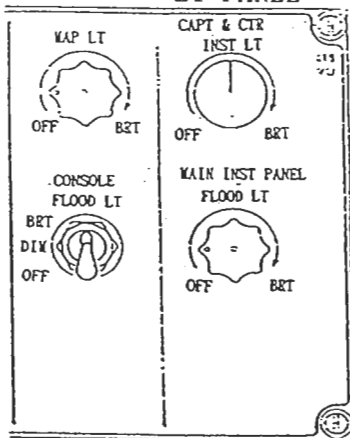
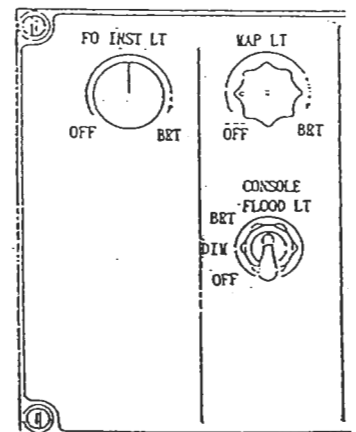
Attached Figure 23 Layout of Lighting Switches in Cockpit

- (3) From the conversation between the CAP and F/O, recorded on CVR, about control of a light, it is recognized that the CAP was adjusting a light (refer to attached Figure 23).

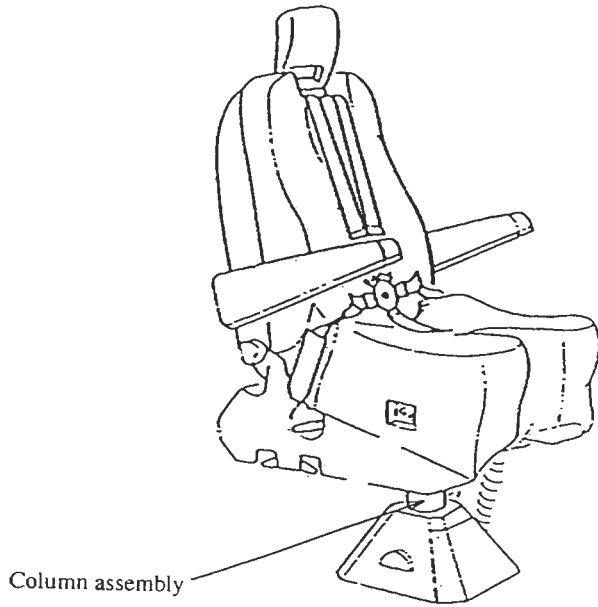
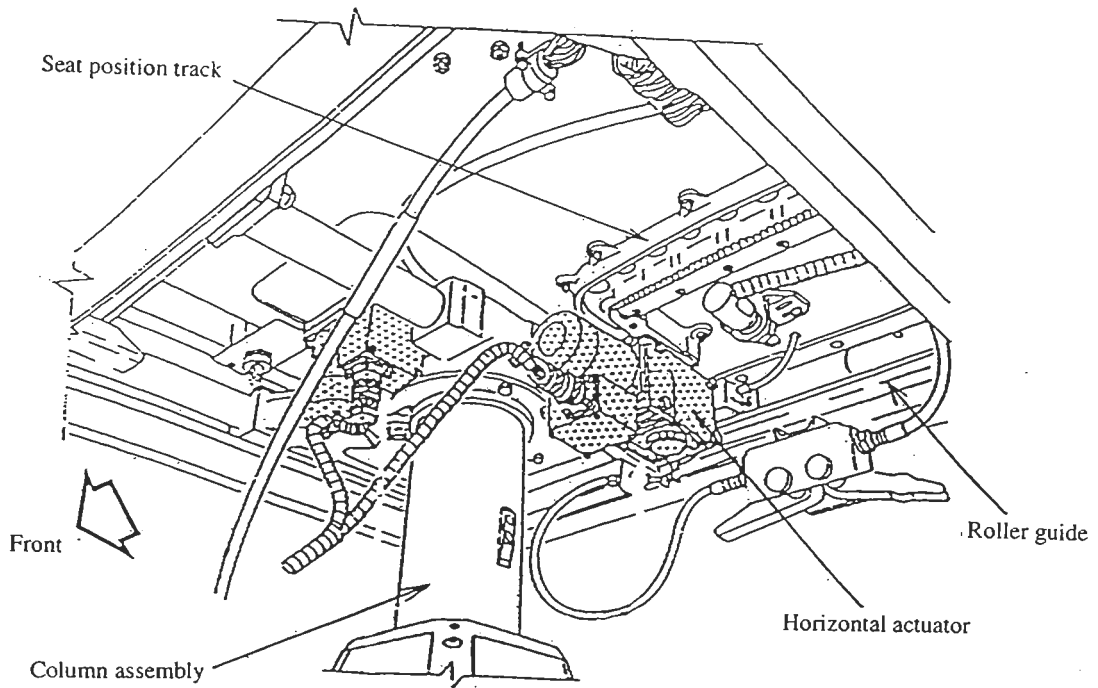
Attached Figure 24 External View of Pilot's Seat

According to their airman medical certificates, the CAP and the F/O were 162.5 cm and 178.1 cm tall, respectively. (See attached Figures 24 and 25.)

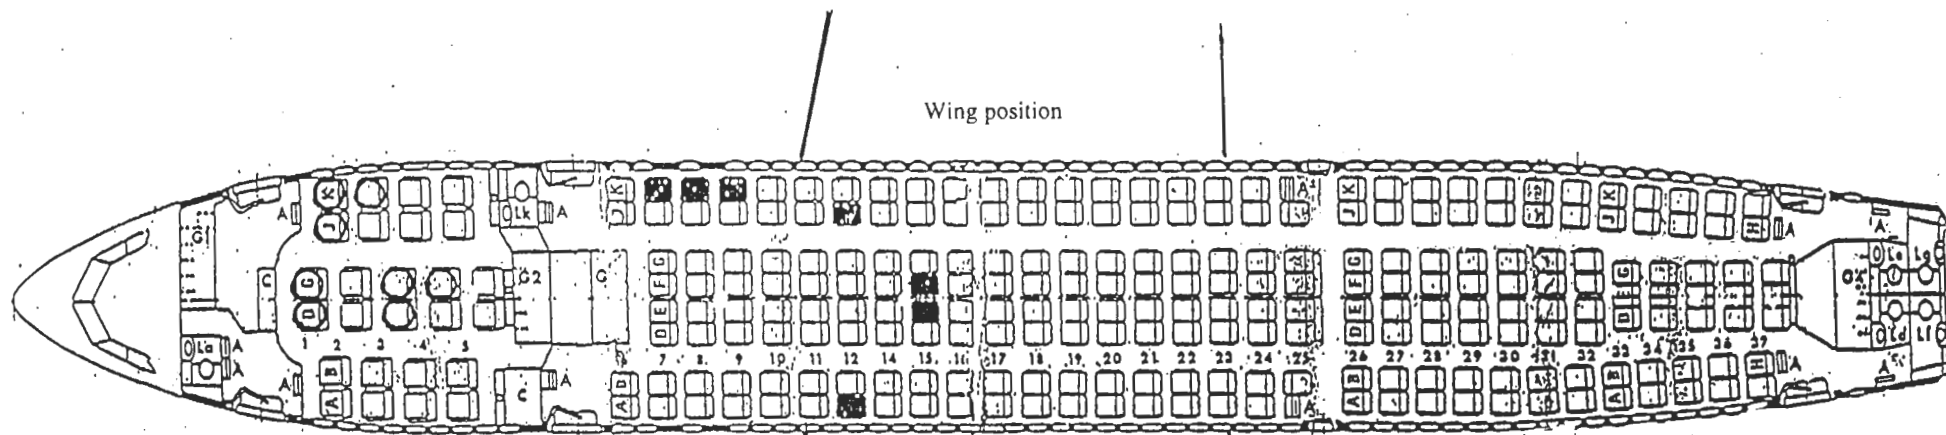
Attached Figure 26 Seat Arrangement Chart

Adjacent to the cockpit and behind the F/O's seat, a galley (No.1 galley, see attached Figure 26) was located in which liquors (about 40 bottles of whiskey and other liquors) were stored for passenger service. Also on board were bottles of alcoholic liquor carried by passengers.

✱ ■ seats occupied by survivors.

○ seats were not occupied. The rest of seats were occupied by the deceased.

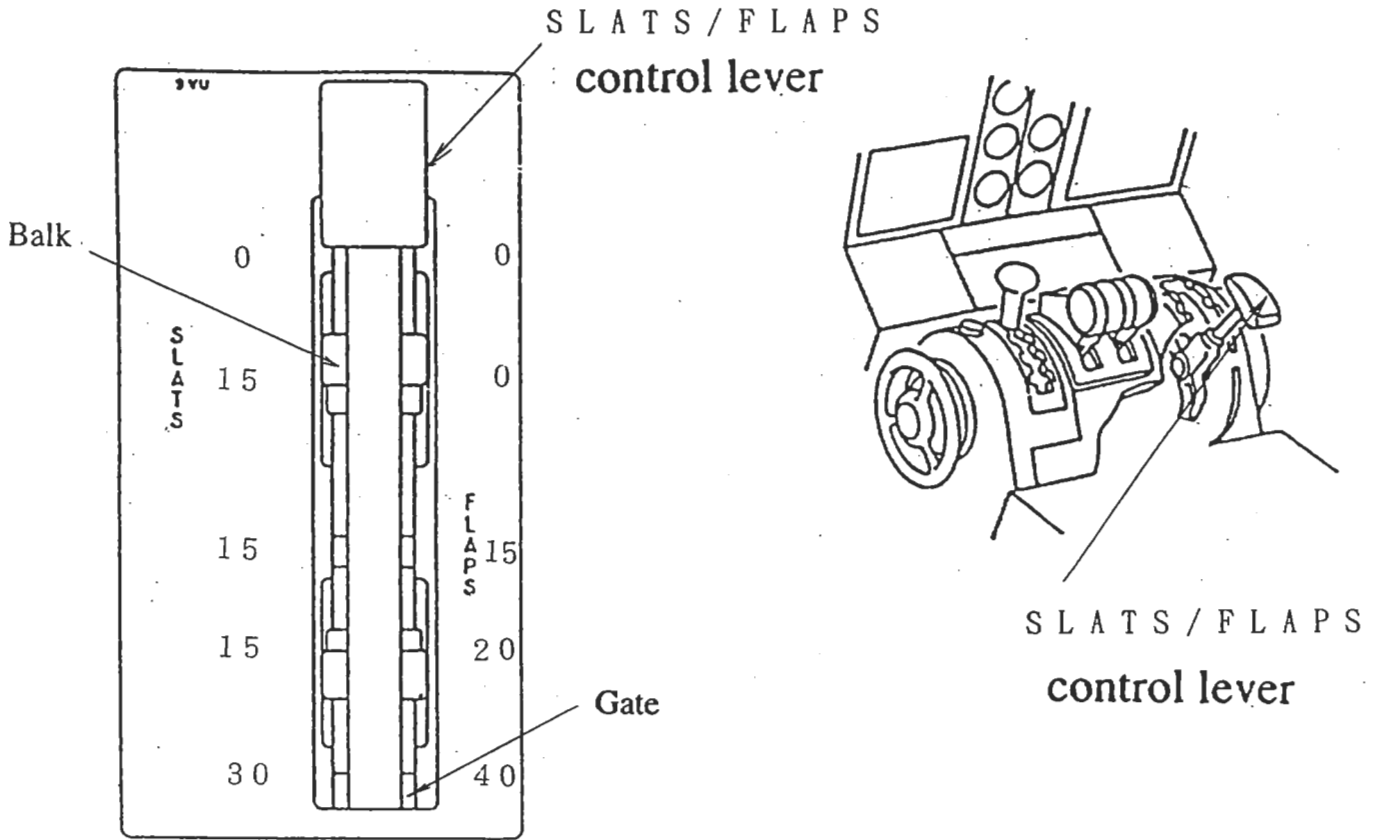
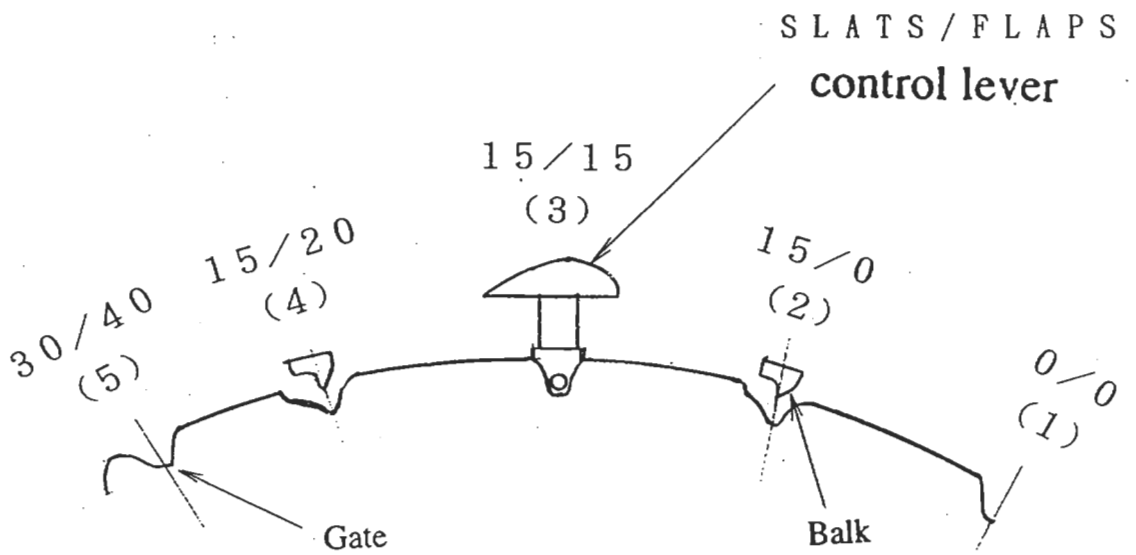
Attached Figure 27 Sketch of SLATS/FLAPS Control Lever Gate and Balk

- 1115:18 The sound indicating passage of the SLATS/FLAPS lever through the baulk attached gates was recorded twice (see attached Figure 27).
According to normal go-around procedure, the SLATS/FLAPS lever should be moved from the 30/40 position one step higher to 15/20. However, judging from the numbers of times the SLATS/FLAPS lever sound was recorded, it may have been moved beyond the 15/20 position, perhaps to the even higher 15/0, or 0/0 position. Later, at 15:27, a sound presumably indicating the SLATS/FLAPS lever's downward movement passing through the baulk attached gate was recorded on the CVR. Also on the DFDR is a record showing that the SLATS/FLAPS lever was set on the 15/15 position at 1115:28.

While the SLATS/FLAPS lever should be moved from 30/40 to 15/20, from the CVR record it is considered possible that the lever was moved to 15/0 or even higher, to the 0/0, before being lowered again to the 15/15 position. The landing gears were left in the down position (See attached Figure 27.).

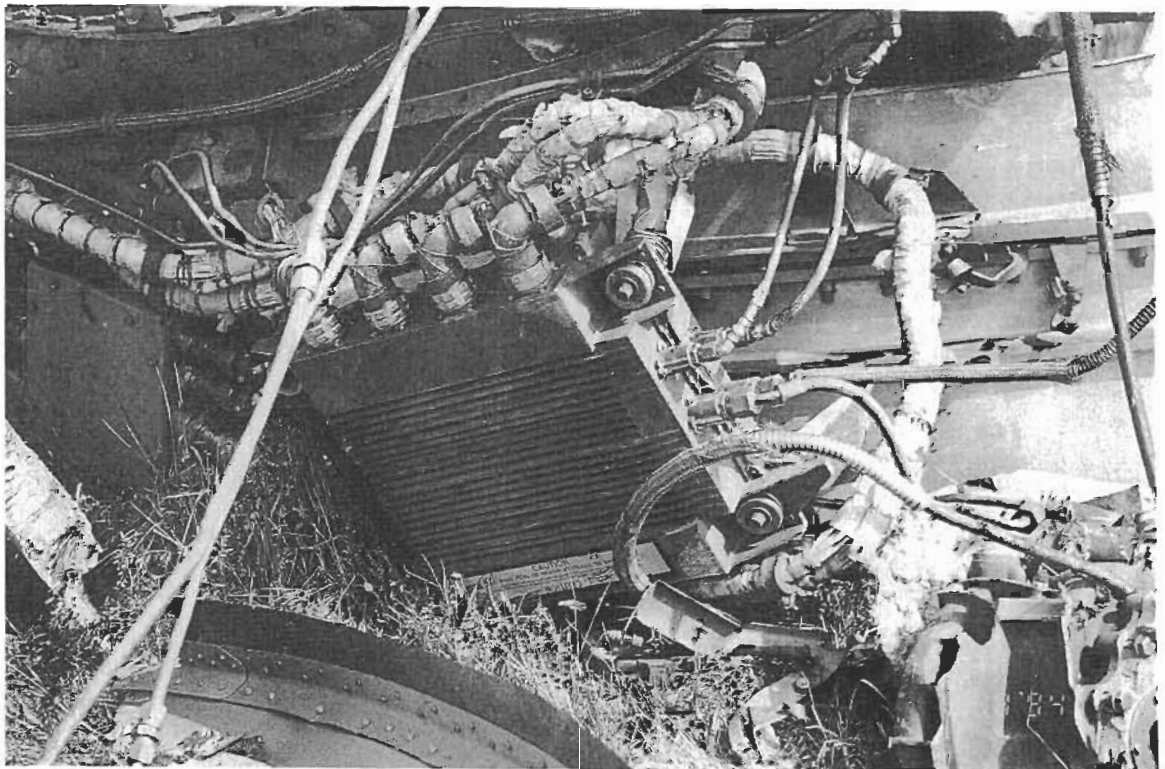
Photo.32 No.1 Engine FADEC

The FADECs had a dual system consisting of channels A and B. Their disassembly inspection showed that the processor boards for both channels in each FADEC were in good conditions. The fault memories storing the engine control failure condition records were readable on all the channels. As a result of the analysis of these records, evidence of surges which indicate a rapid drop of pressure in the engine combustor in flight before crash, was detected in channels A and B of the FADEC for both engines (See Photograph 32).

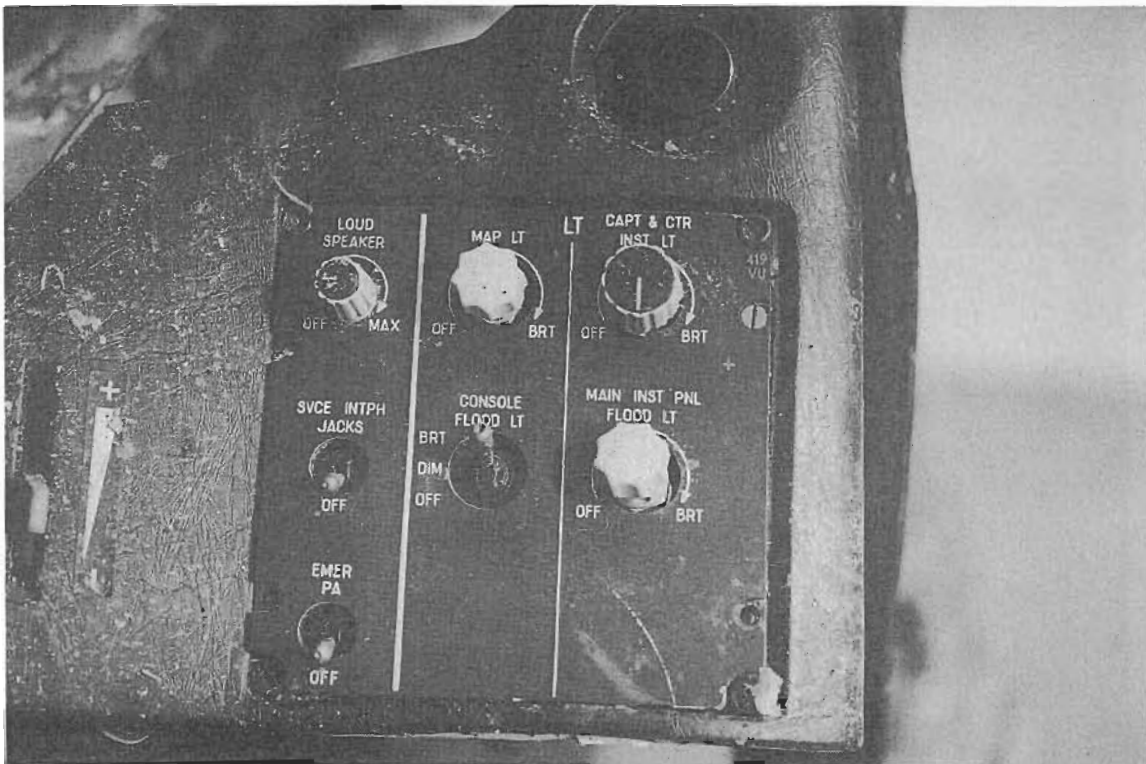
Photo.42 Captain and Center Light Panel

- ④ Lights operated from CAP's or F/O's seat through a knob on the pedestal:
 - Pedestal and overhead panel light
- ⑤ Lights operated from CAP's seat (also from F/O's seat) through controls on the cockpit light panel in front of the overhead Panel CAP's seat:
 - Dome light
 - Storm light
- ⑥ Lights operated from CAP's or F/O's seat through the glareshield lightning controls :
 - Each window of the glareshield panel
 - Push-button switch integrated light (See attached Figure 23 and Photograph 42.)
