**AIRCRAFT ACCIDENT
INVESTIGATION REPORT**

**AIR FRANCE
FGSPD**

Japan Transport Safety Board

**AIR FRANCE
BOEING 777-200, FGSPD
ABOVE ABOUT 21KM SOUTHEAST OF NIIGATA AIRPORT
AT ABOUT 08:19 JST, MARCH 5, 2009**

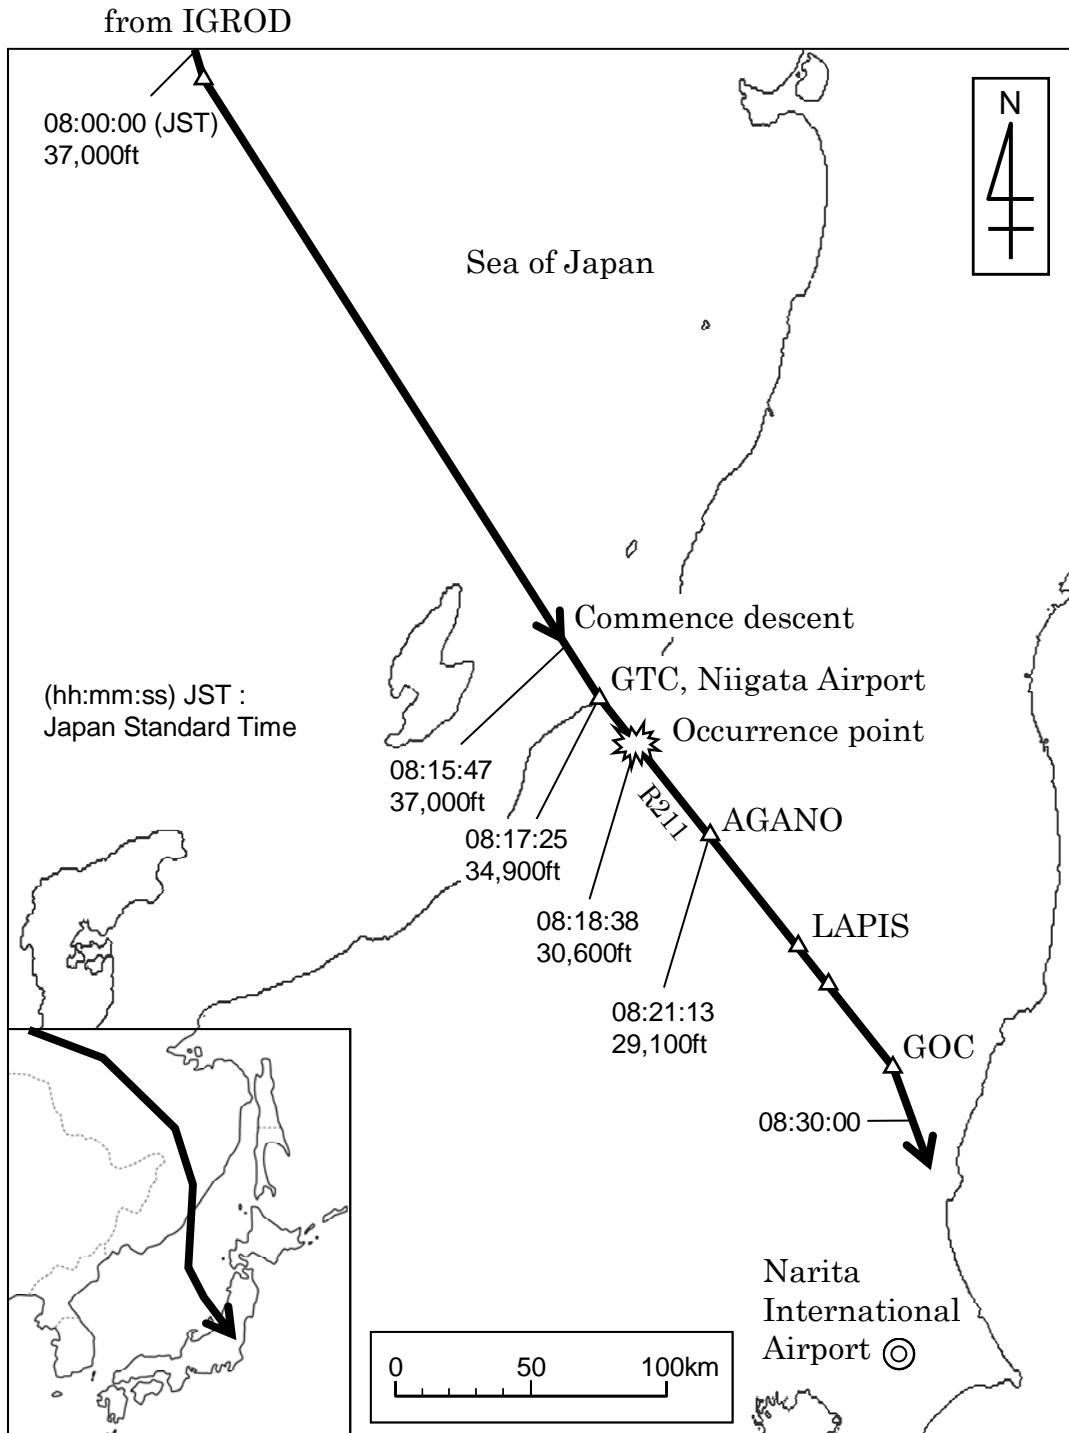
Figure 1 Estimated Flight Route

Passing GTC, the Aircraft was flying to LAPIS in the airway R211. A/P and auto-throttle were used. The weather condition was good and there were no clouds. The weather radar in the Aircraft did not show any signs of shake. I sat in the left seat as PNF, FO in the right seat was PF and the second FO was seated in the observer seat.
