**AIRCRAFT SERIOUS INCIDENT
INVESTIGATION REPORT**

KOREAN AIR

H L 7 2 4 0

**KOREAN AIR
AIRBUS INDUSTRY A300B4-600R, HL7240
AT AN ALTITUDE OF APPROXIMATELY 33,000 FT, OVER THE
VICINITY OF HIKARI CITY, YAMAGUCHI PREFECTURE,
JAPAN
AT ABOUT 19:36 JST, JUNE 23, 2009**

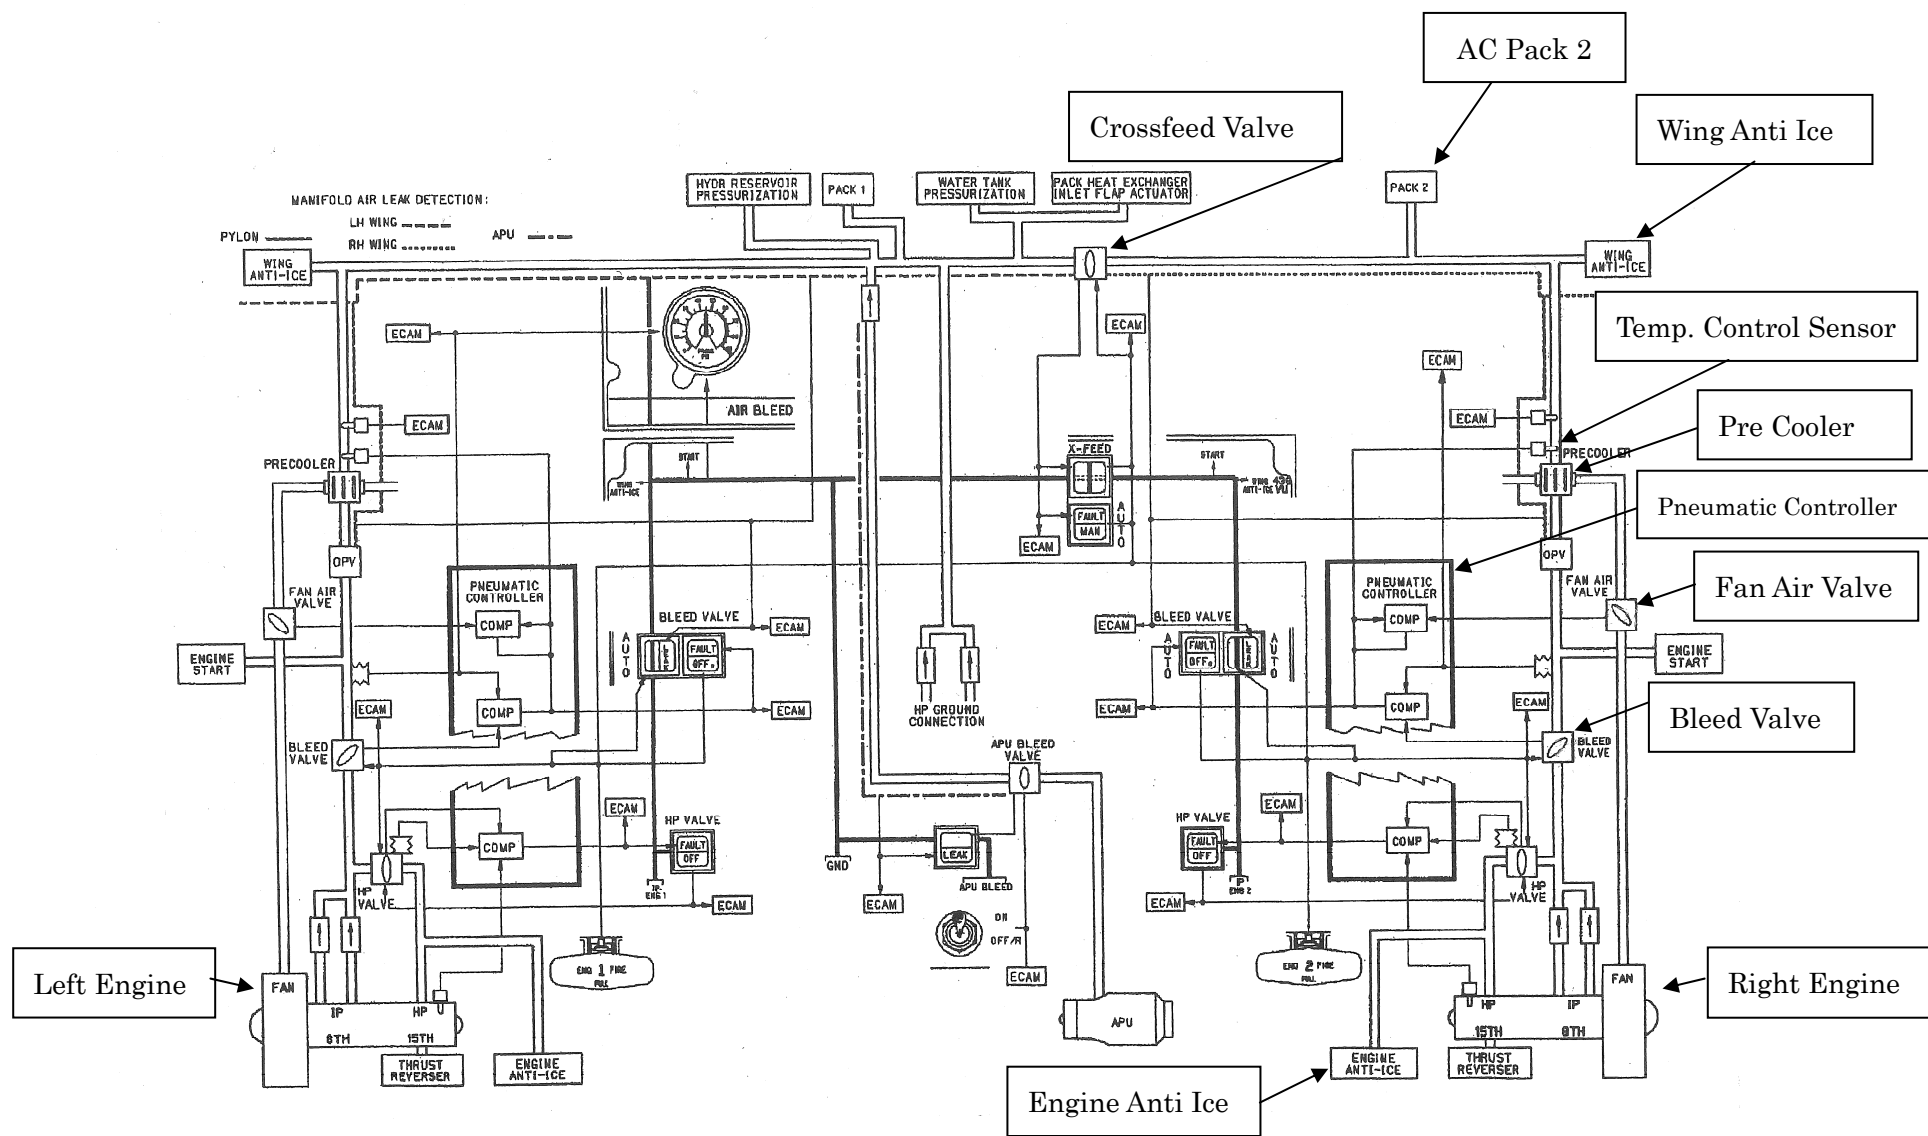
Figure 5 Pneumatic System

- (2) According to the A300-600 aircraft maintenance manual (AMM) issued by the manufacturer of the Aircraft, the temperature of the pre-cooler is controlled by adjusting the opening of the fan air valve, thereby adjusting the flow rate of the cold air. This control is managed by the pneumatic controller based on signals from the temp. control sensor downstream of the pre-cooler. Normally, the opening of the fan air valve is adjusted so that the temperature of the pre-cooler outlet is maintained at $177 \pm 12^{\circ}\text{C}$. When bleed air from one of the engines ceases to be supplied or the wing anti-ice switch is set to ON (hereinafter referred to as "temperature shift"), the temperature of the pre-cooler outlet is adjusted to $227 \pm 12^{\circ}\text{C}$. At the time of temperature shift, the pneumatic controller adjusts the opening of the fan air valve to provide higher temperature. In addition, the pre-cooler has an overheat detection function, which closes the bleed valve of the relevant system when the outlet temperature reaches $207 \pm 3^{\circ}\text{C}$ in normal operation or $255 \pm 3^{\circ}\text{C}$ in temperature shift. After the pre-cooler, the air adjusted as described above is sent to the AC pack (air cycle machine) system, the anti-ice system and other components. (See Figure 4 - Air-Conditioning, Pressurization and Ventilation Systems; Figure 5 – Pneumatic System)

It is considered highly probable that the two AC systems stopped functioning as the failures of the No. 1 fan air valve and the No. 2 pneumatic controller lead to closure of both engine bleed valves.

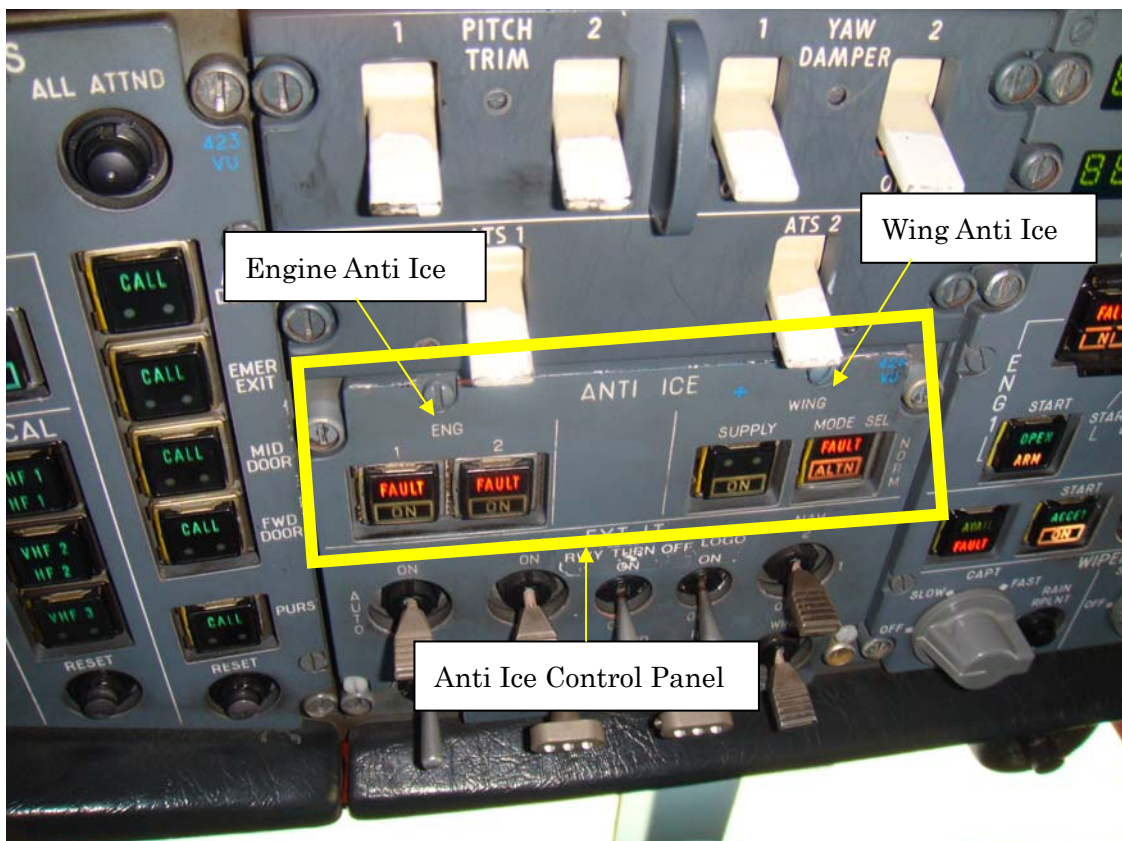
Photo2 Anti Ice Control Panel

*Wing Anti-Ice on and in abnormally high temperature conditions (recorded temperatures up to ISA*¹² +19 °C during the flight period when both bleed systems were lost).*

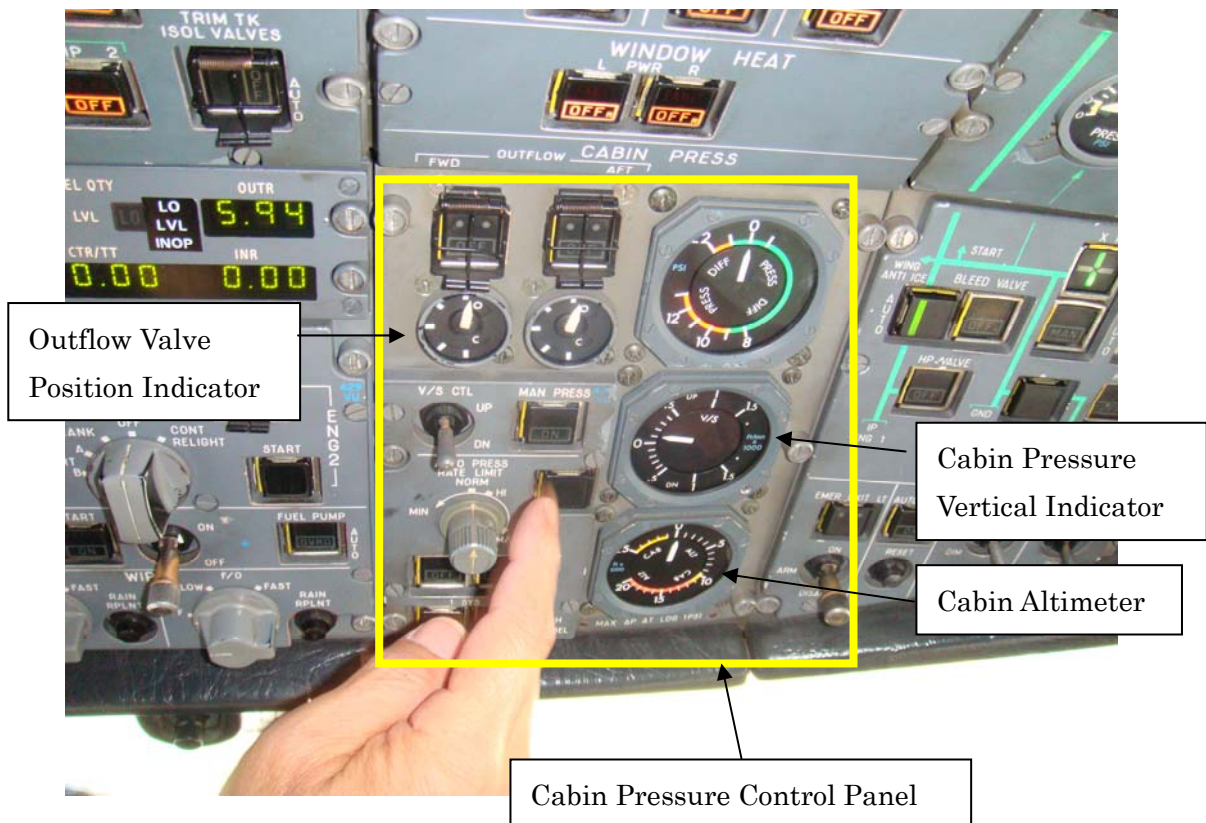
Photo 4 Cabin Pressure Control Panel

descent, the Aircraft's cabin pressurization system returned to normal. Subsequent inspections at Chubu Centrair International Airport and in Korea found no faults in the open/close control system of the outflow valves. The cause of the full-open display of the outflow valves could not be ascertained.
