**AIRCRAFT SERIOUS INCIDENT
INVESTIGATION REPORT**

**KOREAN AIRLINES CO., LTD.
HL 7573**

AIRCRAFT DISABLED TO CONTINUE TAXIING
DUE TO FRACTURED LANDING GEAR AXLE
KOREAN AIRLINES CO., LTD.
BOEING 777-300, HL7573
AT NARITA INTERNATIONAL AIRPORT, JAPAN
AROUND 12:43 JST, JUNE 29, 2018

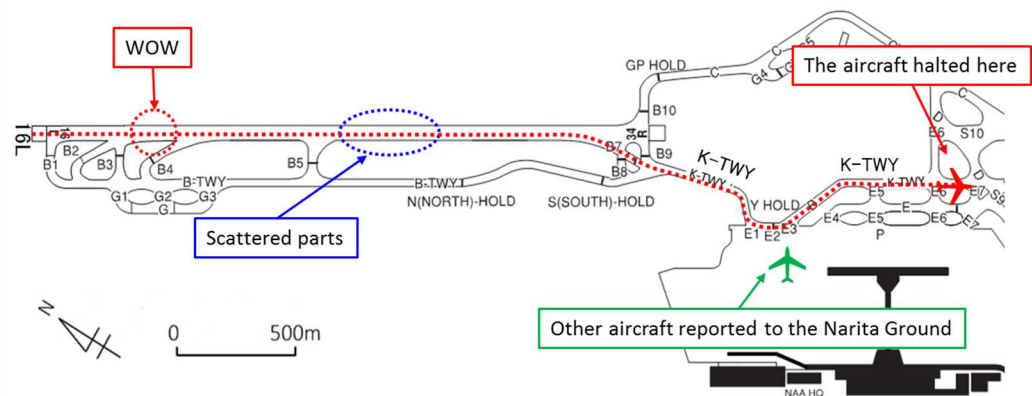
Figure 1 Serious Incident Site

Around 12:41, other aircraft, which was taxiing after the aircraft on the right side, reported with radio communication to the Narita Ground that it sighted something, which was seemingly smoke, on the right main landing gear aft of the aircraft; and subsequently, the Narita Ground instructed the aircraft to halt at the position where it was.

Around 12:43, the captain halted the aircraft in accordance with the instruction from the Narita Ground. The position where the aircraft halted was between E6 and E7 on taxiway K.

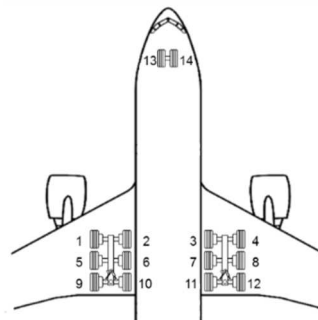
Figure 6 Number Assigned for Each Tire

The captain and the first officer checked the condition of the aircraft with EICAS*1 after halted the aircraft. There were no warning and caution messages appeared on EICAS; however, they confirmed that the temperature of the No. 12 brake was disappeared (see Figure 6), the hydraulic quantity on the right system was gradually decreasing, and status messages of “MAIN GEAR STEERING” and “BRAKE TEMP SYS” were appeared.

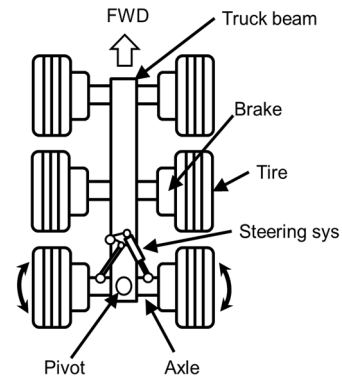
Figure 7 Image of MLG Steering System

The aircraft adopts a main landing gear steering system, which has a mechanism to make a main landing gear aft axle operate by hydraulic pressure in response to the movement of a nose landing gear steering.
