**AIRCRAFT ACCIDENT
INVESTIGATION REPORT**

ASIANA AIRLINES INC.

H L 8 2 5 8

PASSENGER INJURY BY THE SHAKING OF THE AIRCRAFT
ASIANA AIRLINES INC.
AIRBUS A330-300, HL8258 (THE REPUBLIC OF KOREA)
AT AN ALTITUDE OF APPROX. 40,000 FT, OVER MATSUE CITY,
SHIMANE PREFECTURE, JAPAN
AT AROUND 15:17 LOCAL TIME, AUGUST 21, 2012

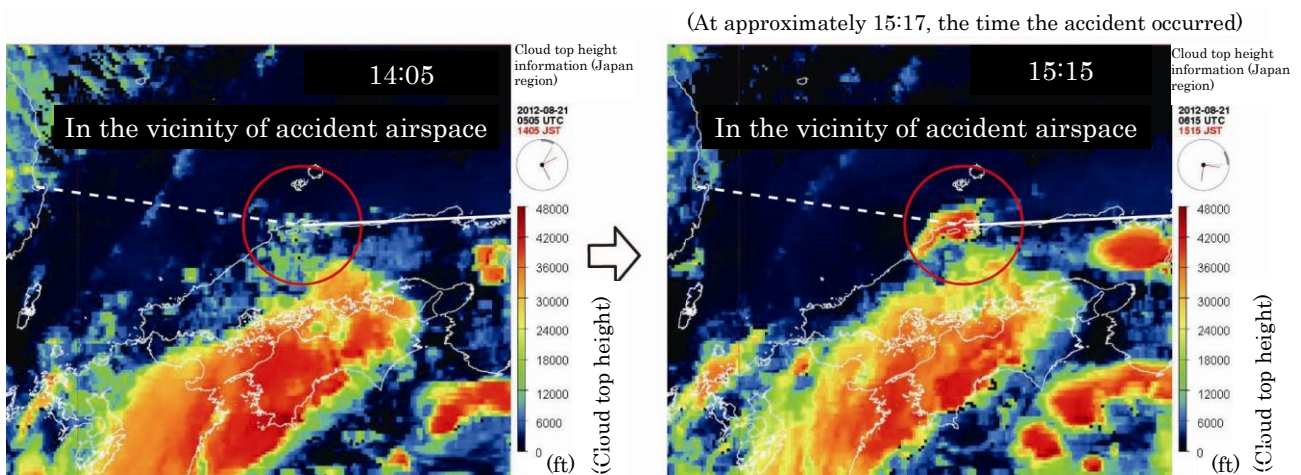
According to Rapid Scan Observation imagery *⁷, at 14:05, clouds with a low cloud top height were scattered in the vicinity of the accident airspace, but as time passed, more clouds developed, and at 15:15, immediately before the accident, clouds reaching a high-altitude cloud top height were analyzed.

According to Doppler radar echo top distribution imagery from equipment installed at Miho Aerodrome adjacent to the accident occurrence point, within the time period of the accident multiple cumulonimbus were generated as a cluster in the vicinity of the accident airspace. The clouds were analyzed to be cumulonimbus with a cloud top height exceeding the Aircraft's flight altitude of 40,000 ft.

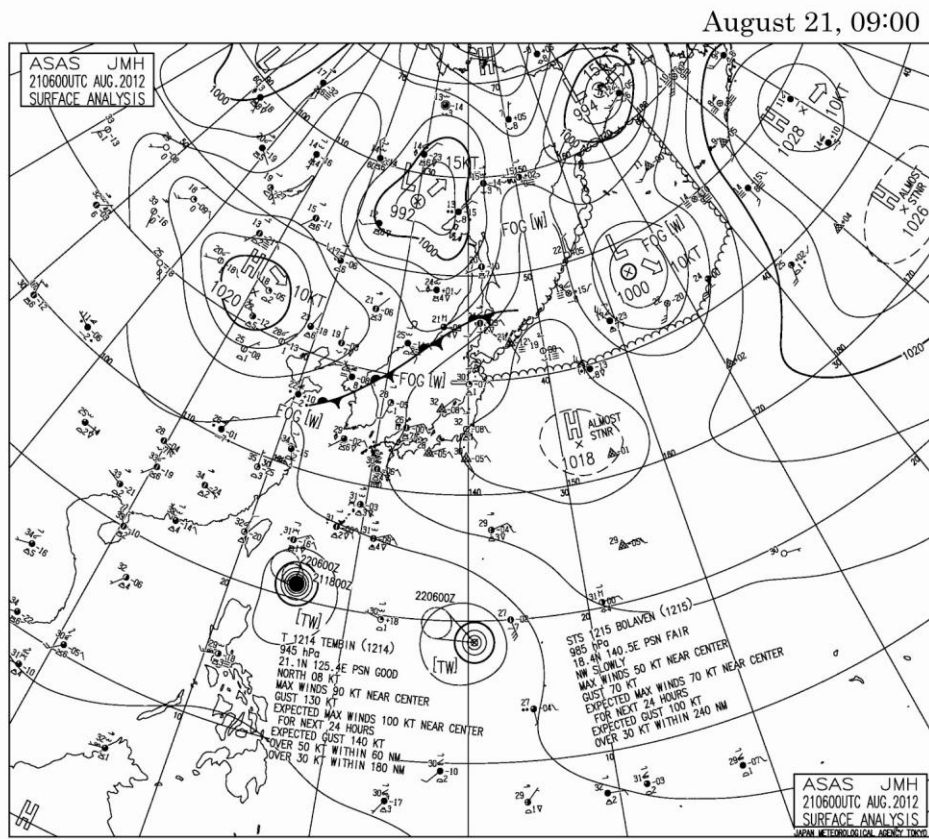
Figure 5: Asia Surface Analysis Chart

moisture-laden warm air*⁶ moving around the edge of the high-pressure area over the sea to the east of Japan were flowing from the Pacific Ocean side into the West Japan region, the atmospheric conditions over all areas of West Japan became unstable making it easier for cumulonimbus to be generated.

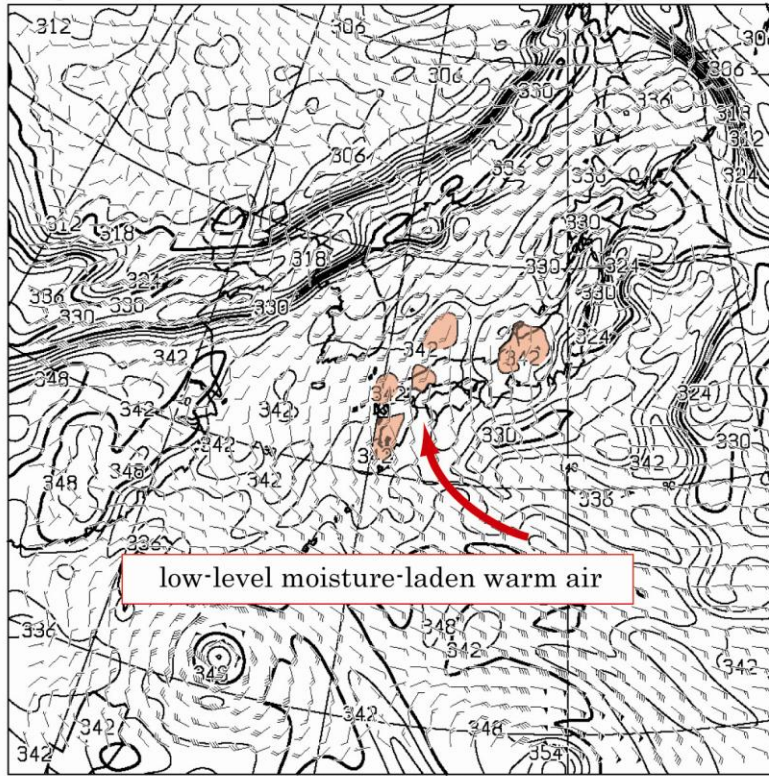
Figure 7: Wind and Equivalent Potential Temperature Prognostic Chart (850 hPa)

: Region of equivalent potential temperature 342K or higher (K: Kelvin)
