**AIRCRAFT SERIOUS INCIDENT  
INVESTIGATION REPORT**

**THAI AIRWAYS INTERNATIONAL PUBLIC CO., LTD.  
H S - T G X**

**EMERGENCY OPERATION TO AVOID CRASH INTO THE GROUND  
THAI AIRWAYS INTERNATIONAL PUBLIC CO., LTD.**

**BOEING 747-400, HS-TGX  
ABOUT 3.5 NM NORTHEAST OF  
TOKYO INTERNATIONAL AIRPORT, JAPAN  
AT ALTITUDE OF ABOUT 300 FT  
AROUND 23:52 JST, APRIL 11, 2018**

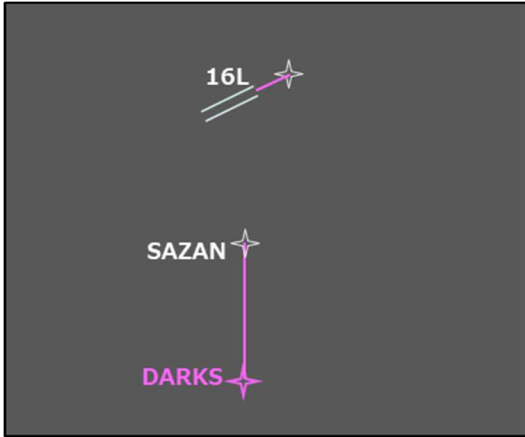
Figure 1: Estimated navigation display (ND) (for image only) when resetting FMS

The flight was smooth at take-off and in cruising. The FO attempted to reset FMS to approach the Airport in accordance with the instruction from the PIC after receiving ATIS “B” of the Airport; however, VOR A approach was not registered in FMS navigation data base. In dealing with that, after inputting DARKS ARRIVAL, the FO inputted SAZAN after DARKS, which was the final point of DARKS ARRIVAL and then created a FIX at a point 1 nm from Runway 16L threshold on the final leg to make them references course. (See Figure 1)

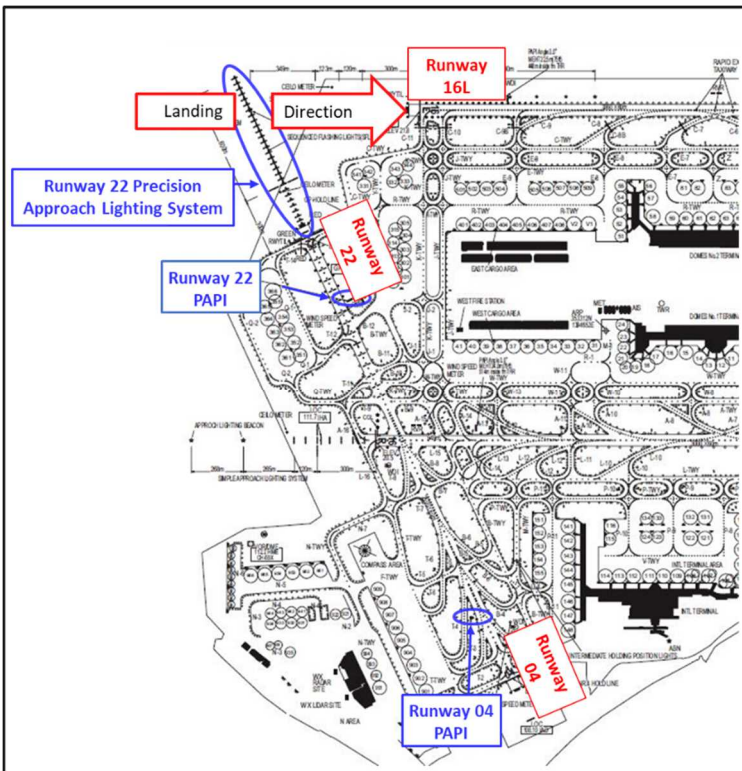
Figure 2: Runway 22 Precision Approach Lighting System and Runway 04/22 PAPI

Lightings pertinent to Runway 22 were; precision approaching lighting system was turned off, and lightings such as PAPI that could be switched to runway 04 side were illuminated on runway 04 side to avoid misrecognition of preferential landing runway of 16L. (See Figure 2)

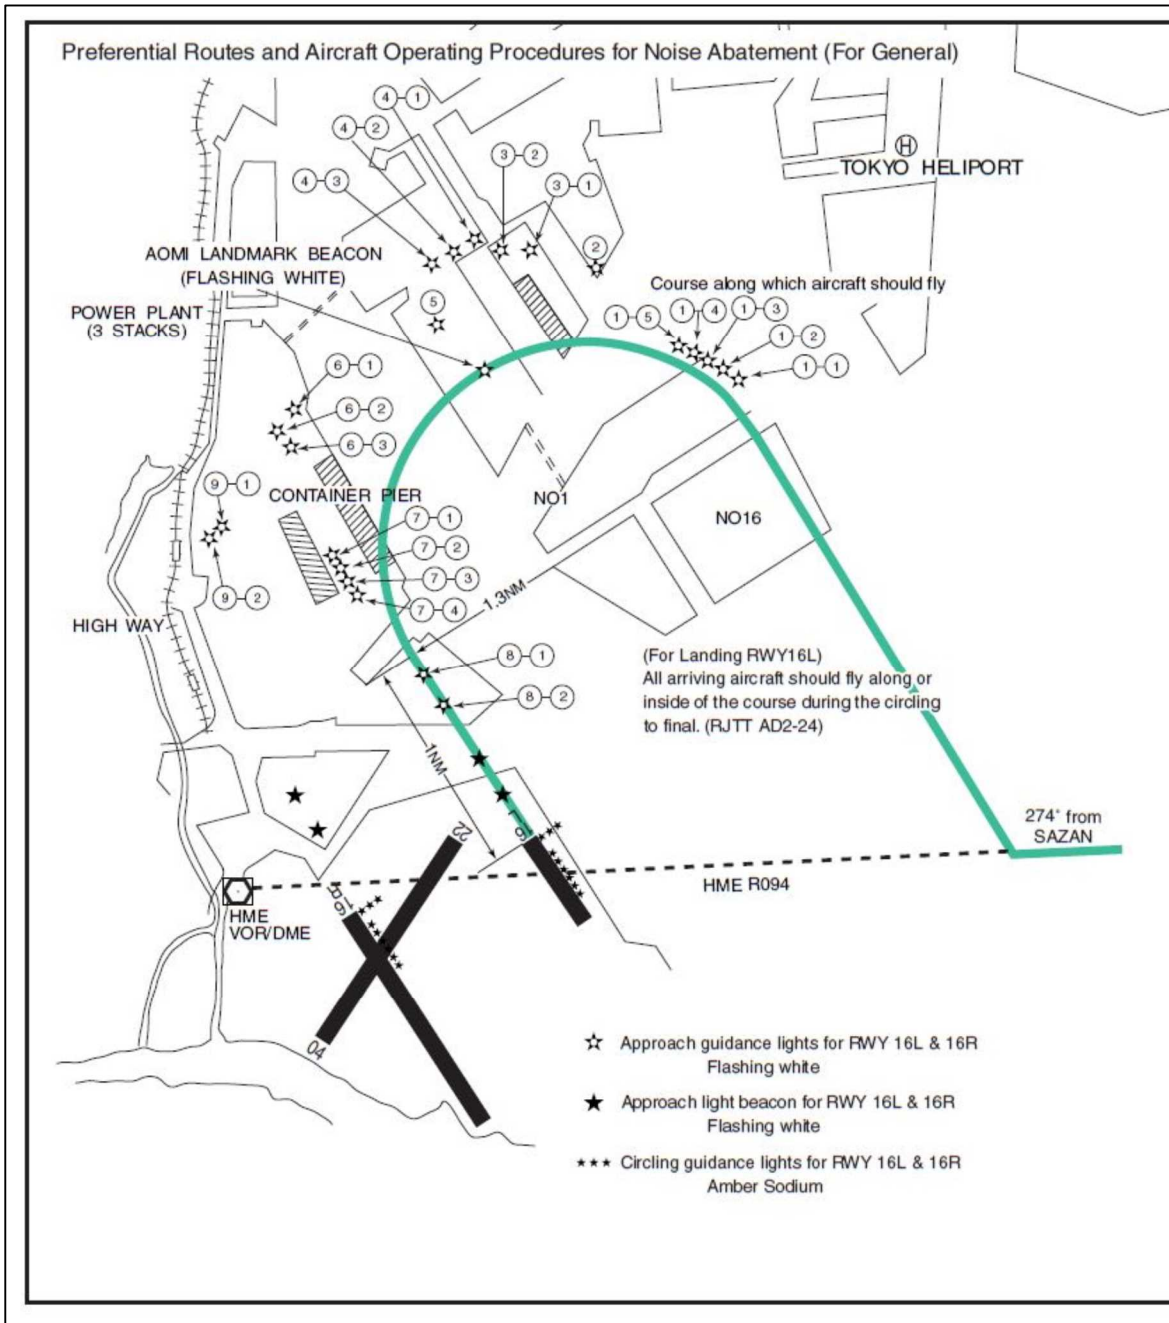
# Appended Figure 9: AIP Noise abatement flight course drawing (excerpt)

As described in 2.8.3, noise abatement flight course is published in relation to the circling approach course at the Airport, and aircrafts are required to fly along or inside the flight course. However, it is somewhat likely that visual selections of the flight course were easy to vary depending on crew members who selected the flight course because the AIP chart (see Appended Figure 9) for
