AI2009-6

**AIRCRAFT SERIOUS INCIDENT
INVESTIGATION REPORT**

**JAPAN AIR COMMUTER Co., Ltd.
J A 0 0 1 C**

JAPAN AIR COMMUTER CO., LTD.
SAAB-SCANIA SAAB 340B, JA001C
AT ABOUT 11:26 JST, DECEMBER 18, 2007
NEAR THE RUNWAY AT IZUMO AIRPORT

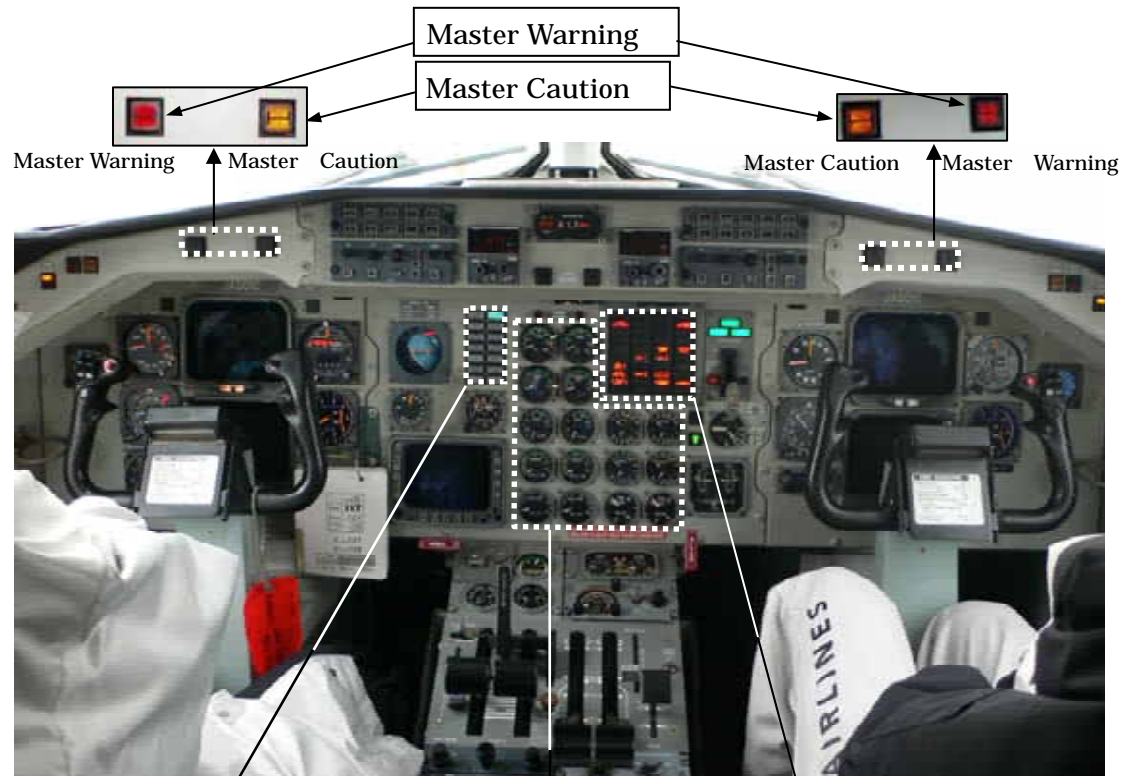
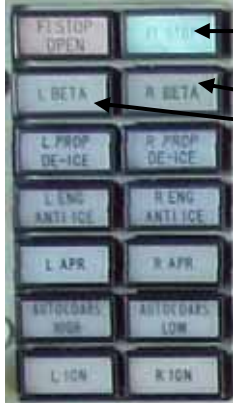
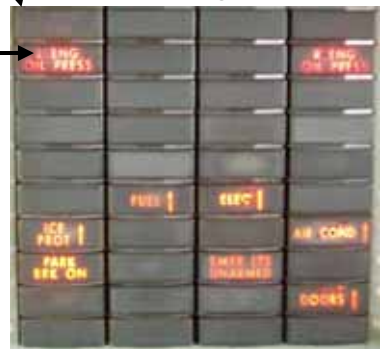
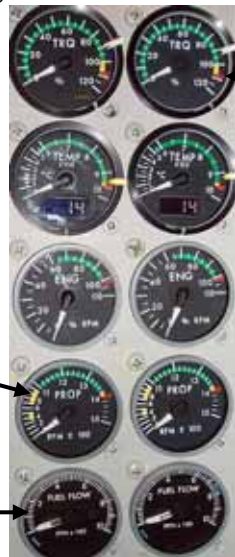
Photo 1 Placement of Instruments and Panels

If, at that time, the FO had checked the annunciator panel as required by the Airplane Operating Manual described in 2.11 (3) and (4), it is considered highly probable that he would have duly found the drop in speed of the left propeller because he would have noticed the abnormal left engine oil pressure and eventually would have checked the engine instruments.

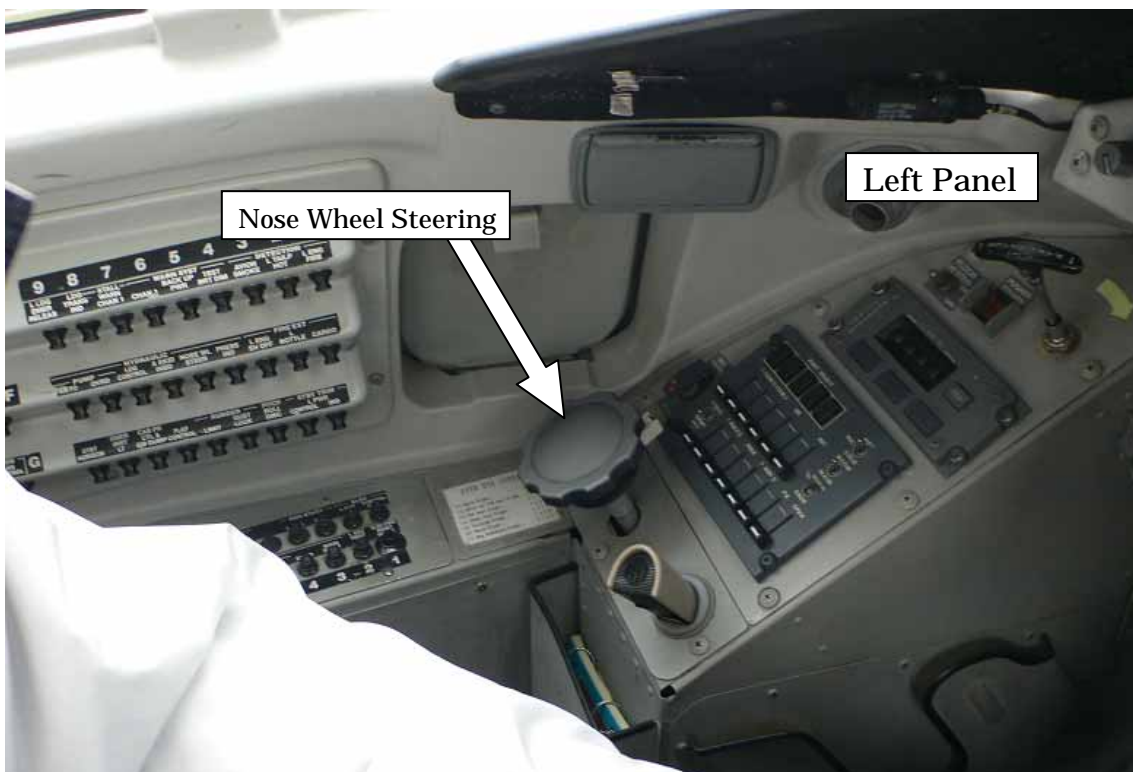
Photo 6 Nose Wheel Steering

As described in 2.13.3 (2), pushing the control column forward after landing enables the Steering to control the direction effectively since this operation causes the nose gear to be forced against the runway surface.
