**AIRCRAFT SERIOUS INCIDENT
INVESTIGATION REPORT**

**Privately owned
JA 007Z**

AIRCRAFT SERIOUS INCIDENT INVESTIGATION REPORT
 DRAGGING DURING LANDING OF ANY OTHER PART OF
 THE LANDING GEARS OF THE AIRCRAFT
 PRIVATELY OWNED
 SOCATA TBM700, JA007Z
 YAO AIRPORT, YAO CITY, OSAKA PREFECTURE
 AT ABOUT 18:06, MARCH 6, 2022

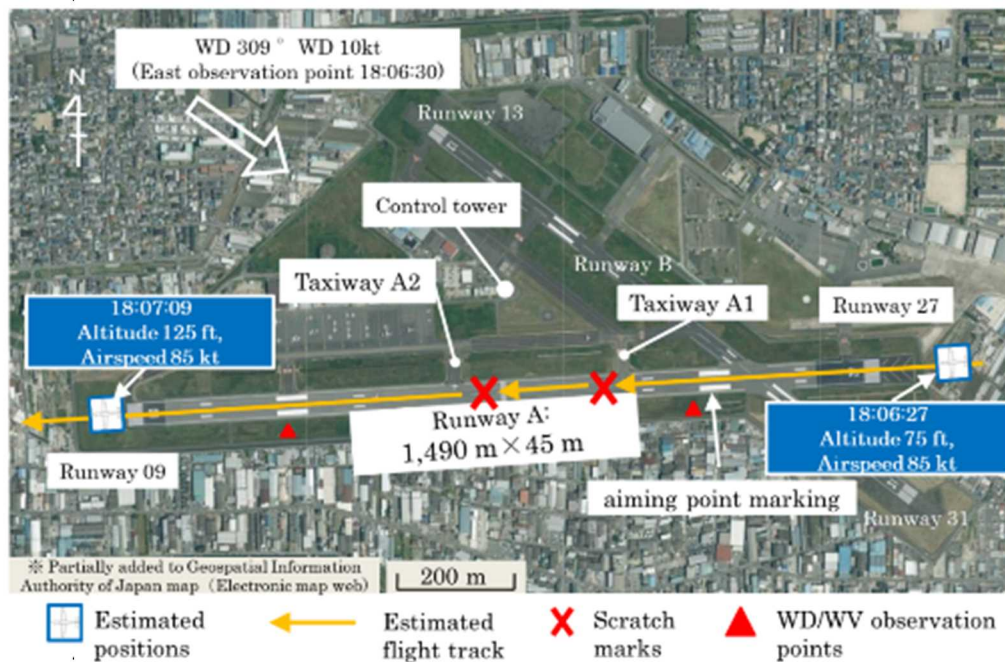
Figure 1: Estimated flight route

back into the air, therefore, the captain judged that it would be dangerous to continue landing, and commenced a go-around in the vicinity of the south of Taxiway A2 (see Figure 1). The captain felt that the Aircraft touched down from the nose gear one time while it was repeatedly bouncing.

(The estimated position information is based on Flightradar24*4 tracks.)
