# AIRCRAFT SERIOUS INCIDENT INVESTIGATION REPORT

CASE WHERE A SLUNG LOAD CARRIED EXTERNAL TO THE  
AIRCRAFT WAS RELEASED UNINTENTIONALLY  
SAITAMA DISASTER PREVENTION AIR SQUADRON  
(ENTRUSTED OPERATIONS BY HONDA AIRWAYS CO., LTD.)  
AGUSTA AW139 (HELICOPTER), JA03FD  
IN HONDA AIRPORT,  
KAWAJIMA TOWN, HIKI COUNTY, SAITAMA PREFECTURE  
AT ABOUT 10:24 JST, FEBRUARY 17, 2024

May 16, 2025

Adopted by the Japan Transport Safety Board

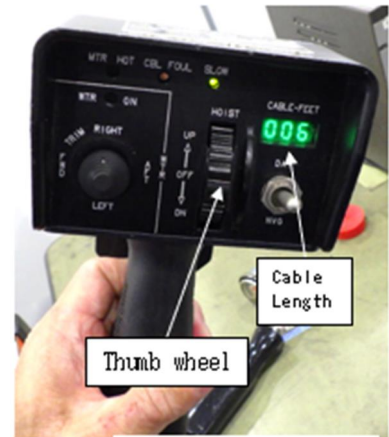
Figure 5 Pendant

On February 15, Mechanic B began to unwind the old cable using the thumb wheel on the pendant with the hoist installed on the helicopter. Mechanic B stopped unwinding when the full-out limit switch actuated and the drum stopped, confirmed that the number of cable wrap which was 4 remaining on the drum and took a photo with his smartphone. And then, Mechanic B removed the screw which fixed the cable end (hereinafter referred to as “the old screw”) to pulled out the old cable from the slot on the drum and completed the day.
