**AIRCRAFT ACCIDENT
INVESTIGATION REPORT**

**SPRING AIRLINES JAPAN CO., LTD.
JA03GR**

CABIN ATTENDANT INJURY BY THE SHAKING OF THE AIRCRAFT OVER ASO CITY, KUMAMOTO PREFECTURE, JAPAN AT ABOUT 13:38 JST, OCTOBER 22, 2017

SPRING AIRLINES JAPAN CO., LTD.
BOEING 737-800, JA03GR

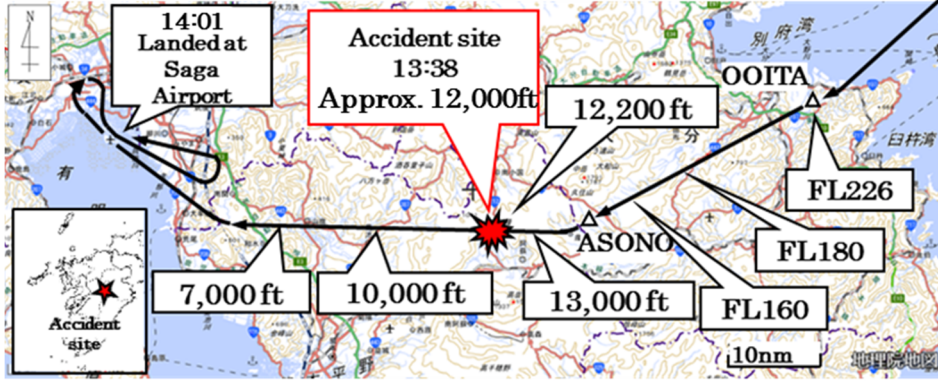
<p style="text-align: center;">Figure 2 QAR records</p>

At about 13:34, while flying in around FL180, the wind direction and speed changed from the southeastern wind at a speed of about 50 kt to calm wind conditions, and changed again to the westerly wind at a speed of about 35 kt while flying just before ASONO (waypoint).

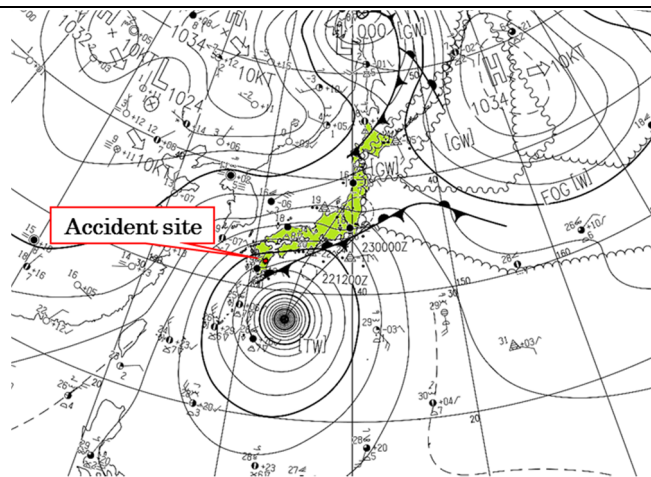
Figure 4 Asia-Pacific Surface Weather Chart as of at 09:00 JST on October 22, 2017

2.6 Meteorological Information	<p>(1) General weather conditions According to the excerpt from the Asia-Pacific Surface Weather Chart (See Figure 4) at 09:00 JST on October 22, 2017, in Japan it was widely raining from Kyushu to Tohoku, especially heavily in the Kinki and Tokai region because the autumnal rain front was activated along with Typhoon No. 21 that was moving northward.</p>
