AA2023-7

**AIRCRAFT ACCIDENT  
INVESTIGATION REPORT**

**Japan Transocean Air Co., Ltd.  
JA 07R K**

## CABIN CREW MEMBER INJURY BY SHAKING OF THE AIRCRAFT JAPAN TRANSOCEAN AIR CO., LTD. BOEING 737-800, JA07RK AT AROUND 11,300 M (FL 370) ABOUT 56 KM SOUTHEAST OF MIHO AIRPORT AT ABOUT 12:55 JST, OCTOBER 3, 2022

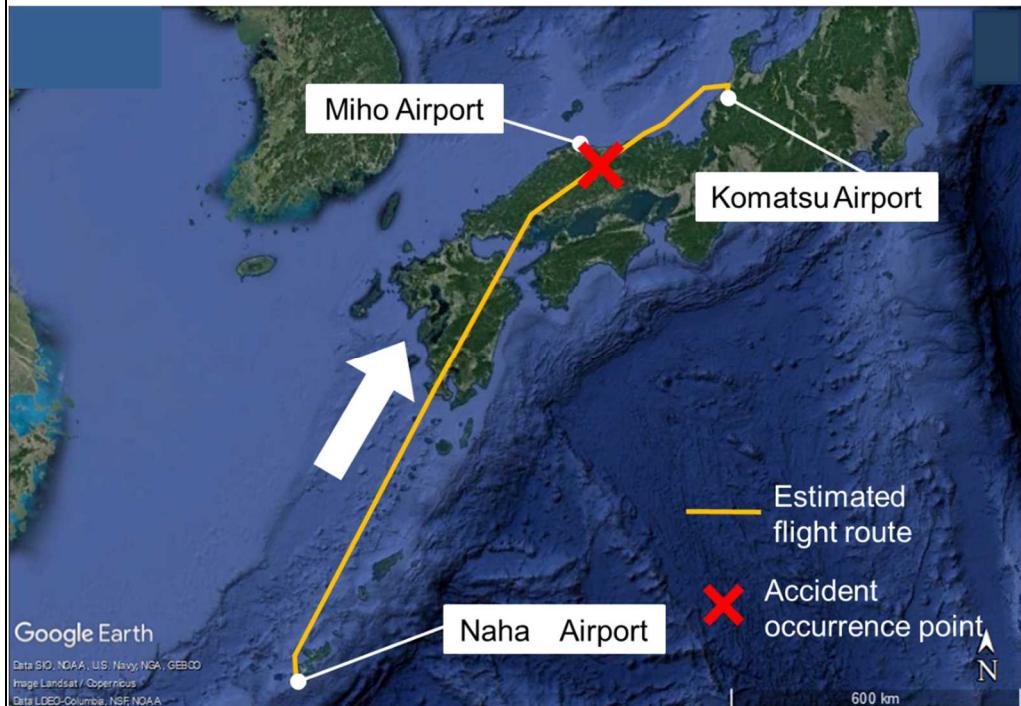
Figure 1: Estimated Flight Route  
(made with some additions to Google Earth)

At about 12:50, while cruising at the pressure altitude of 41,000 ft (Flight Level (hereinafter referred to as “FL\*2”) 410) where there was no cloud, the aircraft suddenly encountered a significant shaking (the 1<sup>st</sup> Shaking). Therefore, the PIC turned on the belt sign, and commenced to descend to FL 390 in order to avoid shaking. Even after reaching FL 390, the aircraft continued shaking, therefore, the PIC commenced to descend further to FL 370.

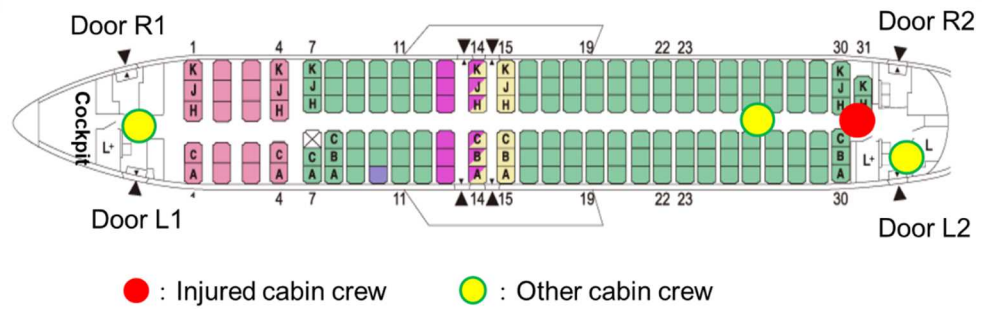
Figure 2: Location of Cabin Crew Members at the Time of the Accident

At about 12:54, the aircraft stopped shaking after reaching FL 370 to be in a stable condition, and as it was expected to encounter turbulence after the start of the descent to Komatsu Airport, the PIC turned off the seat belt sign to secure time for passengers to go to the lavatory, considering there were neither changes in wind that could be expected to cause turbulence nor clouds near the flight path that could cause turbulence. As the seat belt sign was turned off, the cabin crew member, who was injured in this accident (hereinafter referred to as “Cabin Crew A”), left the cabin attendant seat in the aft galley, and headed for passenger seats to attend to passengers (see Figure 2).

At about 12:55, when Cabin Crew A came to the aisle, the aircraft encountered significant shaking, being shaken from left to right (lateral tremor) again (hereinafter “the 2<sup>nd</sup> Shaking”). Due to this shaking, after hitting the wall on the left side of the aisle, Cabin Crew A was about to be thrown to the right side. Cabin Crew A grabbed the headrest of a passenger seat on the left side so as not to fall down to the right side, stood the ground with the right foot, and avoided falling down (see Figure 3).
