**AIRCRAFT ACCIDENT  
INVESTIGATION REPORT**

**OSAKA AVIATION INC.**

**ROBINSON R22 BETA (ROTORCRAFT)**

**JA102D**

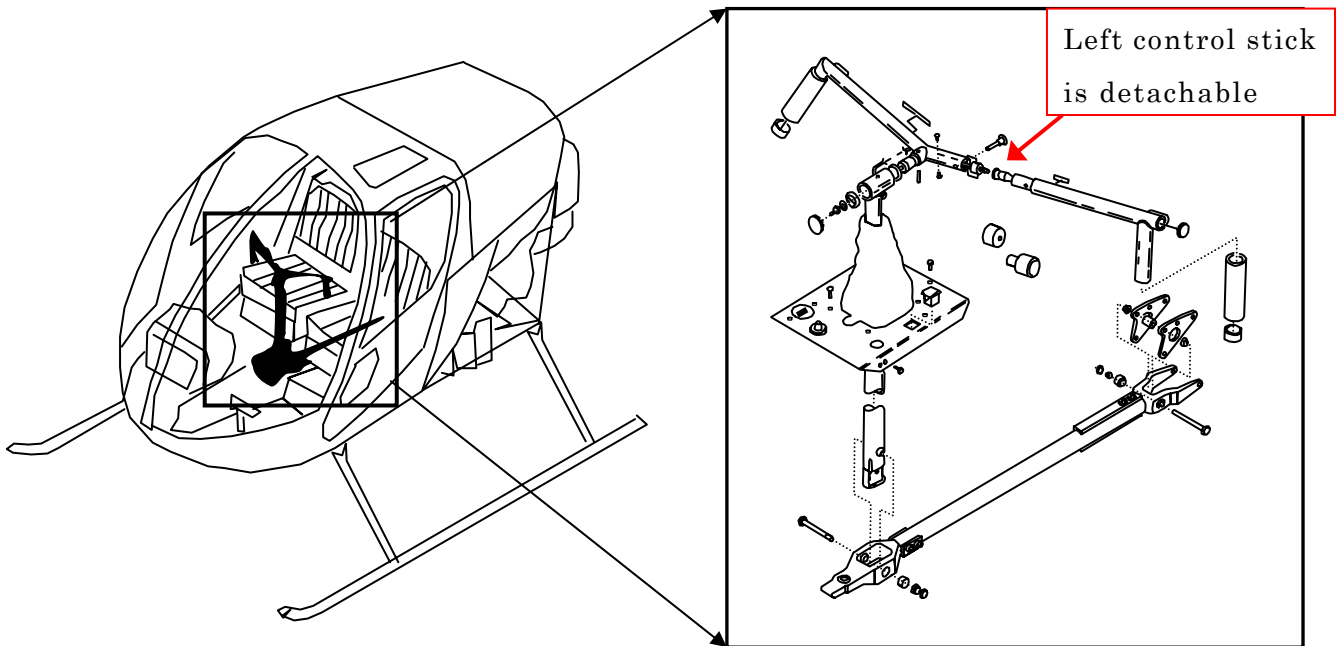
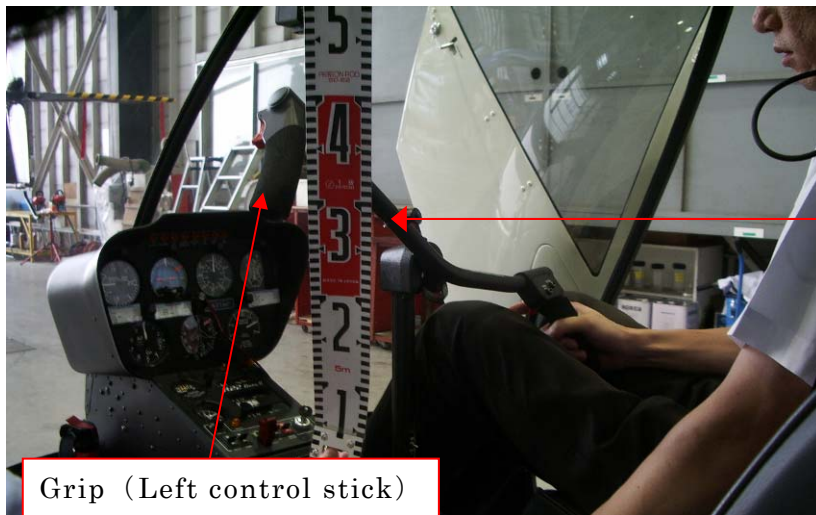
Figure 5 Control Stick

Press-to-talk switch is provided.  
Radio frequency selection switch is not provided.

If the person in the left seat attempts to hold the control stick with his/her right hand when the person in the right seat is operating the control stick that has been brought to a point in front of him/her, the person in the left seat must raise his/her right hand to a considerably high level. (grip moves upward by approximately 30 cm)

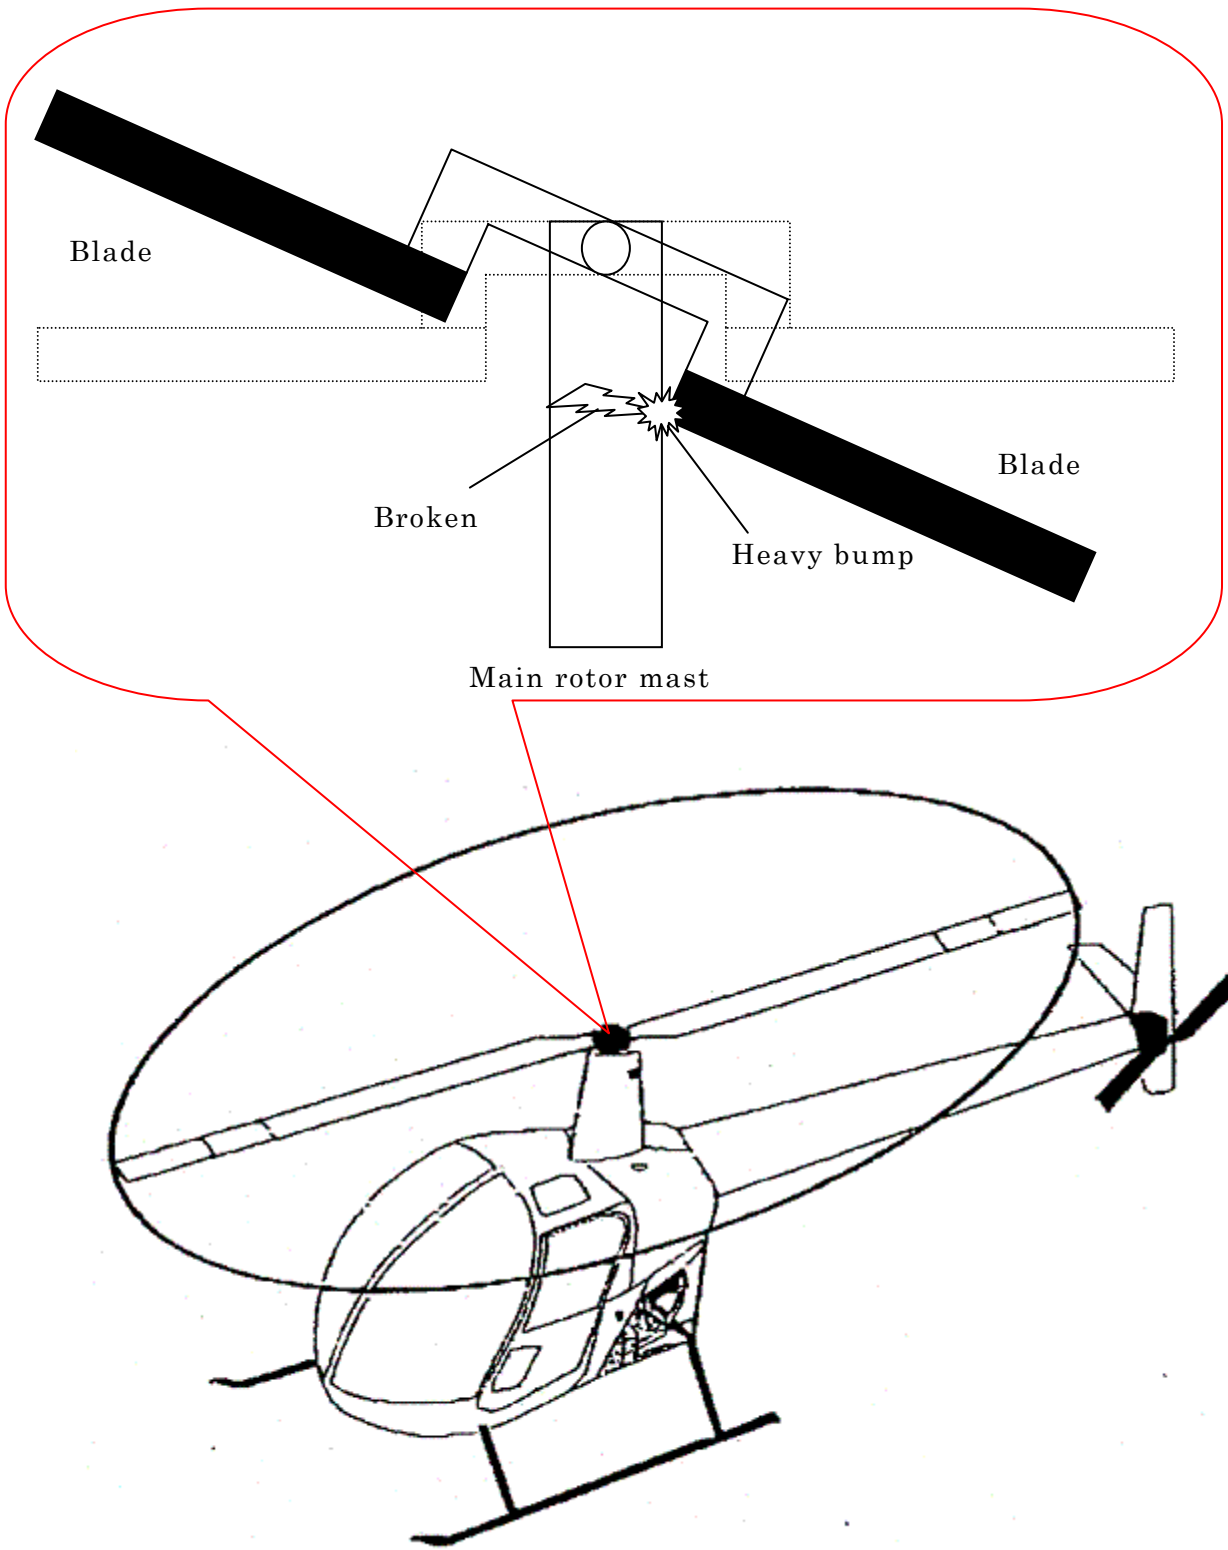
Figure 6 Image of mast bumping

- (3) As described in 2.8.2 (2), the teeter stop for the black blade had been crushed and broken into top and bottom halves, which remained adhered by fusion, and the teeter stop location on the mast had been heavily damaged. Considering this, it is recognized that, when the black blade hit the tail cone, the main rotor hub hit the mast with a large force.
