AIRCRAFT ACCIDENT INVESTIGATION REPORT

**Iwate Prefectural Disaster Prevention Aviation Corps
J A 1 0 T E**

FIREFIGHTER INJURY DUE TO WATER SPRINKLED FROM AIRCRAFT DURING FIREFIGHTING OPERATIONS IWATE PREFECTURAL DISASTER PREVENTION AVIATION CORPS (ENTRUSTED OPERATION TO TOHO AIR SERVICE CO., LTD.) AGUSTA MODEL AW139 (ROTORCRAFT), JA10TE IWAIZUMI TOWN, SHIMOHEI DISTRICT, IWATE PREFECTURE, AT ABOUT 15:31, APRIL 3, 2022

January 13, 2023

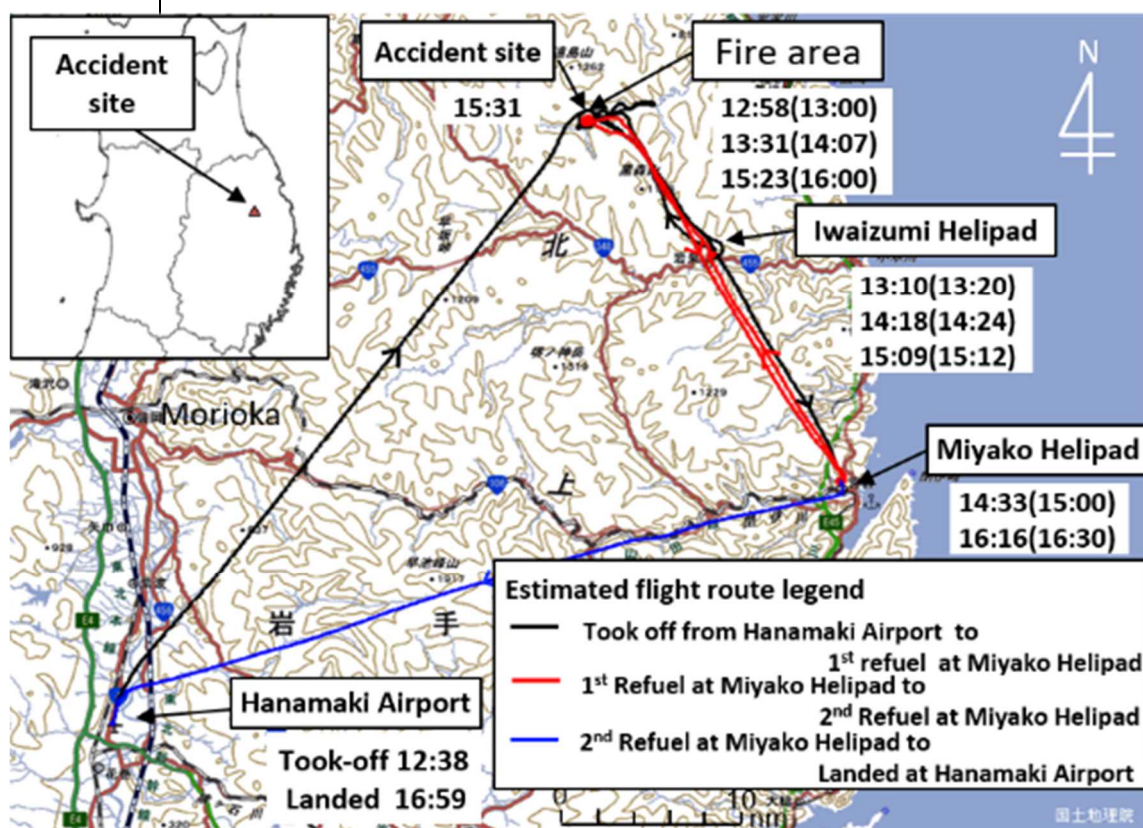
Figure 1: Estimated flight route of the rotorcraft

- (1) Outline of the history of the flight (See Figure 1)
- 12:38 The helicopter took off from Hanamaki Airport.
- 12:58 When the fire area was checked from the sky, a weak easterly wind was blowing, and the fire area was spreading to the mountain slope.

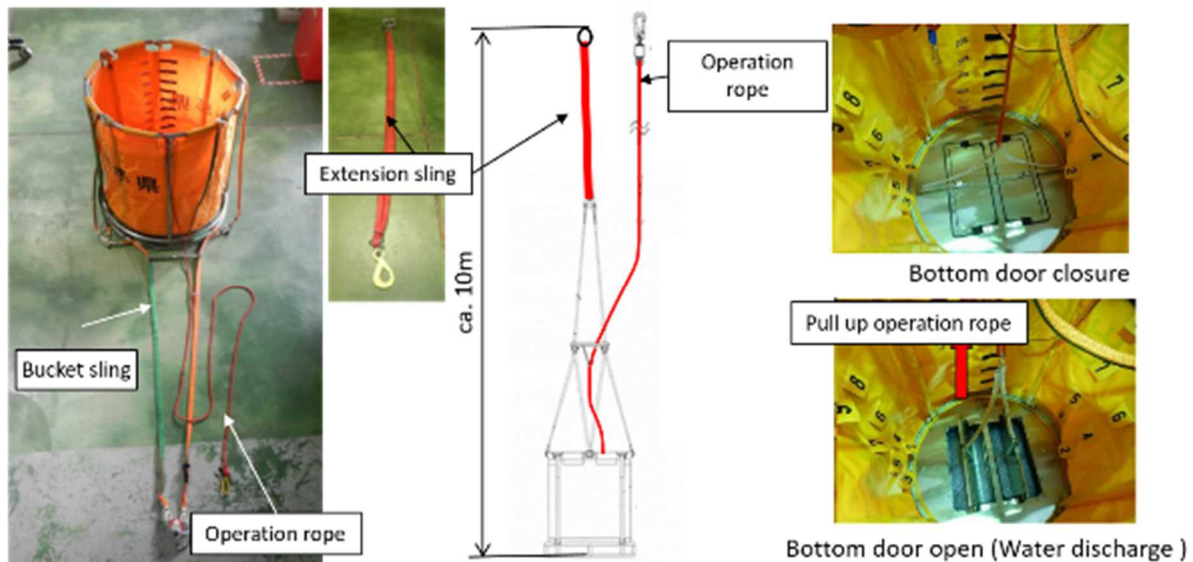
Figure 5: Externally suspended firefighting bucket

The externally suspended firefighting bucket is a device, which is attached by a cargo hook to the helicopter, that can carry up to 1,200 liters of water and fire-extinguishing agent for aerial firefighting operations where water is sprinkled through its bottom on the fire area. The collapsible bucket can be carried aboard the helicopter, and at the time of sprinkling water, the onboard crew pulls the operation rope manually and water is sprinkled by opening and closing its bottom door.

There were no anomalies found in the helicopter and the externally suspended firefighting bucket.
