AIRCRAFT ACCIDENT INVESTIGATION REPORT

CRASH

SCHEMPP-HIRTH ARCUS M

(MOTOR GLIDER, TWO-SEATER), JA11AM

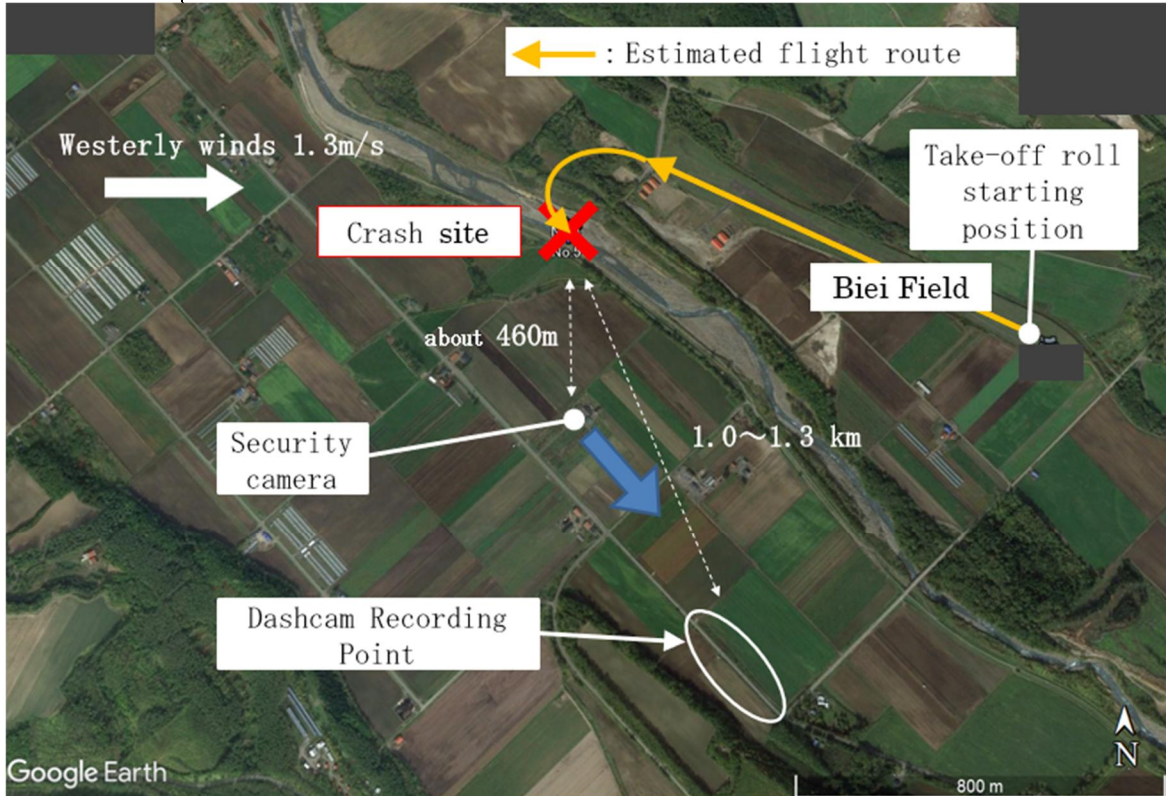
Figure 1: Locations of the Biei Glider Field, Security Camera and Dashcam Recording Point

According to the statement of a witness of a fellow pilot who helped the two glider pilots to prepare for their flight with the glider, and the record (track information) of the GPS device installed in the glider and the dashcam footage from the vehicle travelling around the accident site, the history of the flight is summarized as follows: (see Figure 1).

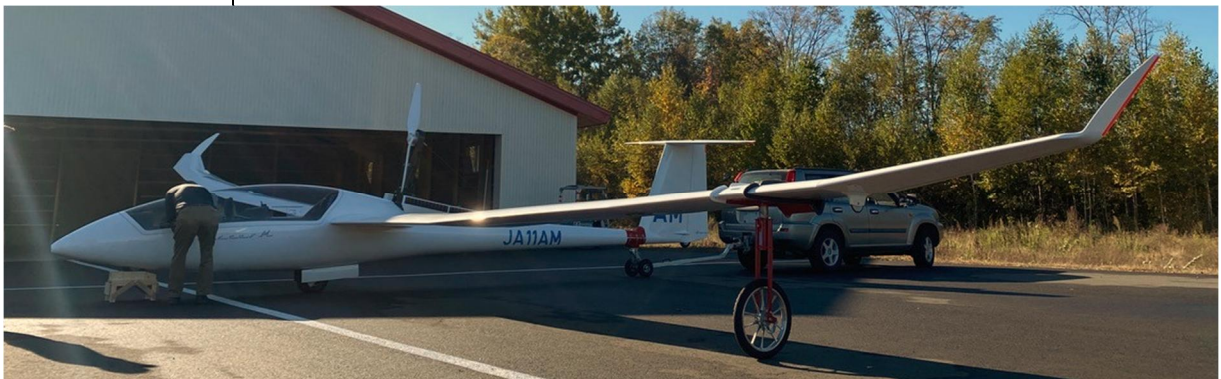
Figure 2: The Glider in Flight Preparation

At about 08:00 Japan Standard Time (JST: UTC+9 hr: unless otherwise stated all times are indicated in JST) on October 12, 2021, Pilot A and their colleagues began preparing for the flight in a privately owned Schempp-Hirth Arcus M, JA11AM. Pilot A moved the glider from the hangar to the apron and conducted a five-minute engine test run.
