**AIRCRAFT ACCIDENT
INVESTIGATION REPORT**

**Fukushima Prefectural Police Aviation Unit
J A 1 3 9 F**

INJURIES TO PERSONS ON BOARD AND ROTORCRAFT DAMAGE CAUSED BY HARD LANDING FUKUSHIMA PREFECTURAL POLICE AVIATION UNIT AGUSTA AW139 (ROTORCRAFT), JA139F AT MIHOTA TOWN, KORIYAMA CITY FUKUSHIMA PREFECTURE, JAPAN AT ABOUT 08:08 JST, February 1, 2020

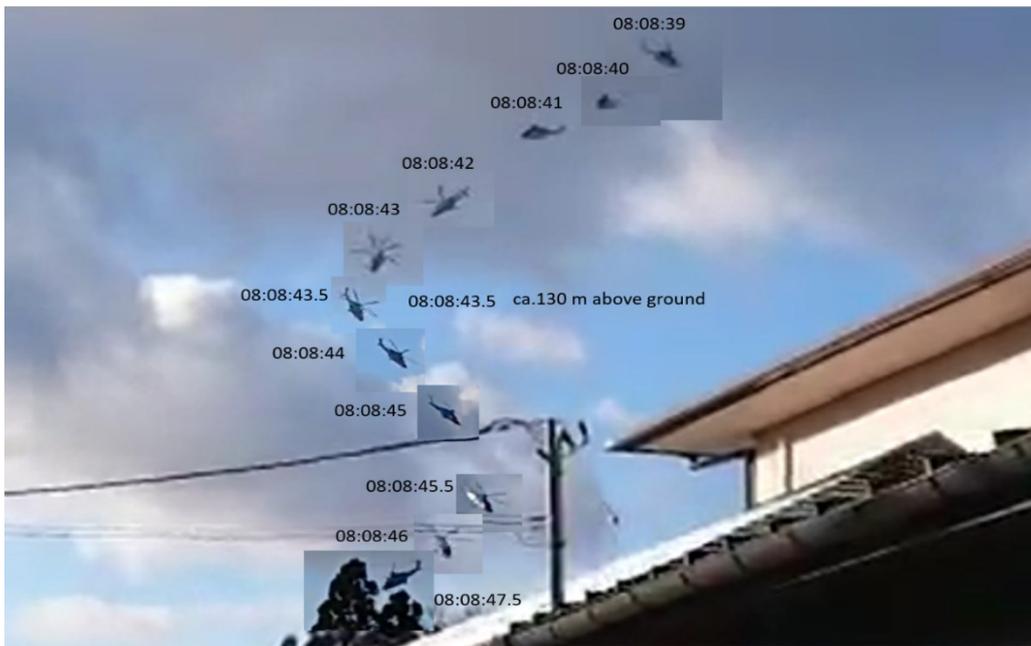
Figure 3: Composite view of images taken by the Eyewitness

The eyewitness A visually recognized the helicopter at a point 560 m north-east of the forced landing site. And the eyewitness A saw the helicopter making some two turns in the sky and heard unusual sound, taking a picture with a tablet quickly. The helicopter rapidly descended, flew southward while rotating, became invisible, and afterwards, the engine sound disappeared. (See Figure 3)

It is probable that after falling into tail rotor drive failure condition, the helicopter flew somewhat straight when the IAS increased, and repeated turning to the right due to the deceleration. From the video information from the Eyewitness (Figure 3) described in 2.1.2 (6) and the MPFR records, it is highly probable that just before the touchdown, its attitude was raised up while the helicopter continued to turn to the right, and landed in a state of tilting to the right.

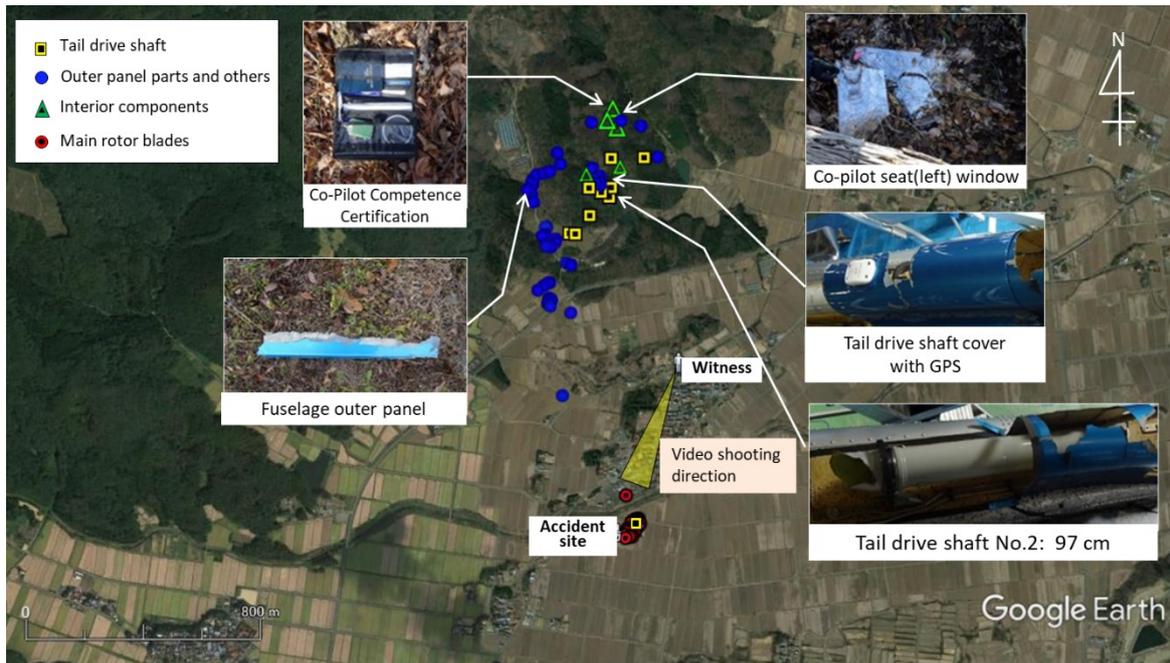
Figure 10: Flyable objects located on the north side of the accident site and the eyewitness's video shooting direction

- The tail section separated in front of the vertical stabilizer, and there was no significant damage to the tail rotor blades.
- The red colored part of tail drive shaft No.2 at the front upper portions of the tail section was found together with other upper tail drive shaft cover including the No.2 GPS antenna in the mountains about 1,300 m north of the accident site. (See Figure 9 and 10.)
- The fracture surface seen from the side of the tail drive shaft cover at the aft fuselage coincided with the position and shape when the main rotor blade lowered, and the left cover had more damage than the right cover. In addition, the lower fuselage where the tail drive shaft was damaged had scratch marks.
- A part of the tail drive shaft (corresponding part in Figure 15) had contact marks with jagged shaped dents.

As described in 3.4.4, when the helicopter started a rapid right rolling motion, at about 08:07:38, the main rotor blades contacted with the tail drive shaft. From the location (Figure 10 in 2.9.2 (2)) where scattered objects of the tail drive shaft and the outer panel were found, it is probable that the tail drive shaft was completely severed while the helicopter was moving southwestward, the outer panel parts to which the GPS antenna was attached and some parts of in-flight equipment were scattered.

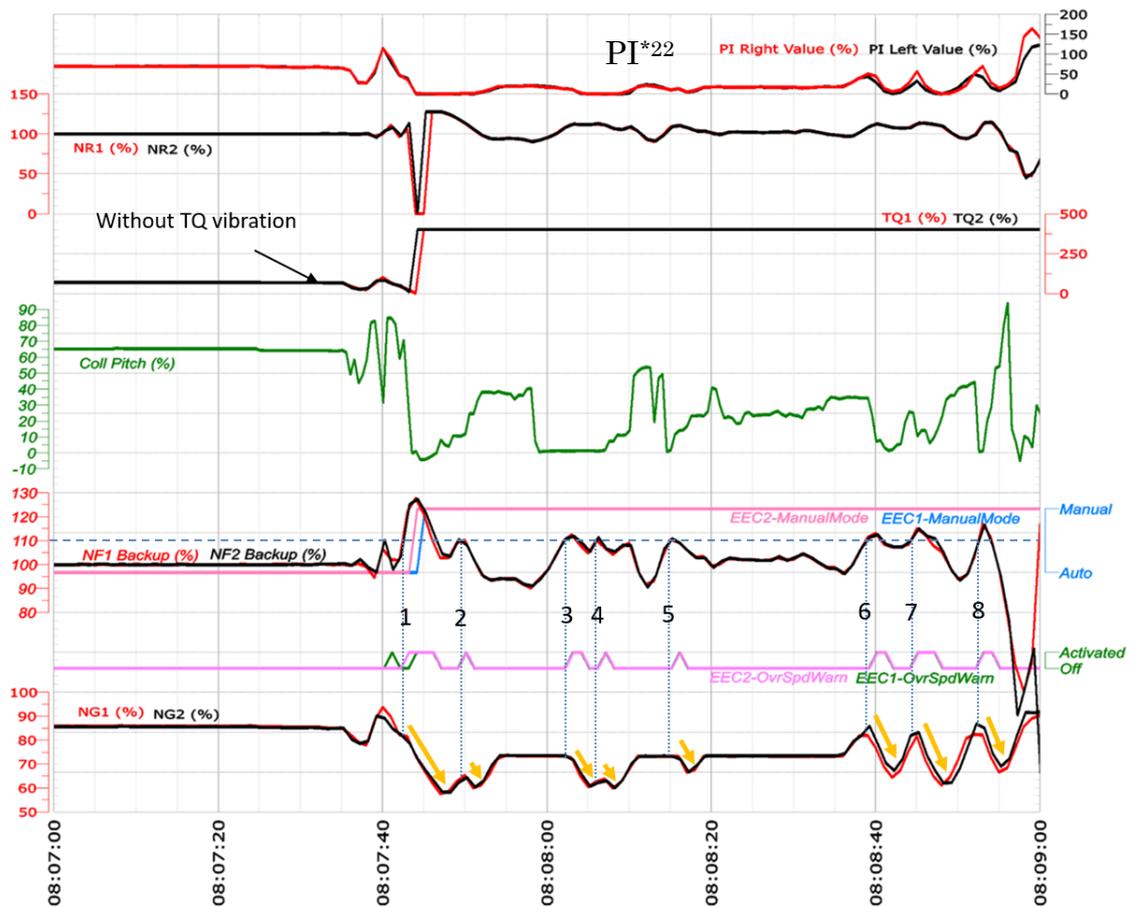
Figure 16: Engine operating conditions from just before right rolling motion to emergency landing

The Design Company of the engines installed on the helicopter conducted the investigation regarding the recorded data on the DCU with the witness of the accident investigation authority in the relevant State (TSB of Canada). The investigation results were shown in Figure 16 and Table 1.

In Table 1, the event data is shown in blue for No. 1 engine, and those in orange for No.2 engine. According to the MPFR record in Figure 16, the category a and b show the first event data at 08:07:44. The NF^{*23} value for No. 1 engine was recorded at “125.527 %”, and at “123.496 %” for No. 2 engine. Subsequently, from Category c to f, the NF value exceeded the measuring range 0.432 seconds after the occurrence of the first event, thus, 0 for the NF value was recorded. Almost at the same time, the engines were switched to the manual back-up mode. In Category g, it was recorded at “-111” indicating that the signals of both No.1 and No.2 engines were lost at 08:09:01 of 76.46 seconds after the occurrence of the first event. This was when an abnormal value of rotor speed was recorded after the helicopter rolled over.

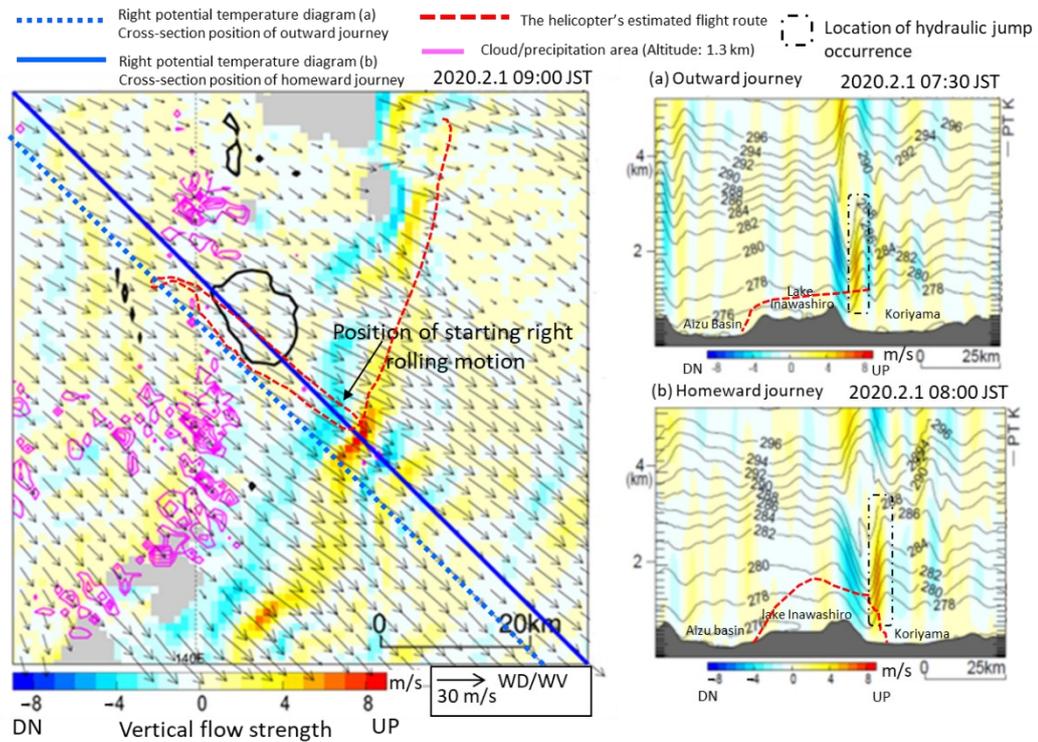
Figure 19: Numerical Analysis A Horizontal distribution of vertical and horizontal flows at an altitude of 1.3 km (Left) and Cross section of potential temperature and vertical flow according to the blue dotted line / the blue solid line in the left (Right (a) / (b))

The left in Figure 19 shows the result of analyzing the distribution of vertical and horizontal flows at an altitude of about 1.3 km at 09:00 on the day of the accident, using the 1 km horizontal resolution model. A wind of about 20 to 30 m/s was almost uniformly blowing from the northwest, and as described in 2.6 (1), there was the vertical flow pattern extending through the north-northeast to the south-southwest that seemed to correspond to the wavelike clouds shown in the Meteorological Satellite Visible Imagery in the right in Figure 5. This is more likely an internal gravity wave (mountain waves) generated when stably stratified air currents hit in a direction almost perpendicular to the mountain range.

the helicopter flew to and from Aizu Operation Site. On the round-trip flight routes, there were downdrafts and the updrafts corresponding to a hydraulic jump^{*32} above and on the southeast side of the mountainous terrain located on the southeast side of Lake Inawashiro. The helicopter likely encountered these vertical flows on the round-trip flight routes.

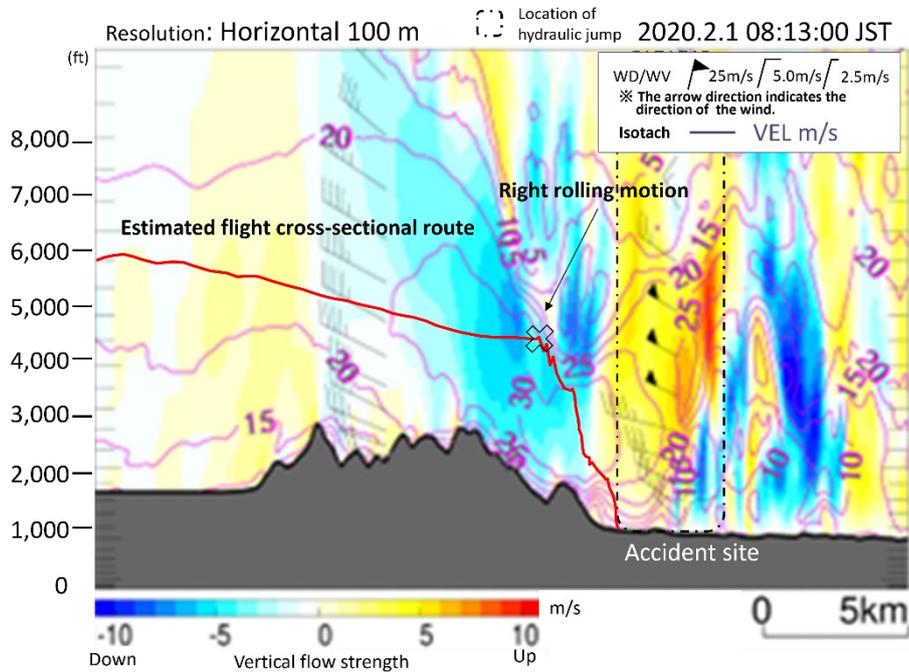
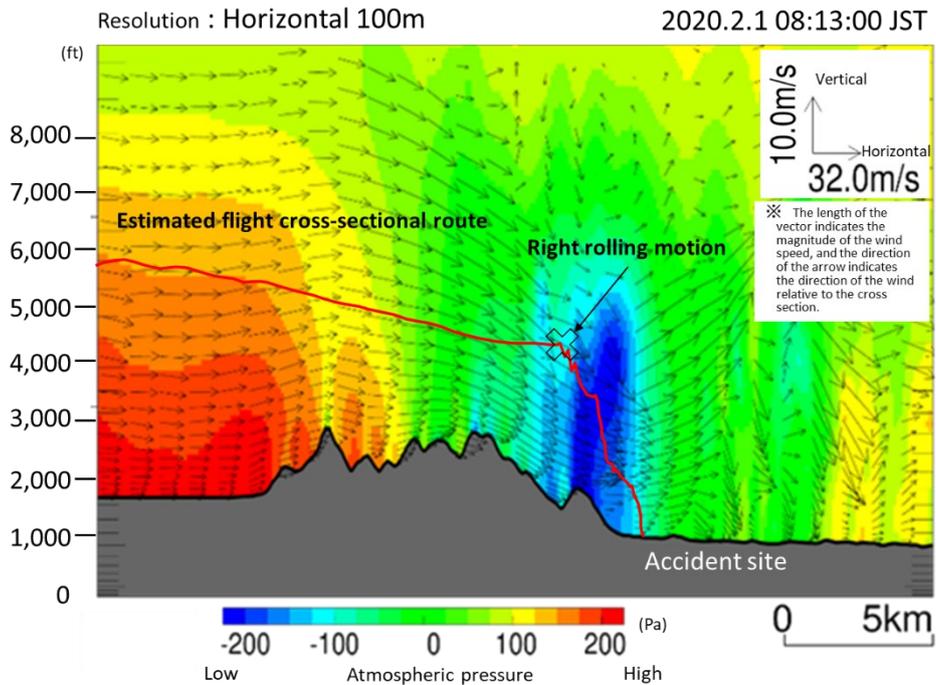
As a result of matching the position at 08:07:36 when the helicopter started right rolling motion and the area where the horizontal wind velocity decreased rapidly and a strong downdraft was generated from the numerical analysis results in Appended Figure 9 and Figure 10, there was a gap of about 5 minutes from the numerical analysis time, however, the helicopter possibly flew in the area where updrafts and downdrafts change over a short period of time, as shown in these figures. Figures 21 and 22 are enlarged views of Appended Figures

9 and 10 at 08:13:00. There is an area on the east side of the mountain range where the atmospheric pressure is about 2 hPa (200 Pa) low, and near this area there are parts where the horizontal component of the wind is decreasing. It is possible that the helicopter flew in an area where the atmospheric pressure was low.

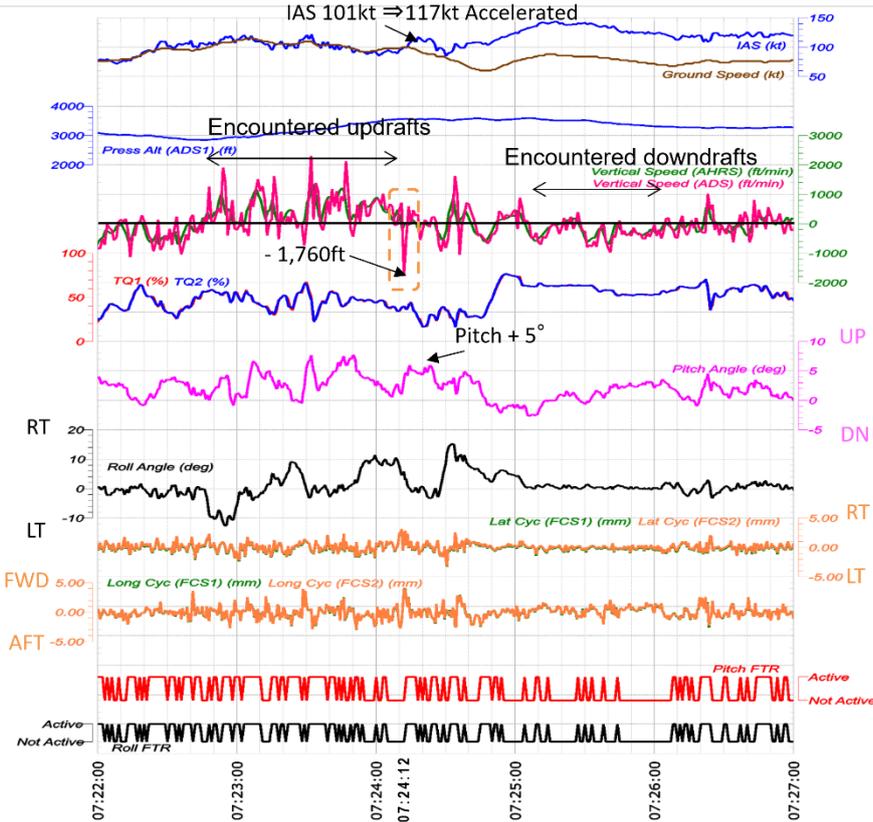
Figure 23: Flight status in the vicinity of the mountains on the southeast side of Lake Inawashiro on the outward journey up to Aizu Operation Site

As described in 3.3.2, it is probable that strong vertical currents occurred on the southeast side of the mountain range area in the southeast side of Lake Inawashiro that the helicopter passed through, it is possible that the helicopter encountered this on its outward flight, therefore, as shown in Figure 23, the effects of vertical air flow was analyzed by the MPFR records. From about 07:22:50 to about 07:24:30, when flying southward at IAS about 120 kt from an altitude of 3,000 to 3,300 ft, the helicopter encountered the updrafts while receiving a wind from the right. And there was evidence that the helicopter encountered a downdraft from about 07:25:05 to about 07:26:00 when flying at IAS about 120 to 140 kt while receiving a wind from the front. Especially, at 07:24:12, although the Vertical Speed (AHRS) by the inertial

vertical velocity*³⁴ was at 0 ft/min, the Vertical Speed (ADS*³⁵) by the atmospheric pressure change was recorded at (-) 1,760 ft/min. As for the pitch attitude, the helicopter kept the nose-up attitude at an angle of about 5°, and the power output decreased, but the IAS rapidly increased from 101 kt to 117 kt for six seconds. When comparing the point where the Vertical Speed (ADS) significantly changed at 07:24:12 was aligned with the point in the numerical analysis A in Figure 1: Estimated flight route and in Figure 19 (left), it was in front of the point where the helicopter started turning to Aizu Operation Site on the east side of the Ou Mountain Range, and it was generally consistent with respect to points where strong updrafts were considered to have existed, a result of Numerical Analysis A.

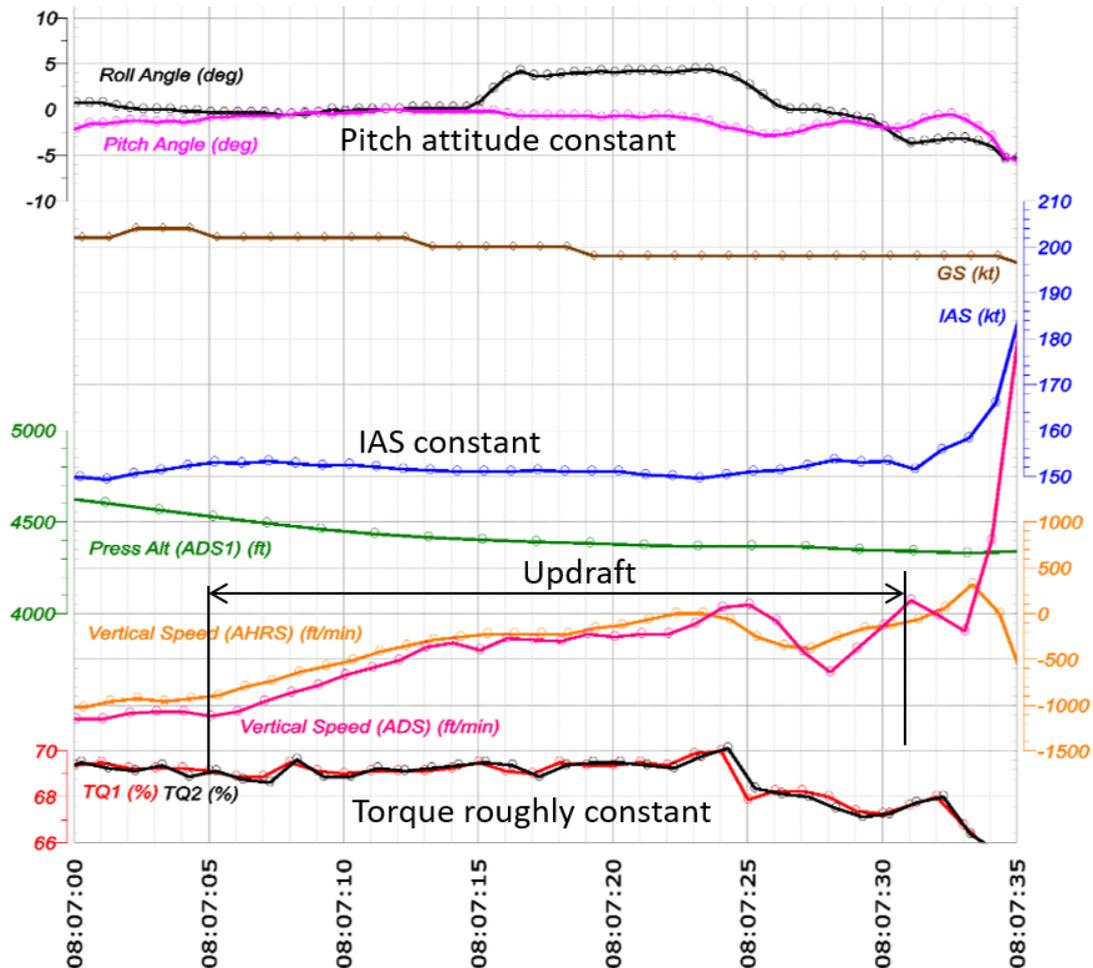
Figure 24 Presence of updraft before rapid IAS increase

At around 08:07:10, the aircraft became level flight at an altitude of around 4,500 ft, with the engine output remaining roughly constant during the descent. Although the IAS pitch attitude was generally constant, the rate of descent decreased from around 08:07:05 and rose temporarily until around 08:07:30, therefore it is possible that there was an updraft of approximately 1,000 ft/min. As shown in the analysis results before and after 08:13:00 in Appended Figures 9 and 10, an updraft region of 3 to 5 m/s can be seen before the right roll

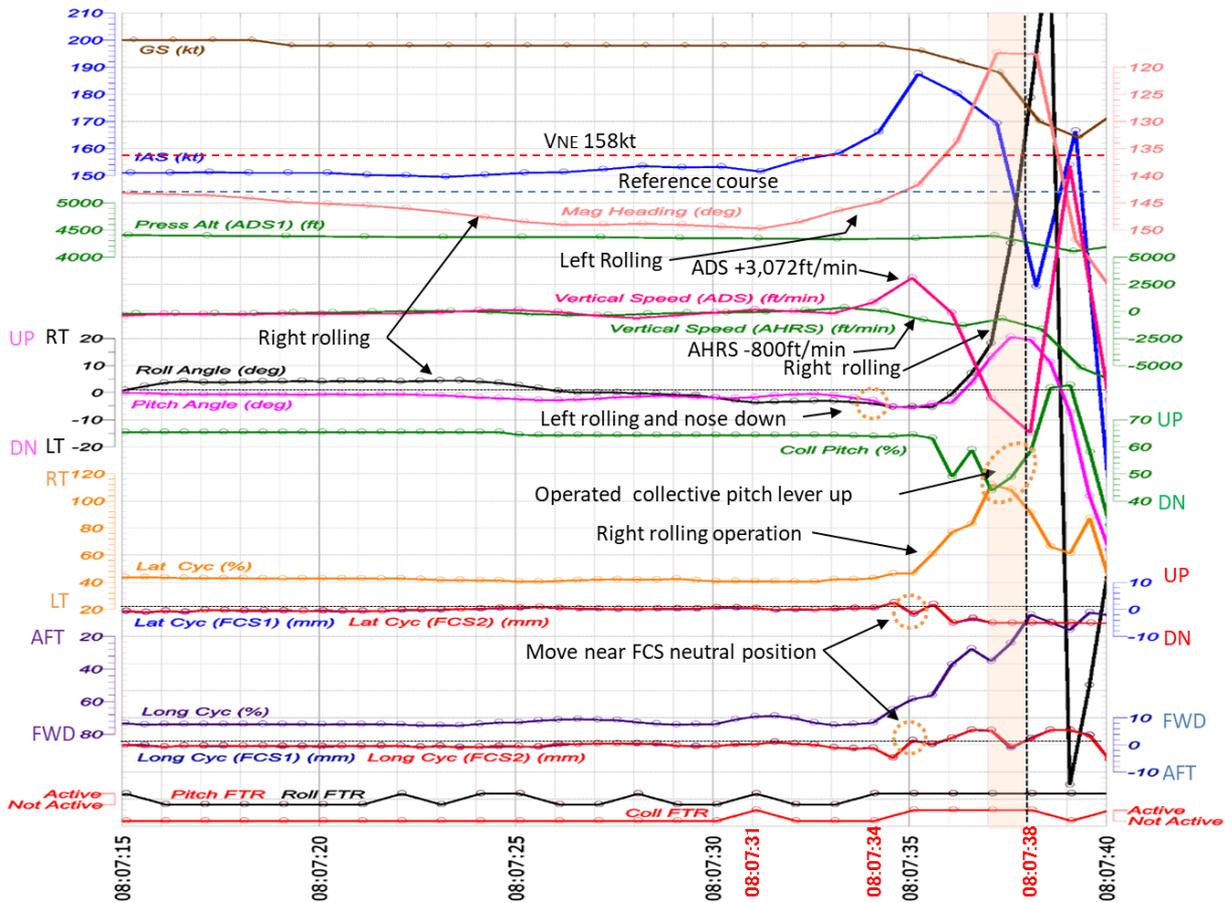
Figure 25: The record of MPFR when the IAS increased rapidly.

As described 2.1.2 (1), the captain stated that while flying at IAS 150 kt while avoiding clouds, before the helicopter looped like being drawn into the forward, the captain felt the movements affecting the heading control from aft section of the helicopter. According to the MPFR records in Figure 25, during the time between 08:07:15 and 08:07:25, the cyclic stick was moved slightly to the right to change the course, after that, at 08:07:31, the helicopter started to veer to the left in order to correct the course, therefore, these operations were more likely course correction to avoid clouds. At 08:07:31, the FTR on the cyclic stick was depressed once, the roll angle was maintained at about 3° left and started to veer to the left. From 08:07:31 to 08:07:35 when the IAS rapidly increased from 152 kt to 188 kt, and from 08:07:33 to 08:07:34, the pitch attitude changed from (-)0.5° to (-)5°, the left roll attitude changed from 3° to 5°, and it continued. It is probable that this is because the flight control system (FCS) instantaneously moved to near the neutral position by pressing FTR, which continued the nose-down and left-roll attitudes. After that, until 08:07:38, the cyclic stick was pulled backward by about 15% while FTR was pressed, and then moved to the 100% position on the right side in about 2 seconds. It was operated in about 2.5 seconds to the 7% position. During this time, the FTR of the cyclic stick was continuously pressed, so it is probable that the manual operation was prioritized while the attitude retention function was stopped, and the rapid right rolling motion started. In addition, the collective pitch lever was lowered by about 20% while moving up and down for about two seconds after the FTR was pressed at 08:07:35. It is probable that the right roll and IAS deceleration started rapidly because the cyclic stick was moved to the right rear while pressing FTR from the 5° left roll and 5° nose down state.

When the IAS increased rapidly to 188 kt, as shown in Figure 25, the Vertical Speed (ADS) by the atmospheric pressure change was recorded as plus (+) 3,072 ft/min and the Vertical Speed (AHRS) by the inertial vertical velocity was recorded as minus (-) 800 ft/min, thus there was a large difference in each Vertical Speed. If an aircraft flying at GS 200 kt encounters an atmospheric pressure change of about 2 hPa (200 Pa) during one second of travel (approx. 100 m), it will become 50 ft when converted to altitude, and the Vertical Speed will be 3,000 ft/min. Therefore, the difference in records of the two types of Vertical Speed was likely the phenomenon created due to the sudden drop in atmospheric pressure, and at this time, the

helicopter probably encountered the downdraft area as described in 3.3.1.2 (2). (Factor analysis is described later in 3.5.1 and 3.5.2.) In addition, the pitot tube of the same type of aircraft is attached to the nose, and the static pressure hole is open vertically at the tip of the pitot tube, so it is possible that this difference in elevation rate was affected by changing pitch attitude. Especially after the right roll movement started, it is more likely that the ADS elevation rate was recorded excessively.

As shown in Figure 25, as for the position of the flight control actuators, when the IAS rapidly increased from 08:07:31 to 08:07:34, the longitudinal cyclic (Long Cyc) was moved gradually backward by attitude retention function, and the lateral cyclic (Lat Cyc) was moved gradually to the right.

However, at 08:07:34, the FTR of the cyclic stick was pressed and held for a long time, which stopped the attitude retention function, and the longitudinal and lateral cyclic flight control actuators shifted from the controlled position to the center position. For this reason, it is probably that the pitch was kept at (-) 5° and the roll was kept at 5° left for about 1 second, and the movement of the cyclic stick was slightly delayed.

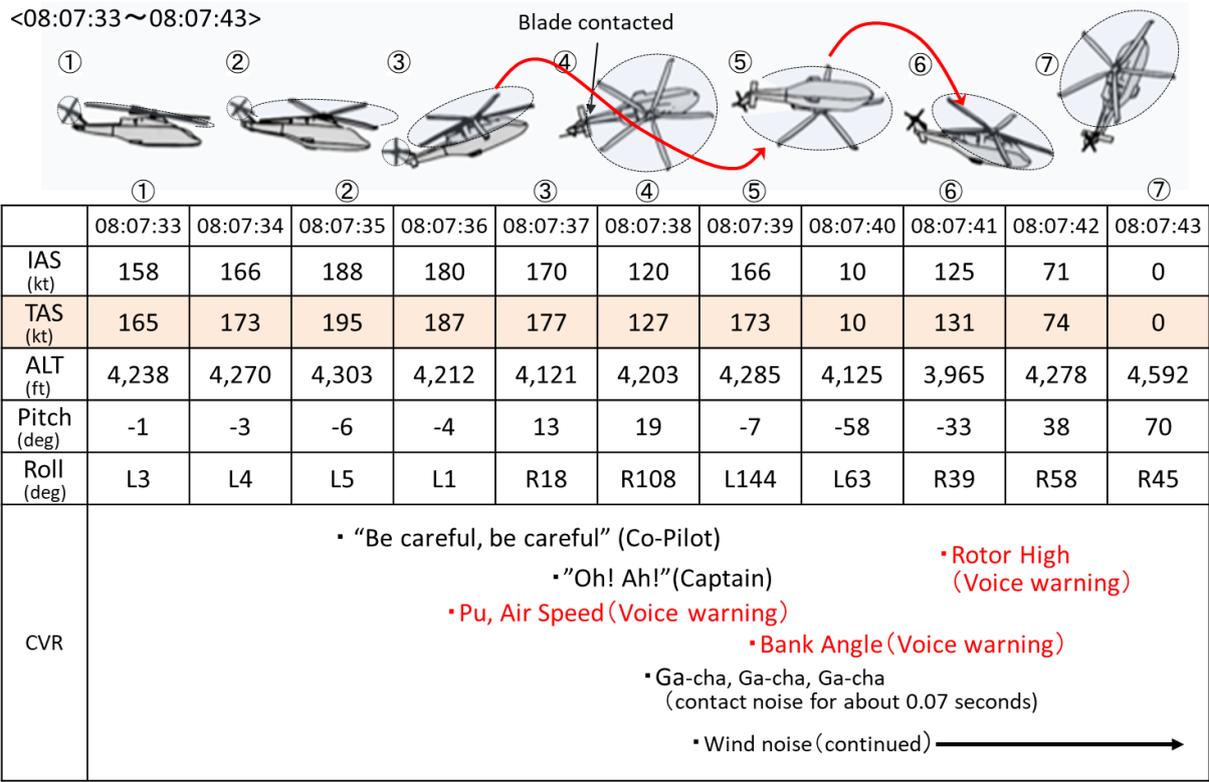
Figure 26 Flight data at the time of contacting with the main rotor blades.

According to the MPFR records at the time of starting a right rolling motion in Figure 25, 26 and Appended Figure 4 to 7, immediately after the IAS increased up to IAS 188 kt at 08:07:35, as described in 3.4.3, the cyclic stick was largely controlled for approximately 2 to 3 seconds, therefore the helicopter started a rapid right rolling motion exceeding 360° with a roll rate of 100 %/second or more. During right rolling motion, the collective pitch lever was operated up and down like exceeding 20% of the control range for about two second. During the right

rolling motion leading to the inversion between 08:07:37 and 08:07:39, and the collective pitch lever with depressing the FTR of the collective pitch lever pulled up from 45 % to 82 %, and as shown in Appended Figure 6, at 08:07:38, (-) 1.4 G was recorded. As shown in Figure 26, after 08:07:38, the contact noise and wind noise in the cabin were recorded as the voice information, and almost at the same time, sudden changes in engine instruments and yaw rate occurred. Therefore, it is probable that at this time, the main rotor blades contacted with the upper part of the tail section.

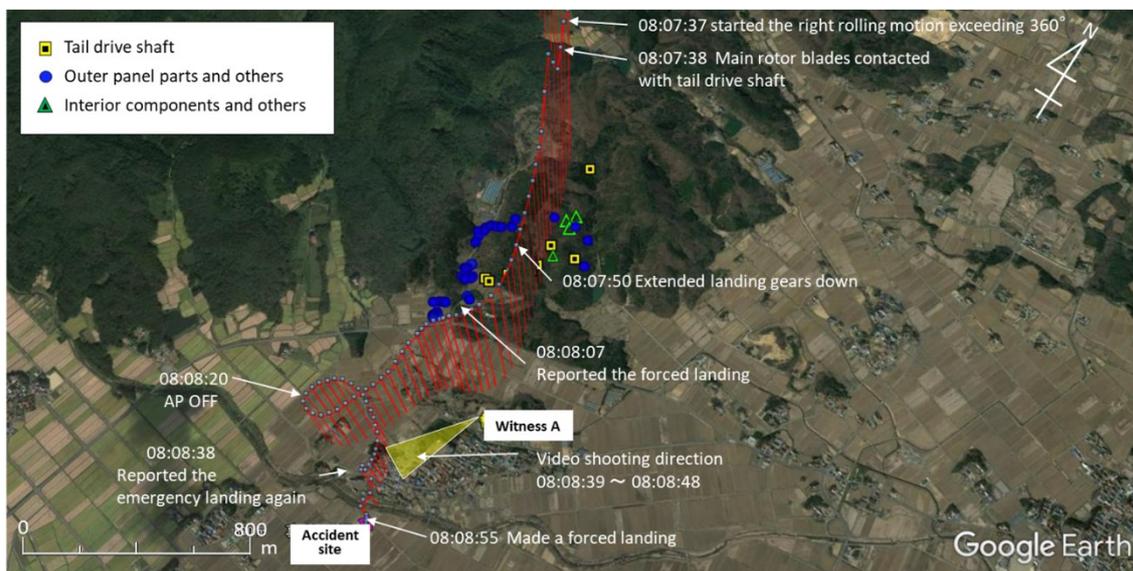
Figure 27: Estimated flight route from the occurrence of the right rolling motion up to the forced landing

After the main rotor blades contacted with the tail drive shaft, judging from the fact that the positional information error increased as GPS antenna had fallen off, therefore as shown in Figure 27, the helicopter's flight route was estimated from the MPFR records, the location of fallen objects and the information provided by the eyewitness.

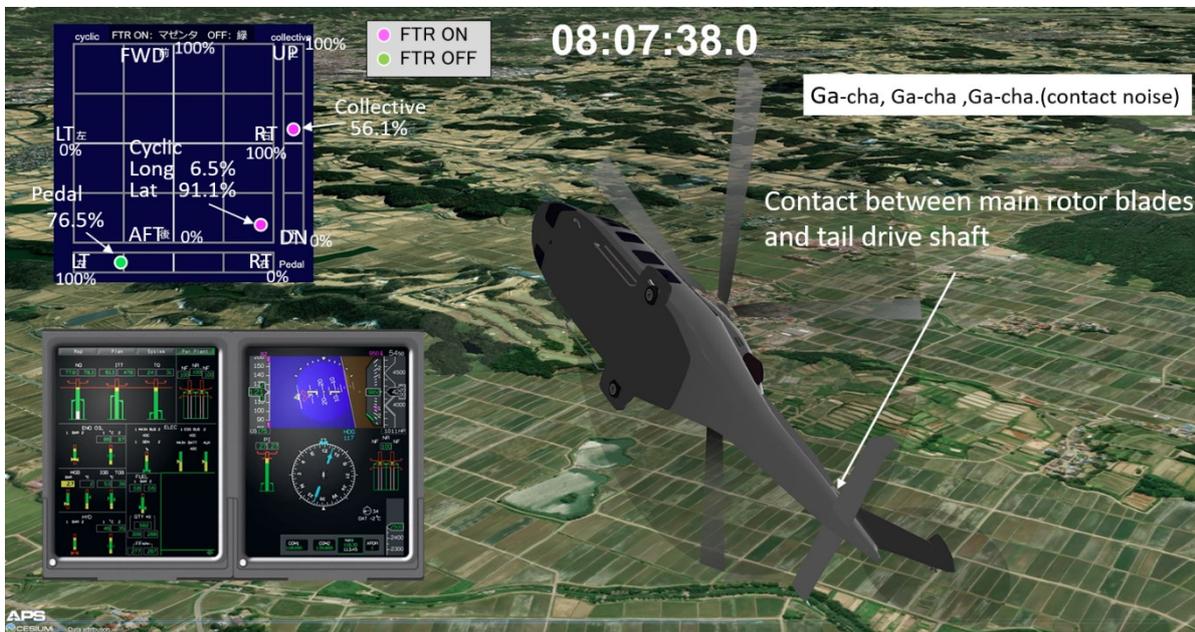
Figure 28: Attitude of the helicopter and location of the flight control system at the time of contacting between the main rotor blades and the tail drive shaft

The main rotor blades of the AW139 are structured to limit the vertical flapping^{*36} movements by upper and lower limiters that make it difficult to contact with the fuselage. As described in 2.13.1, in case of the weight of the helicopter at the time of the accident, the first sign of the stall of the retreating main rotor blade is expected to be shown in the range of TAS 190 to 200 kt. Because while the helicopter was in level flight, the airspeed rapidly increased to IAS 188 kt (TAS 195 kt), in which the sign of the stall should be shown, but low-frequency vibrations of the main rotor blades, including torque oscillations (see Figure 16), did not occur, and because a right rolling motion started in response to the control by auto-pilot and the operation of cyclic stick during acceleration, it is unlikely that the retreating main rotor blades stall caused the main rotor blades to contact with the tail drive shaft.

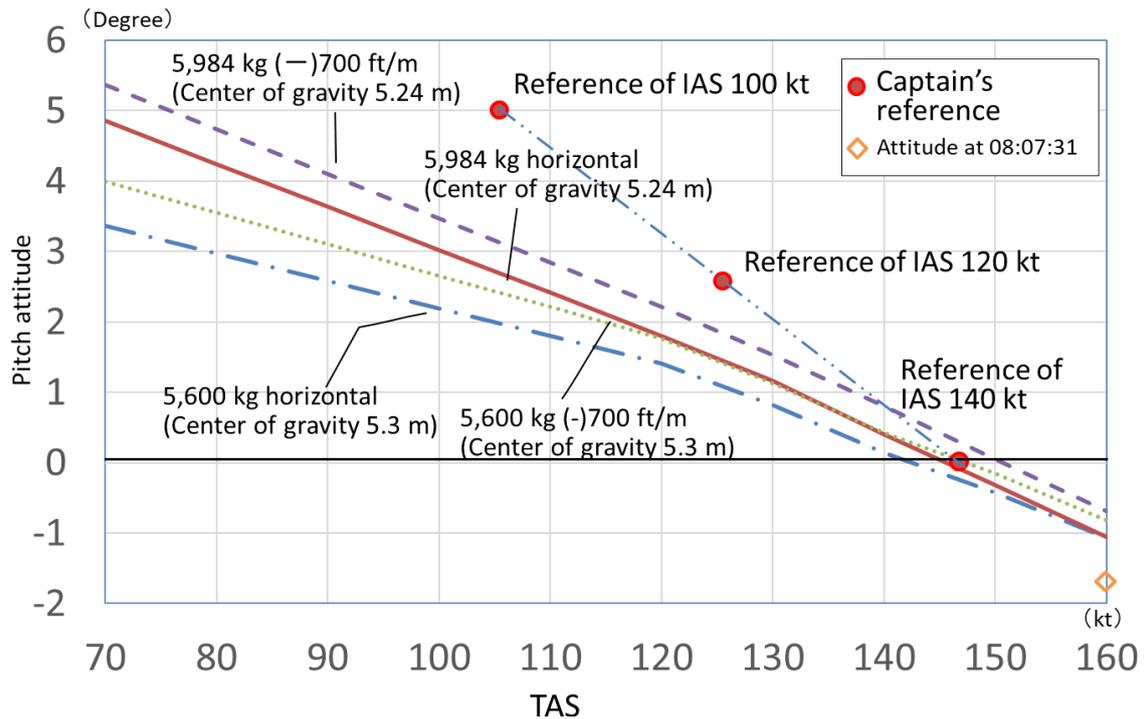
Figure 30: Change in pitch attitude depending on different airspeeds

From the weight and center of gravity at the time of the accident, which was described in 2.5.2, the pitch attitude of level flight at IAS 140 kt (TAS 147 kt) was about 0°, however, according to the MPFR records about the IAS, at 08:07:31, immediately before the IAS increased rapidly, the pitch attitude was (-) 1.75 °at IAS 152 kt that has a difference of 6 kt from VNE. It is probable that the attitude was not maintained according to the reference used by the captain, which caused a speed difference of (+) 10 kt or more, and the attitude easier to exceed the VNE was continued.

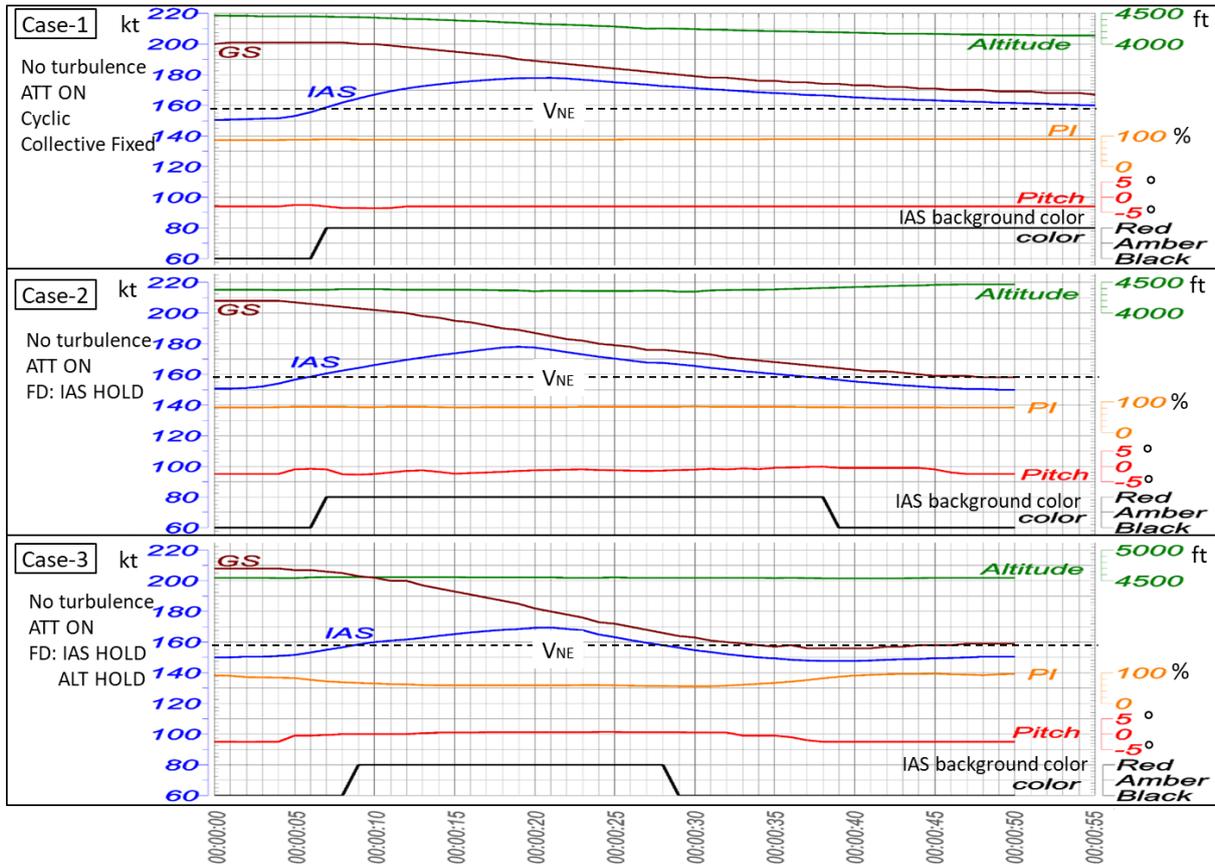
Figure 31: Characteristics of dynamic stability of flight control by hands-off

- a. In all three cases, for about 20 seconds when the wind velocity of the system was 0 kt, the IAS increased and exceeded the VNE.

- b. The maximum IAS value was Case-1 > Case-2 > Case-3, and the VNE exceeding time was shortest in Case-3.

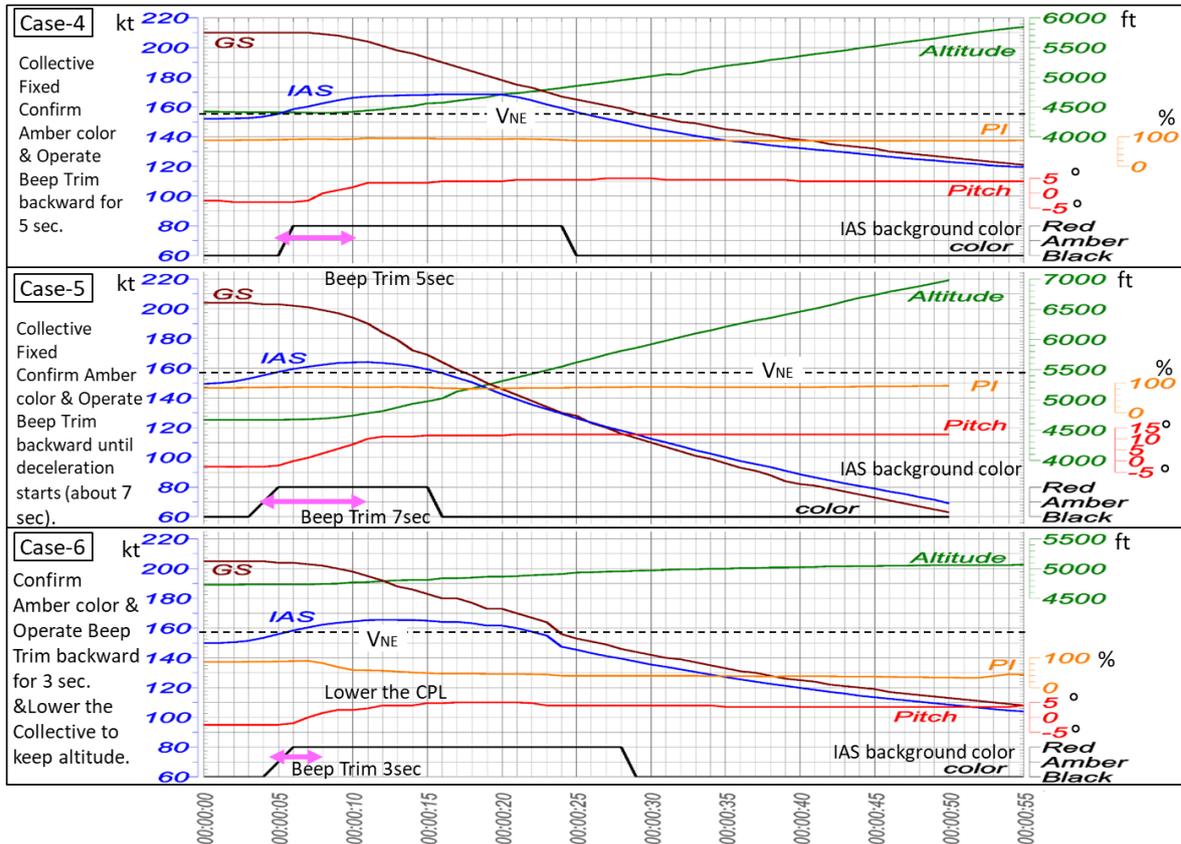
Figure 32: Deceleration operation by Beep Trim in the ATT mode

Case-6 : after checking the amber background color indicated at the time of the IAS increase, operate the Beep Trim backward for three seconds, and then lower the collective pitch lever so as to maintain the altitude.

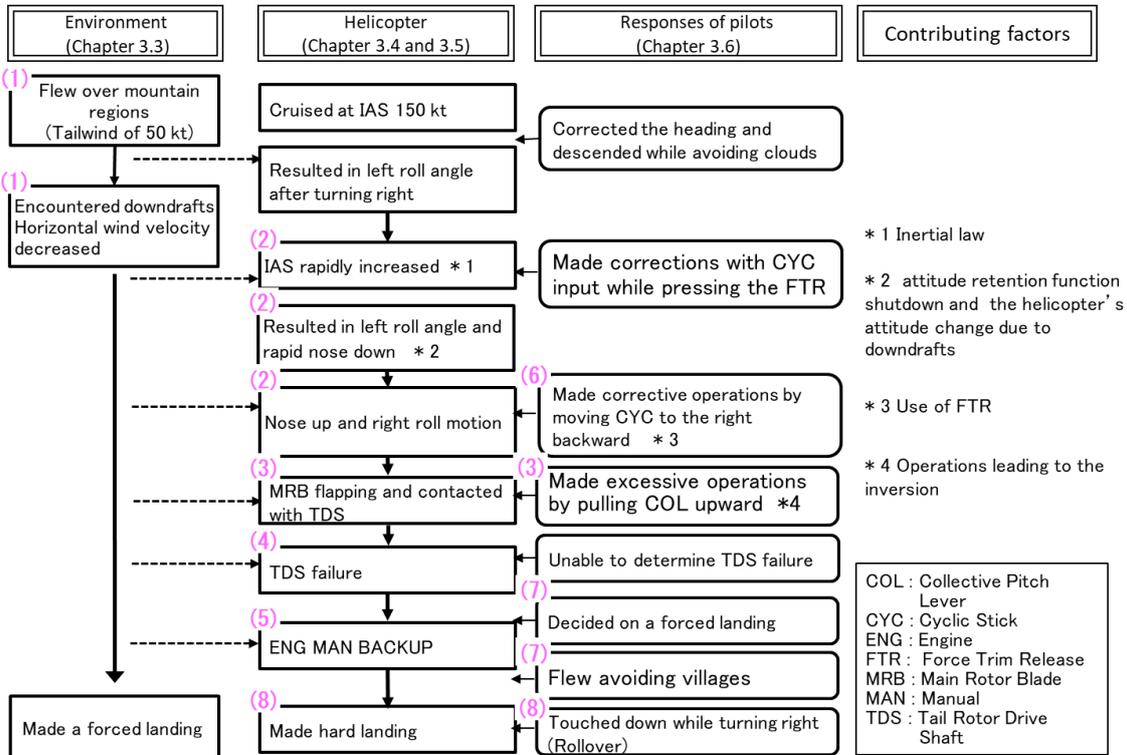
Figure 33 Summary of analysis

- (1) A strong vertical flow was generated over the mountainous terrain on the southeast side of Lake Inawashiro due to strong northwester, and the helicopter flying at high speed with a tailwind probably encountered an area where the air currents drastically changed in a short period of time. It is probably that the flight control of the helicopter was strongly affected by the sudden decrease in horizontal wind speed. (3.3.2)

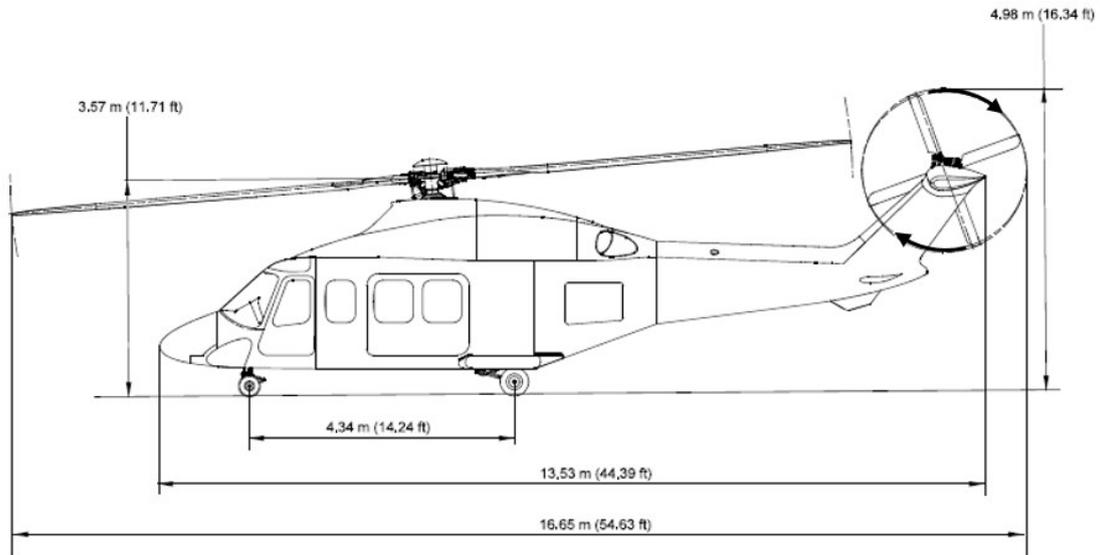
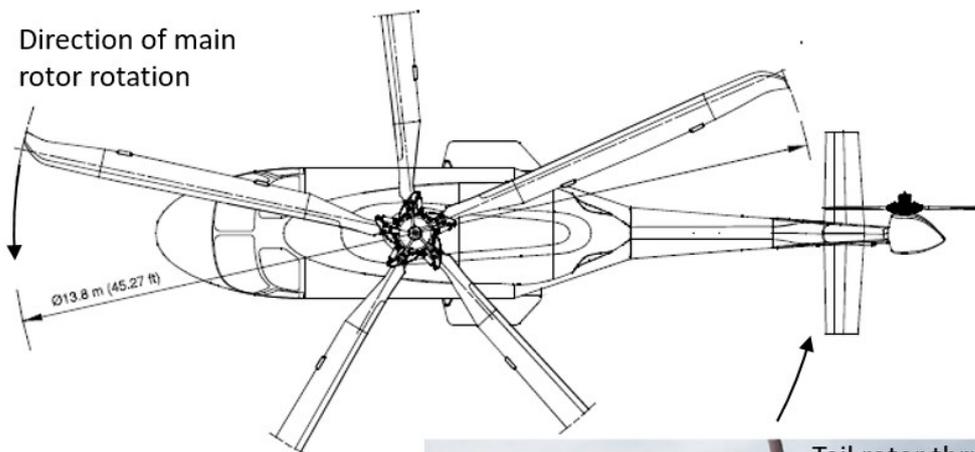
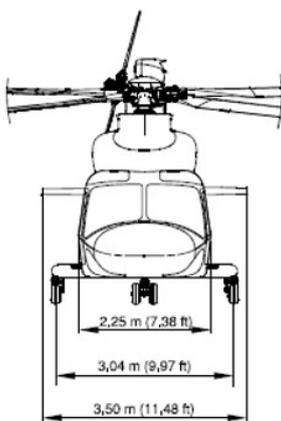
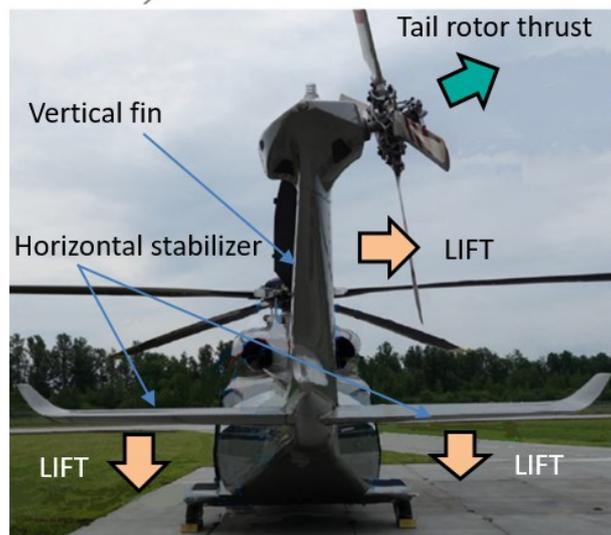
Appended Figure 1: Three Angle View of Agusta AW 139 and Direction of Force Acting on the Tail

As shown in Appended Figure 1, the AW139 tail rotor disc is tilted to the left by about 15°, which can provide the nose-down pitching attitude by giving the lift upward, in addition to movement in a horizontal direction. Besides, the vertical stabilizer holds a right camber and the horizontal stabilizer holds a camber on its upside, which makes it possible to keep the aircraft attitude horizontal during cruise flight and make up for the necessary thrust as an antitorque tail rotor so that the camber of the airfoil can help to produce lift by an increase in airspeed. The tail rotor is mounted on the position higher than the center of gravity, and a right rolling motion can occur due to the change in the tail rotor thrust. Therefore, in order to maintain the desired attitude, corrections in a lateral direction should be made according to the change in the tail rotor thrust.

Tail rotor tilted about 15°

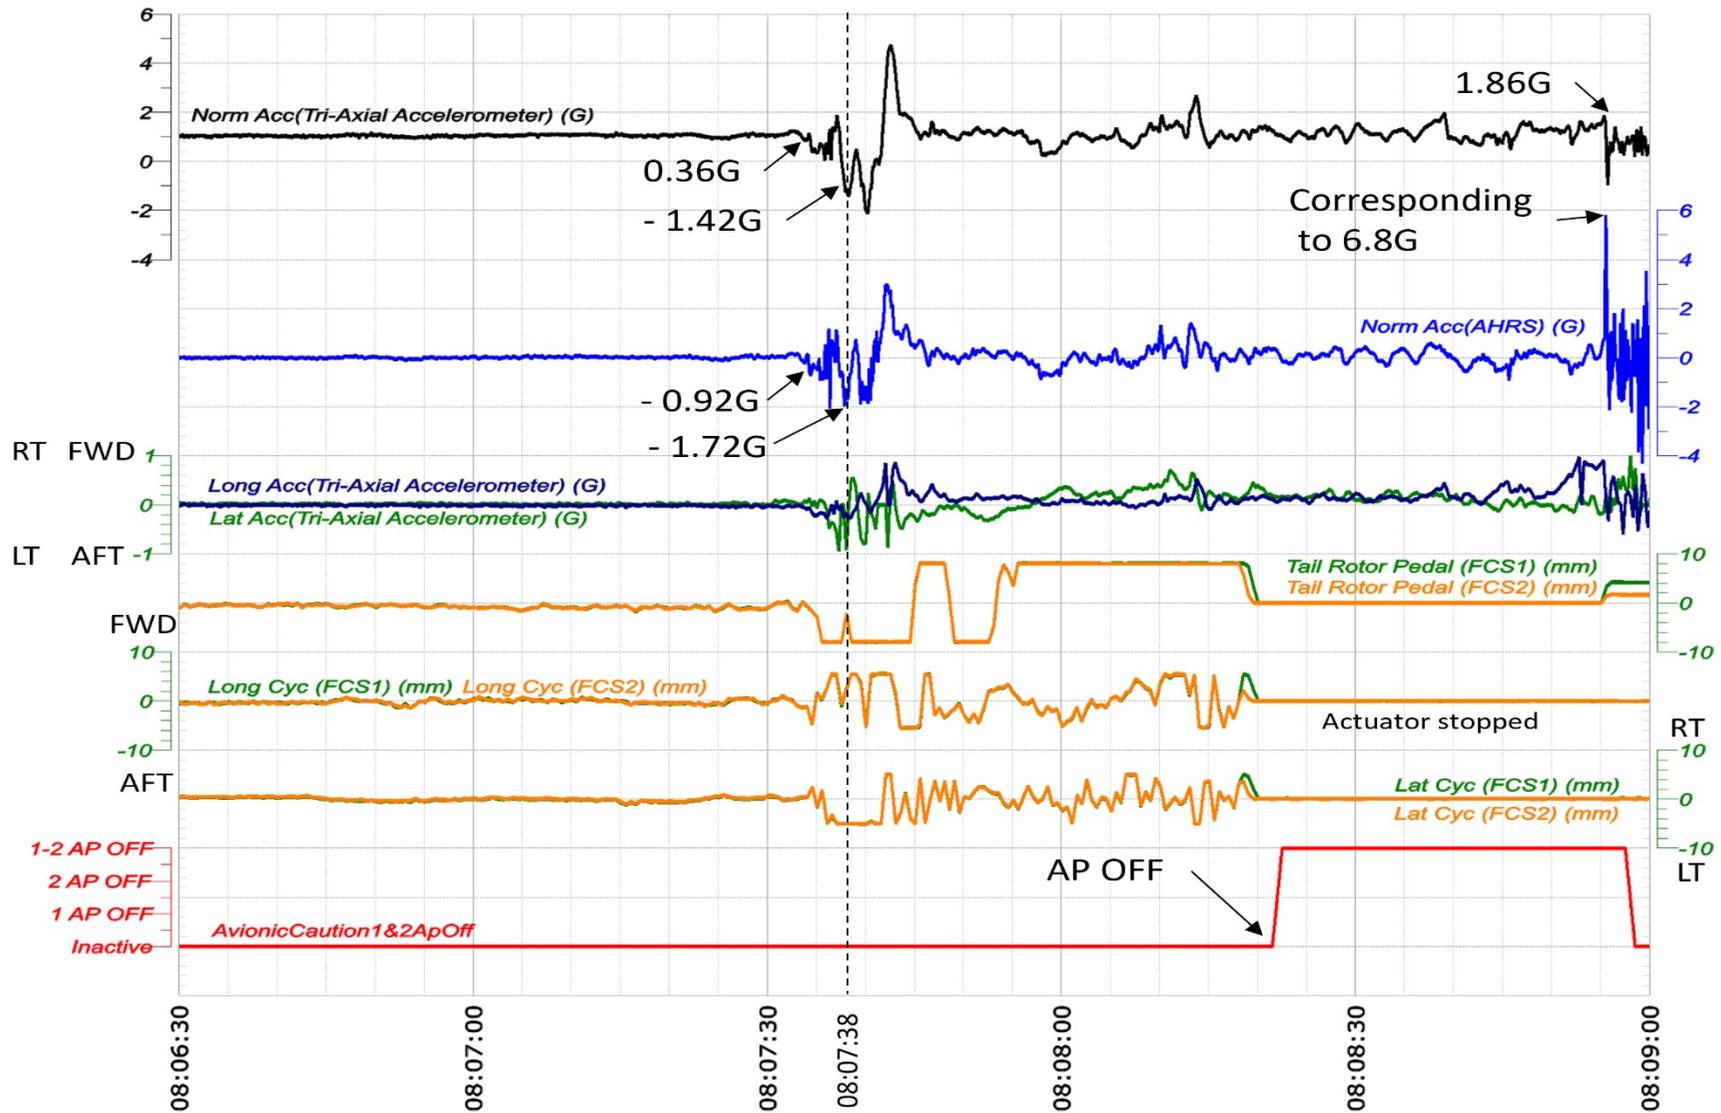
Appended Figure 6: MPFR Analysis before and after right rolling motion - 3

As described in 2.1.2 (2), the co-pilot thought that the flight control system had gone out of control and tried to reset the AP switch. According to the MPFR records in Appended Figure 6, at 08:08:20, the AP was OFF, thus the FO probably left the AP OFF and did not turning it ON again. Therefore, it is possible that the actuator signal of the flight control system (FCS) became zero, and the cyclic stick inputs gradually increased, which caused a large attitude change, resulting in the difficult corrective operation at the time of the forced landing.
