**AIRCRAFT ACCIDENT
INVESTIGATION REPORT**

**PRIVATELY OWNED
J A 2 0 T D**

June 30, 2016

CRASH DURING ATTEMPTING TO OFF-FIELD LANDING
PRIVATELY OWNED, SCHEMPP-HIRTH DISCUS bT
(SINGLE-SEAT MOTOR GLIDER), JA20TD
URASU TOWN, KABATO DISTRICT, HOKKAIDO, JAPAN
AT 12:36 JST, MAY 30, 2015

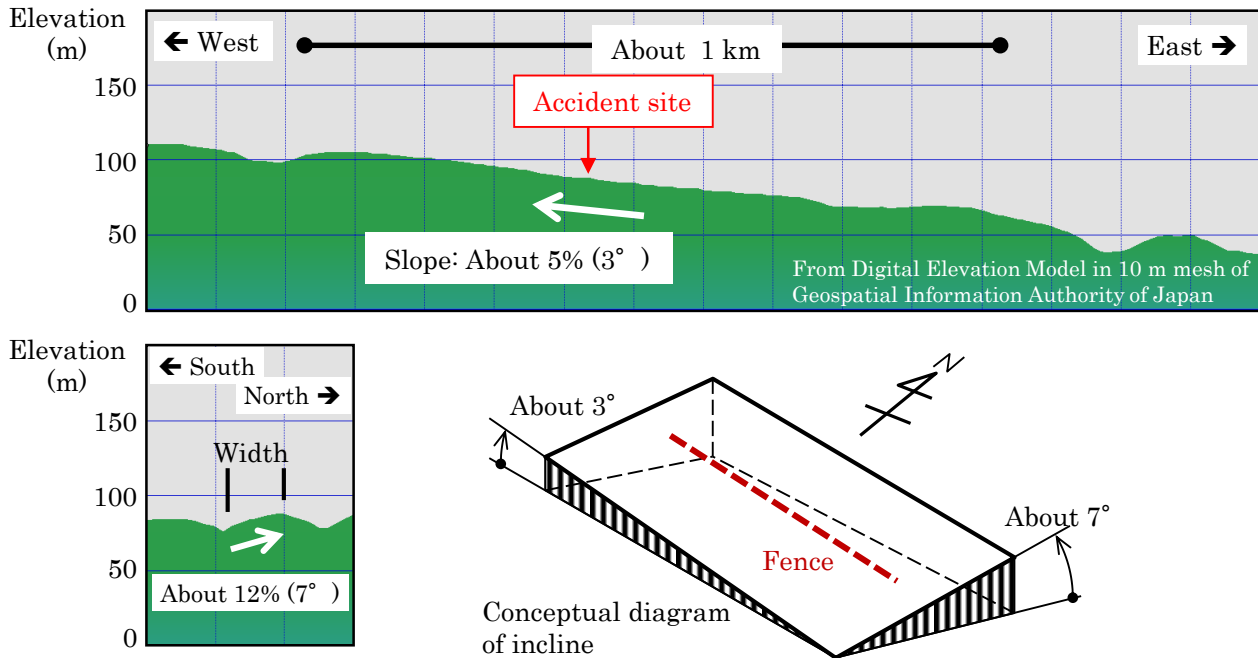
Figure 4: Surrounding Slope of the Accident Site

According to GPS unit records, the Glider approached from the south side of the accident site while turning to the left. First, there was the impact mark by the left wingtip, and the impact mark when the left wingtip was ruptured was left around its north. From that point on, there was the collision mark of the nose, and many pieces of the canopy and other things were scattered near the mark. Further from that point on, the Glider of which the nose was severely damaged and the left main wing and the fuselage were broken halted with the nose roughly headed the south.
