**AIRCRAFT ACCIDENT
INVESTIGATION REPORT**

CRASH DUE TO MID-AIR BREAKUP

PRIVATELY OWNED, GLASFLÜGEL 304CZ-17

(GLIDER, SINGLE-SEATER), JA21BB

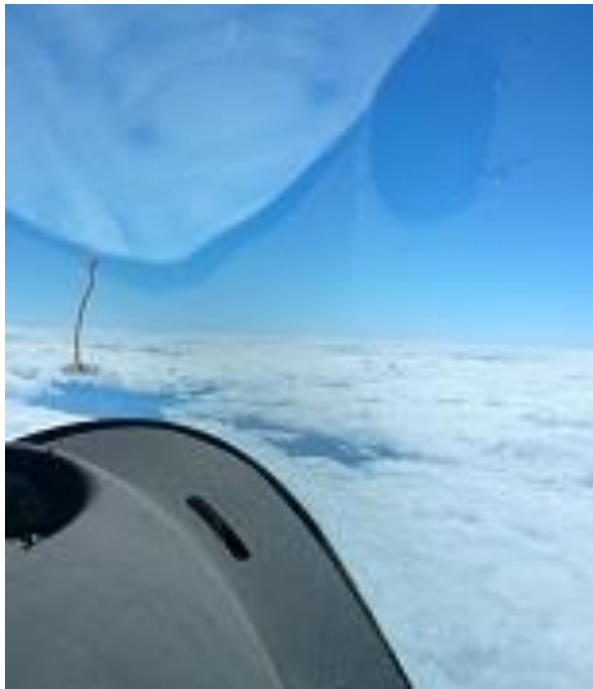
Photo C View toward the nose during flight (13:26 at an altitude of about 18,900ft)

According to the Rapid scan satellite imagery in Photo B, the peak altitude of clouds at the top of the waves was about 10,000-18,000ft. The state of these clouds can also be seen in Photo C (taken at 13:26 at an altitude of about 18,900ft) recorded on the pilot's smartphone.

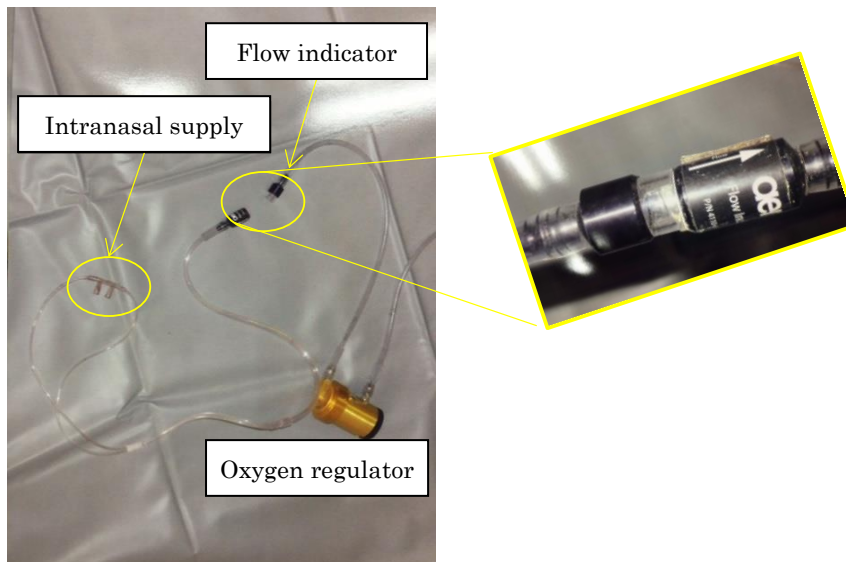
Photo G Oxygen supply pipe

Oxygen valve: Closed position, Oxygen cylinder reserve meter: about 80% (a state in which oxygen is ejected when the valve is opened), In-system oxygen meter (pressure gauge): 0% (0 psi), Oxygen regulator: 5th position^{*1}, Oxygen supply pipe: Oxygen supply pipe missing between decompressor and oxygen regulator, intranasal supply pipe worn by the pilot, portable oxygen device: Unused state

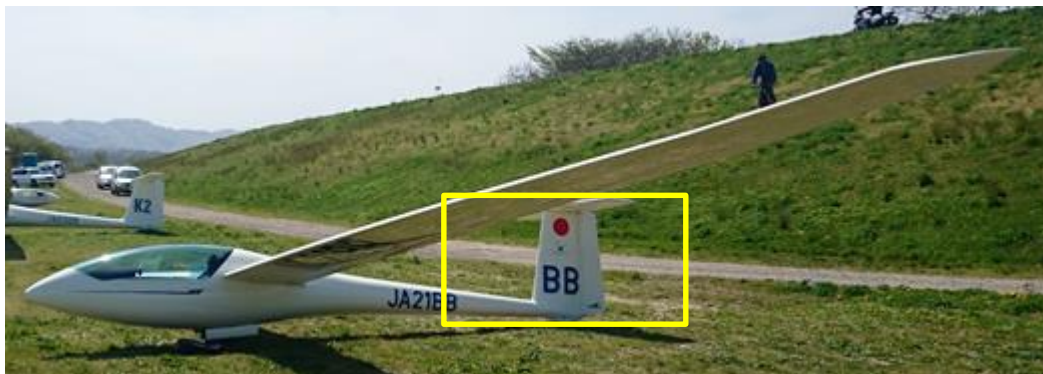
Photo K Separated after fuselage including the tail (state before the accident)

The after fuselage including the tail was broken from the forward fuselage and separated, whereabouts unknown.

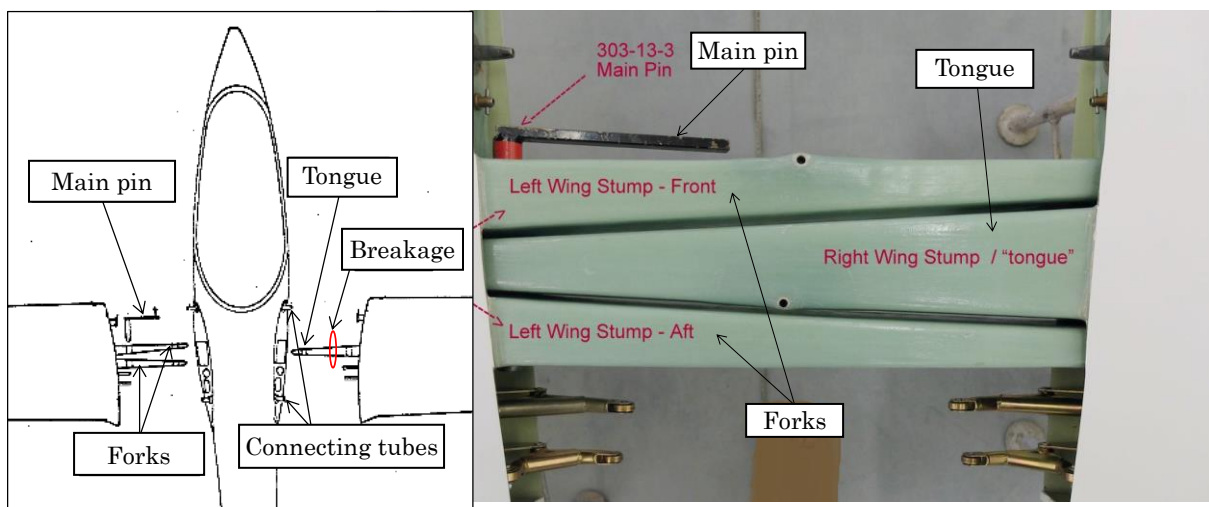
Diag. 2 Sketch of main wing attachment

The structure of the right and left main wings is as shown in Diag. 2 and Photo L, where the two stumps (forks) of the left wing and the single stump (tongue) of the right wing are fastened with a main pin inside the fuselage.

As described in 2.10.2.1 above, in the findings on image analysis of the state of damage to the main wings conducted by the Glider manufacturer, the right wing stump (tongue) is thought to have collapsed and the wings to have eventually slid out of the connecting tubes after the Glider crossed

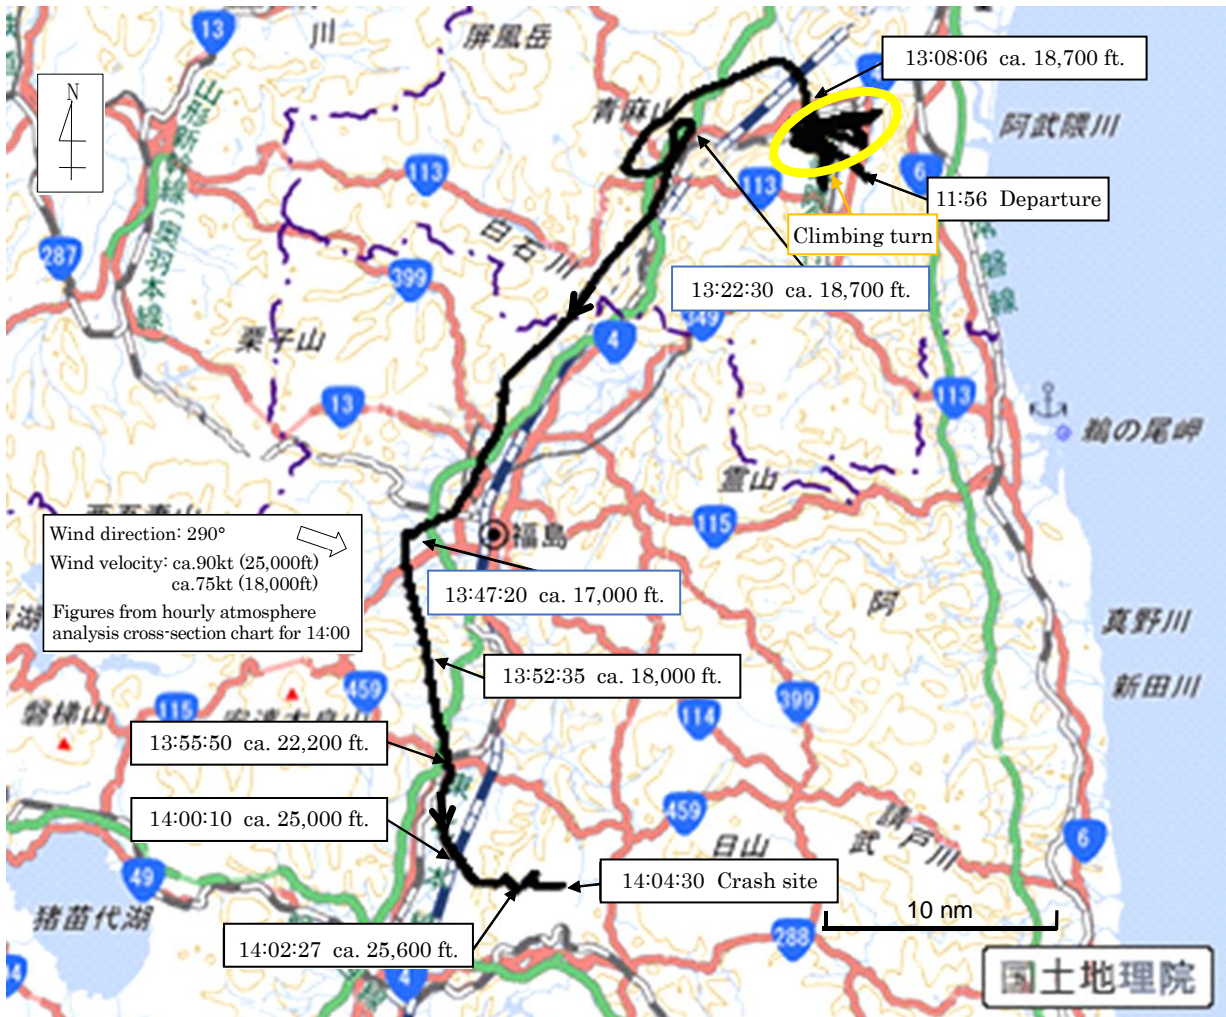
Diag. 3 General map of flight track record

At around 13:53, the Glider started to climb from an altitude of about 18,000ft on a flight course of about 170°, reached an altitude of about 25,000ft at around 14:00, gradually changed course eastward, and reached the crash site at around 14:05. The average rate of climb while climbing was about 920ft/min.

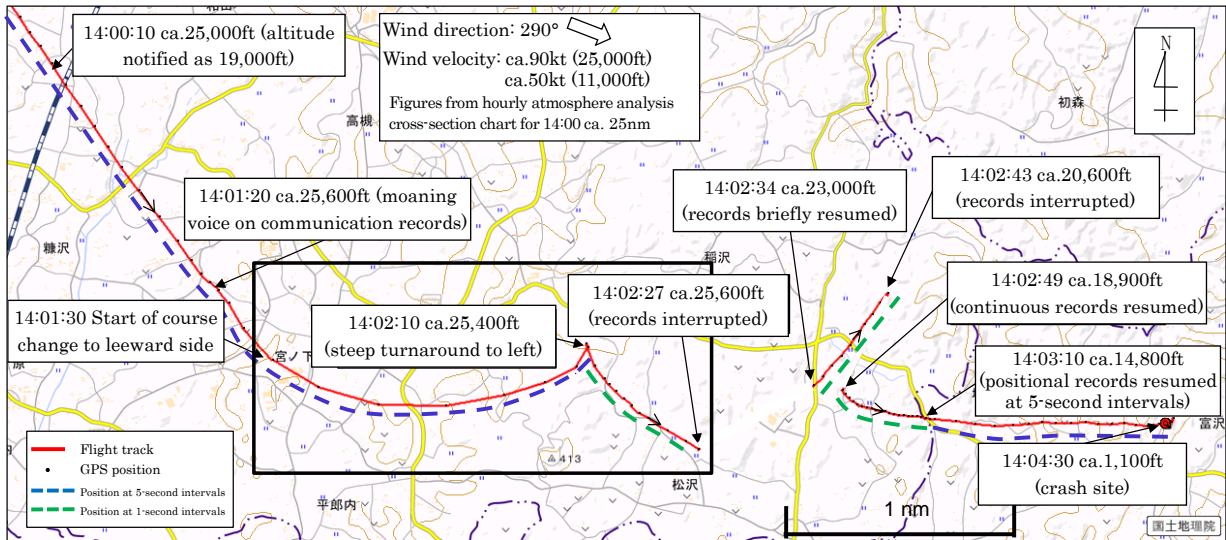
Diag. 4 Map of flight track record near the crash site

At around 14:00, the Glider reached an altitude of about 25,000ft about 5nm west-northwest of the crash site. At this time, as described in 2.1.1 above, the pilot reported an altitude of 19,000ft in communication with the ACC. After this, a sound like a moaning voice and silent noise were recorded at 14:01:20. At this time the Glider was flying at an altitude of about 25,600ft, and after this, from around 14:01:30 it gradually started turning to the left on the leeward side.

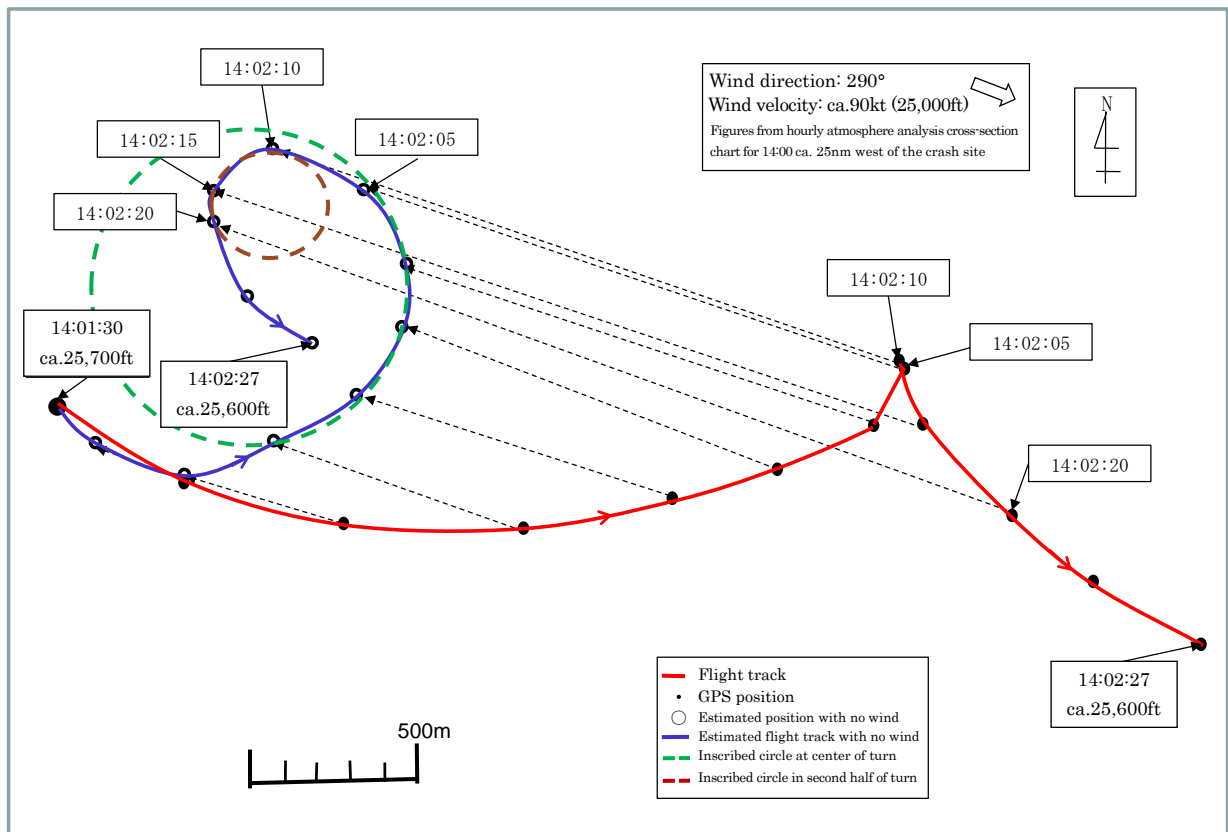
Diag. 5 Flight track while turning

In the estimated flight track with no wind, as shown by the blue line, the turning radius gradually decreases after starting the turn. The turning radius would have been about 450m in the middle part of the turn, as shown by the broken green line in Diag. 5, and would finally have become extremely small at about 150m in the second half of the turn from around 14:02:10 to around 14:02:20, as shown by the broken brown line.
