**AIRCRAFT ACCIDENT  
INVESTIGATION REPORT**

**J A 2 2 N E**

**Japan Transport Safety Board**

PRIVATELY OWNED  
ROBINSON R22 BETA (ROTORCRAFT), JA22NE  
KAMOTO-MACHI, YAMAGA CITY, KUMAMOTO PREFECTURE, JAPAN  
AROUND 14:01 JST, AUGUST 1, 2010

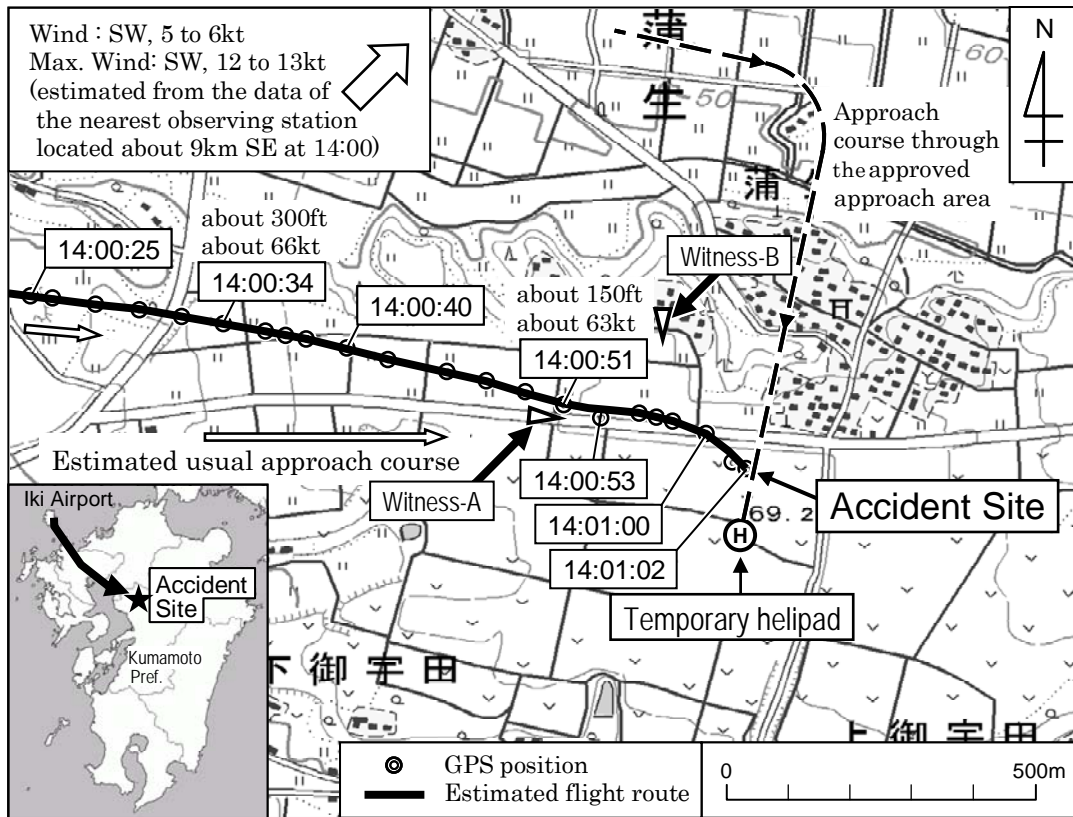
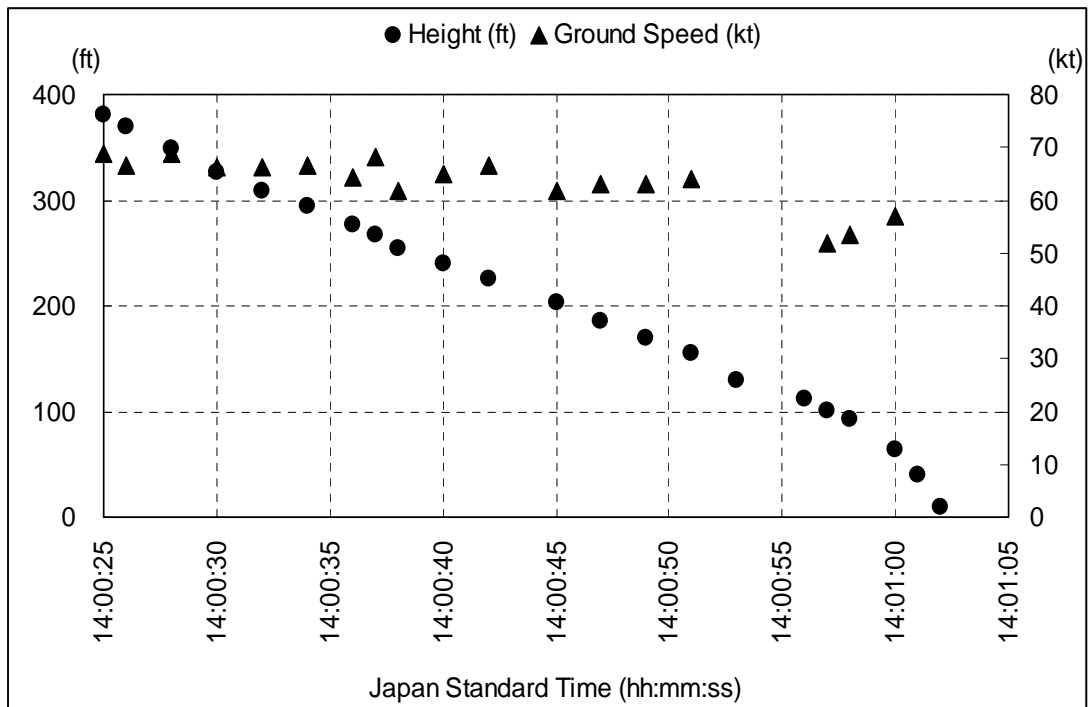
Figure 1 Estimated Flight Route

- a. It is considered somewhat likely that the PF further pulled down the C/P from the descent position at around the middle point of the final approach, at an altitude of about 150 ft AGLH over the vicinity of utility lines.
- b. As described in 2.1.1 and Figure 1 “Estimated Flight Route,” it is considered highly probable that after passing the middle point of the final approach at 14:00:51, the Aircraft deflected to the left from the course which runs diagonally over the utility lines around 14:00:53, and then flew above the utility lines.
- c. As described in 3.3, a maximum instantaneous wind nearly twice as fast as the average wind from the right was observed then around the accident site. Therefore, it is considered somewhat likely that the deflection to the left from the course reflects an influence of the wind that drifted the Aircraft to the left (to the leeward).

- a. As described in Figure 1 “Estimated Flight Route,” it is considered somewhat likely that when the Aircraft was flying above in the vicinity of the utility lines after passing the middle point, the PF had concluded that the Aircraft would come down very close to the utility lines if it continues to descend rapidly and in an attempt to avoid this, he pulled up the C/P, which was earlier pulled down, again to a power position with which 1 m hovering can be made as described in 2.10.2 (2) c and on this occasion, he further applied the left rudder pedal as an usual control.

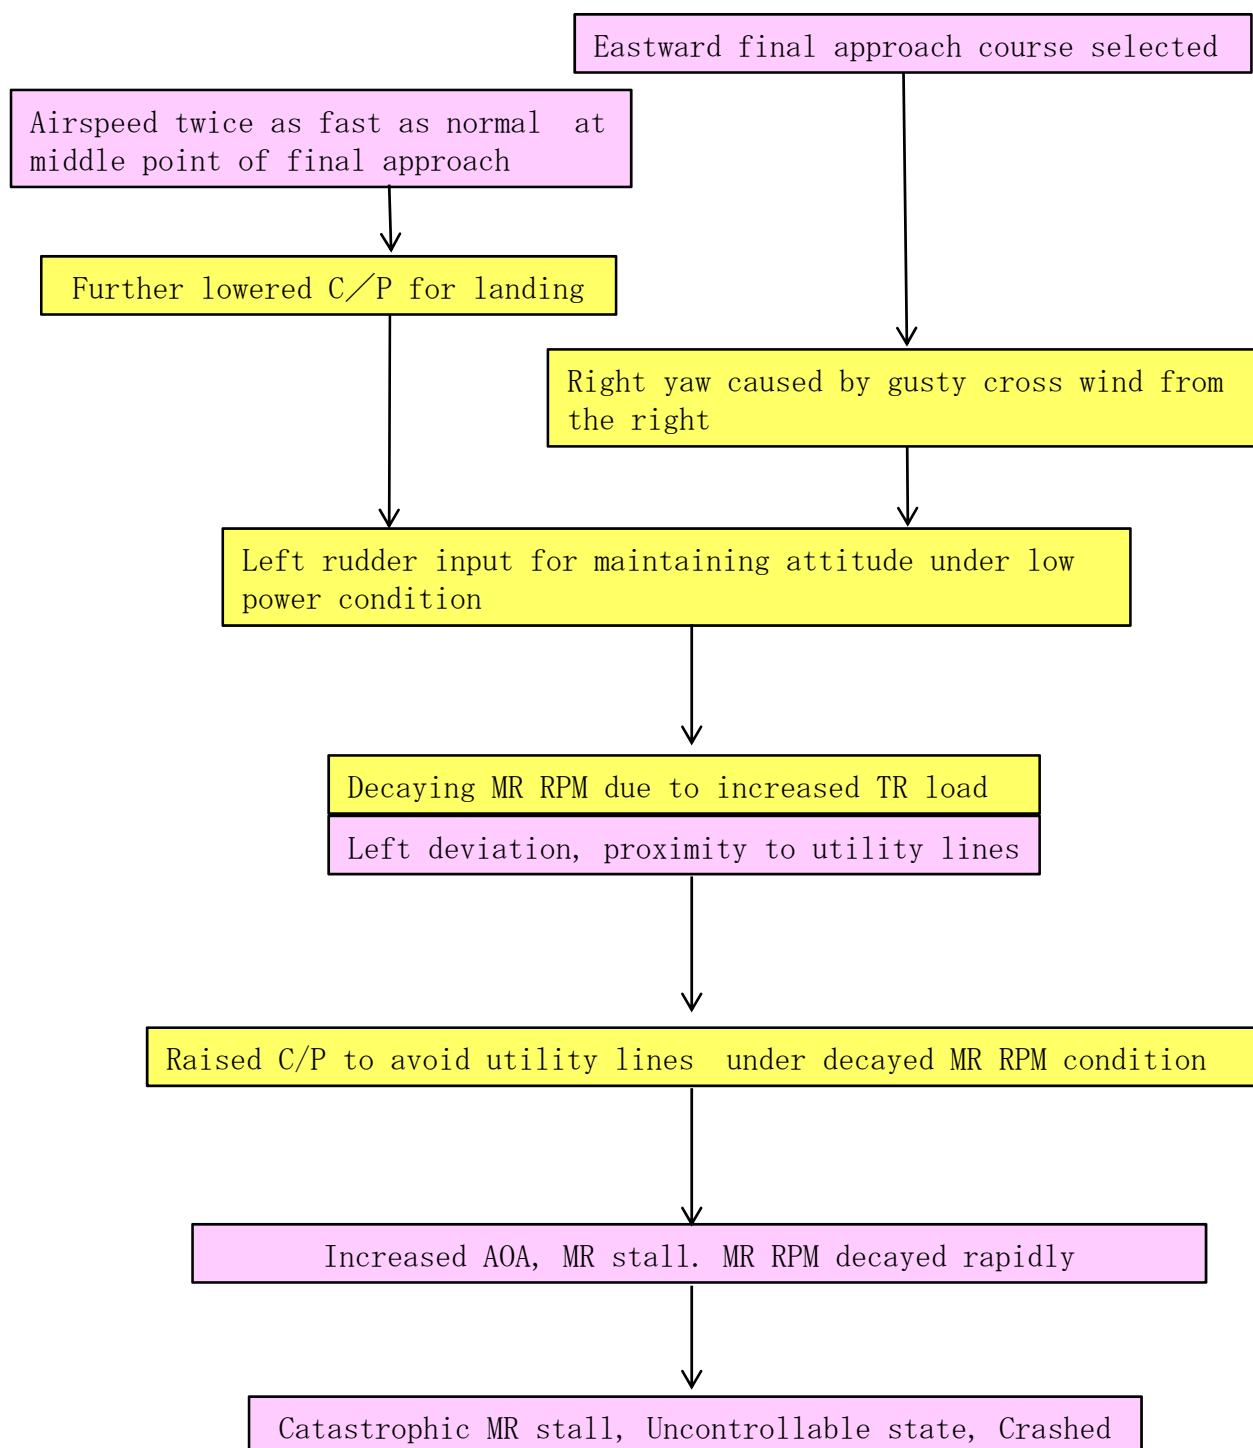
Figure 6 Chain of Events

As to the uncontrollable situation caused by the catastrophic stall out of the entire loss of MR lift, it is considered somewhat likely that the PF's pull-up of the C/P in a low MR RPM condition lead to a substantially increased load and the condition where the required power exceeded the available power, followed by the MR's angle-of-attack reaching a stall angle, and rapid decay of the MR RPM.
