AIRCRAFT ACCIDENT INVESTIGATION REPORT

CRASH

PZL-BIELSKO SZD-55-1(GLIDER, SINGLE SEATER), JA2502

AT ABOUT 13:19 JST, APRIL 9, 2023

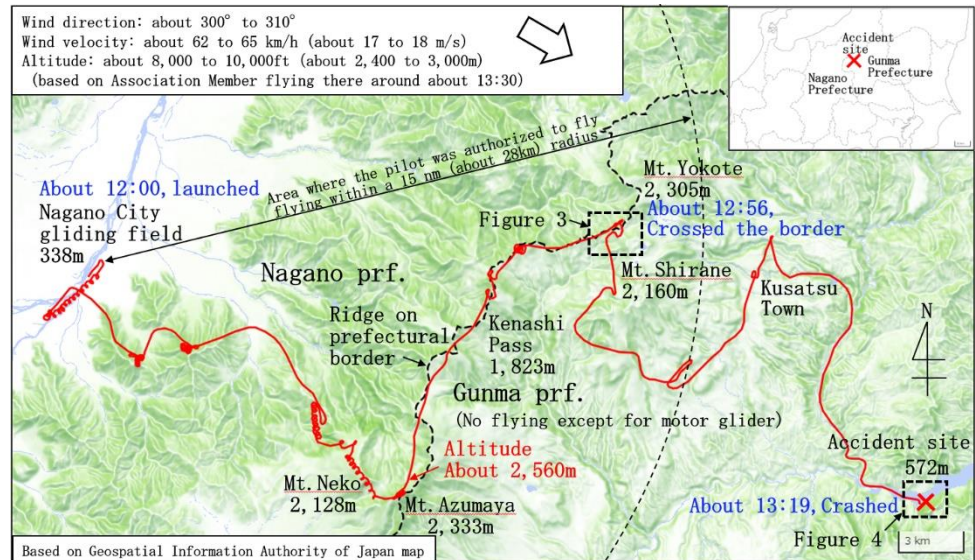
Figure 1: Estimated Flight Route
 (based on the GPS records of the pilot's smartphone)

The pilot met the requirement of "30 hours of flying time over the mountains in Nagano", which was the "standard for flying within a 15 nm radius of the gliding field" in the "standard for the flight area to be followed by all members" specified by the Association, therefore, the pilot was recognized by the instructor as having necessary experience and skills to fly. (See dotted line in Figure 1)

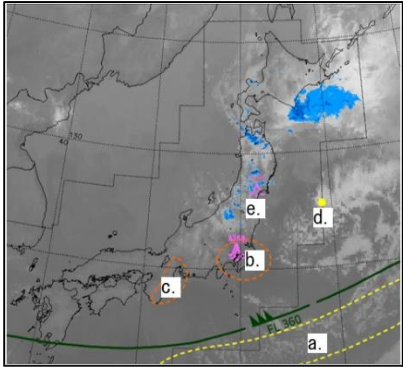
Figure 8: Significant Weather Analysis Chart as of 09:00, April 9

The Significant Weather Analysis Chart as of 09:00 on April 9, 2023 indicated mountain waves (FL 20 to 180 (altitude of about 600 to 5,500 m), weakening) in the Kanto Plain . (Area within the orange dotted line of b. in Figure 8) The Significant Weather Analysis Chart for 12:00 indicated no mountain waves in the Kanto Plain.

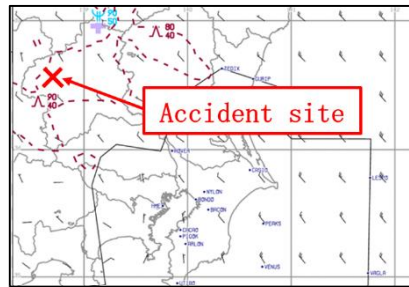
Figure 10: Narrow Area Significant Weather Prognostic Chart(extracted from SIGWX Analysis Chart at 09:00, April 9, and added)

The Narrow Area Significant Weather Prognostic Chart as of 09:00 on April 9, 2023, predicted that a turbulence of MODERATE intensity (FL 40 to 90 (altitude of about 1,200 to 2,700 m)) was expected near the border between Nagano and Gunma prefectures. The Narrow Area Significant Weather Prognostic Chart for 13:00 predicted no turbulence and others near the prefectural border.

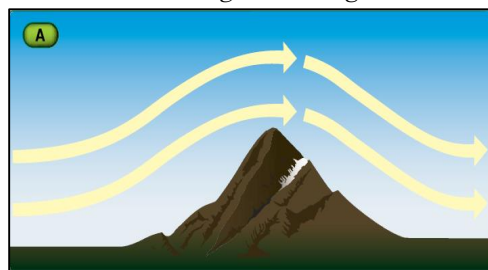
Figure 12: Airflow along the Ridge

(Omitted) *Just as the flow is deflected upward on the windward side of a ridge, it is deflected downward on the lee side of a ridge. (see Figure 12) This downdraft can be alarmingly strong—up to 2,000 fpm or more near a steep ridge with strong winds. Even in moderate winds, the downdraft near a ridge can be strong enough to make penetration of the upwind side of the ridge impossible.*

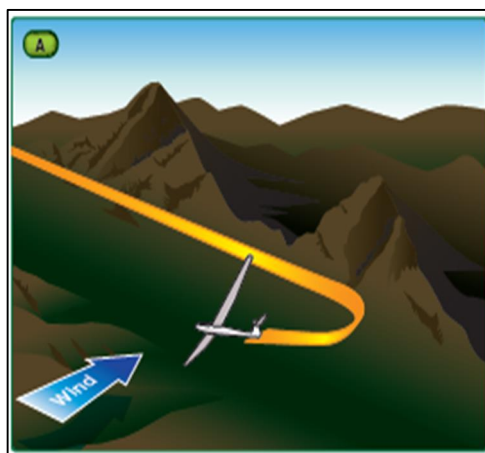
Figure 13: Ridge rules

Make all turns away from the ridge. (see Figure 13) A turn toward the ridge is dangerous, even if gliding seemingly well away from the ridge. The groundspeed on the downwind portion of the turn is difficult to judge properly, and striking the ridge is a serious threat. Even if above the ridge, it is easy to finish

the turn downwind which may take the glider over the ridge crest; this puts the glider into heavy sink.
