**AIRCRAFT ACCIDENT  
INVESTIGATION REPORT**

**J A 2 5 2 9**

## FUSELARGE DAMAGE CAUSED BY HARD LANDING PRIVATELY OWNED SCHEIBE SF25C (MOTOR GLIDER, TWO-SEATER), JA2529 AT SHIKABE AIRFIELD, SHIKABE, KAYABE-GUN, HOKKAIDO, JAPAN AROUND 12:04 JST, MAY 6, 2014

February 27, 2015

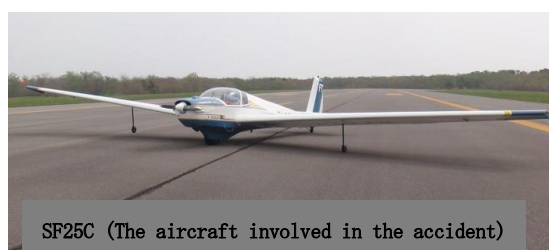
<p>wind information reported by the airfield radio operator was 260° with velocities as strong as 16 kt, maximum 25 kt; accordingly, he increased airspeed to 100 km/h, which is 10 km/h faster than usual. On final approach, he aimed for the touchdown zone marking adjusting the glide path slightly steeper than usual by using spoilers*1. At this time, he did not extend the spoiler a lot. He felt that the elevator response was a bit more sensitive than that of other aircraft of the same type he flew in the past when he initiated the flare*2 at the height between eight meters and 10 meters above ground level (AGL). Subsequently, he felt the flare was relatively high. To correct this situation, he slightly pushed the control stick forward and retracted the spoilers a little. Immediately after that, however, the aircraft hit the ground vigorously, bounced back and came to a halt.</p> <p>According to a witness on the second floor of the airfield office located about 300 meters away from the accident site, who provided landing information to the aircraft, the aircraft started its flare at higher than typical altitude, became high flare*3, lost its speed in level attitude, and then it seemed to drop nearly straight onto the ground. After the witness looked aside from the aircraft for a short period of time, he looked at the aircraft again and found that the aircraft was up again into the air. Thereafter, it landed with its nose slightly lowered and came to halt on the runway.</p> <p>The captain and the passenger evacuated from the aircraft after it halted.</p> <p>The captain did not notice any anomalies of the aircraft before the accident.</p>
