AIRCRAFT ACCIDENT INVESTIGATION REPORT

Company	Privately owned
Type, Registration Mark	Piper PA-28-151, JA3712
Accident Class	Damage to the aircraft during landing
Date and Time of the Occurrence	At about 10:58 Japan Standard Time (JST: UTC+9 hours), June 5, 2024
Site of the Accident	Yoron Airport, Kagoshima prefecture (27°02'38"N, 128°24'09"E)

Summary of the Accident	On Wednesday, June 5, 2024, while the aircraft was landing at Yoron Airport, it deviated from the runway and collided with the airport's perimeter fence, resulting in damage the leading edges of both wings, and so on.
Outline of the Accident Investigation	An investigator-in-charge and two investigators were designated on June 5, 2024. Comments on the draft Final Report were invited from the parties relevant to the cause of the serious incident and Relevant State.

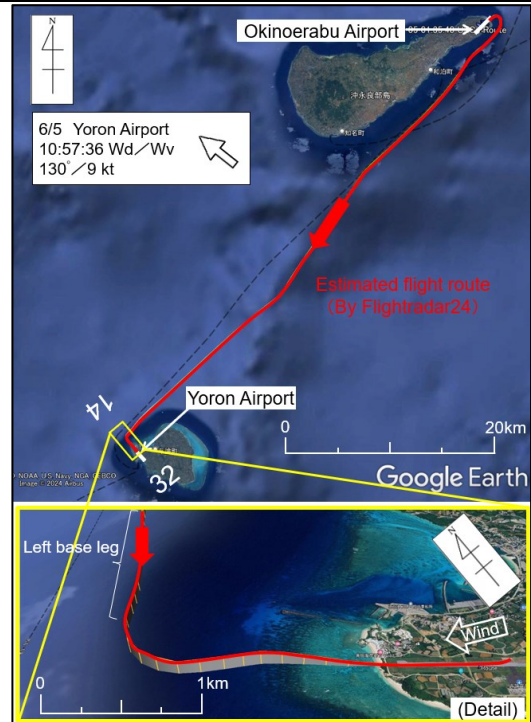
Figure 2: Estimated flight route

While flying on the left base leg, the student made a left turn toward the runway at an altitude of about 500 ft and a speed of about 70 knots and continued the final approach while
