**AIRCRAFT ACCIDENT  
INVESTIGATION REPORT**

**PRIVATELY OWNED  
J A 3 7 6 2**

## DAMAGE CAUSED BY BELLY LANDING A PRIVATELY OWNED BEEHCRAFT A36 JA3762 SENDAI AIRPORT AT AROUND 12:25 JST, NOVEMBER 16, 2015

September 8, 2017

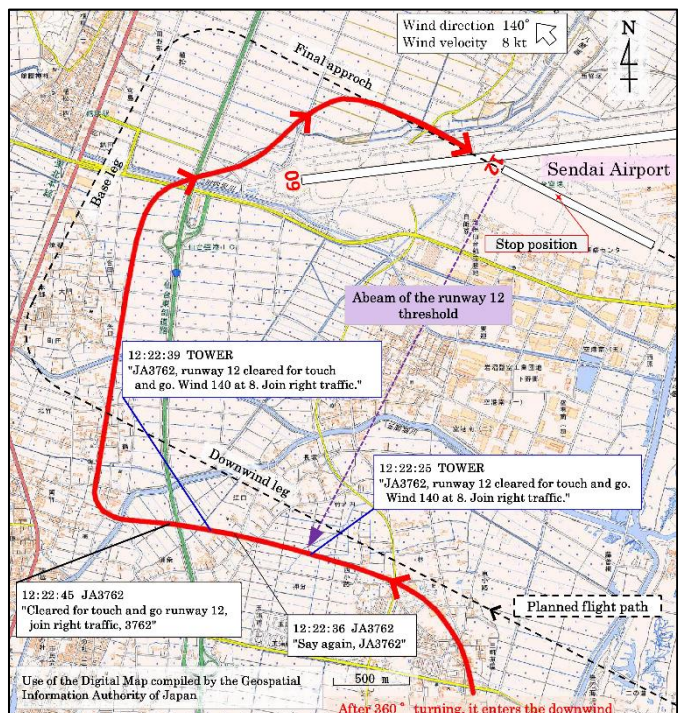
Fig.1 Estimated flight route

When the passenger looked outside of the aircraft as completing the flap operation at the same time with completing the base turn, the runway seen in front was too close so that he reminded the captain that the height was too high. While the passenger told the captain to close the throttle, he took over the piloting from the captain and started to descend with heading to the runway in front.

The captain was watching the passenger’s piloting, but he noticed that the passenger saw the runway 09 which was coming to visual in front as the approach runway 12 by a mistake, he took over the piloting from the passenger as saying “the runway to land is the runway 12” and directed the aircraft to the approach path to the runway 12.

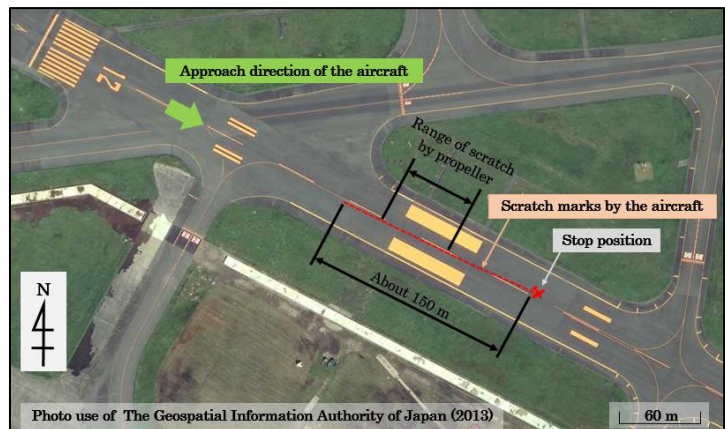
Fig.2 Accident site

The accident occurred on the runway 12 of Sendai Airport (38°08’15”N, 140°55’8”E) at around 12:25 on November 16, 2015.

2.2 Injuries to the Persons	None
2.3 Damage to the Aircraft	<p>Extent of Damage: Substantial Damage</p> <ul style="list-style-type: none"> <li>• Fuselage: Damage on the bottom surface of fuselage (including major structural members)</li> <li>• Wing: Damage of the trailing edge of flap</li> </ul> <p>Deformation of the pitot tube</p>

<ul style="list-style-type: none"> <li>• Landing gear: Damage of the nose gear doors</li> <li>• Engine: Damage of the right and left exhaust pipes</li> <li>• Propeller: Bended of the every blade tip</li> </ul>	<p>Photo 1 The Aircraft on the runway</p>
