AIRCRAFT ACCIDENT INVESTIGATION REPORT

HELICOPTER DAMAGE

ALL NIPPON HELICOPTER CO., LTD.

EUROCOPTER EC 135 T2 (HELICOPTER), JA37NH

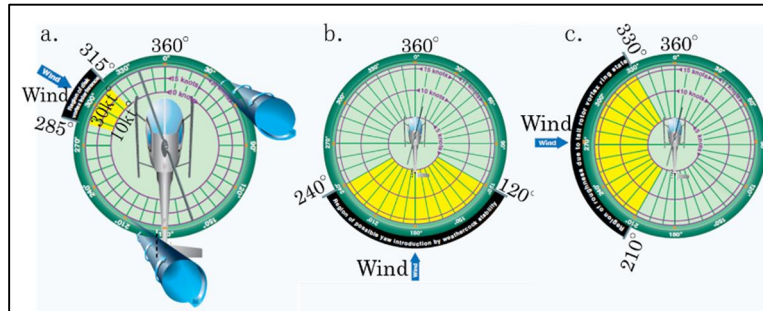
Figure 9: Wind Directions that are More Likely to Cause LTE

The relative wind direction at 285 to 315° and winds at velocities of 10 to 30 kt, MR generating vortices that can blow directly into the tail rotor, interfering with the tail rotor and reducing thrust (see Figure 9, a.). As a result, the nose direction yaws to the right.

In the region of 120 to 240° relative wind direction, *the helicopter* attempts to weathercock its nose into the wind and starts an uncommanded turn either to the right or left (see Figure 9, b.). Particularly when the nose direction yaws to the right, the yaw rate can accelerate rapidly as it turns in the same direction as the torque.

Winds in the range of the 210 to 330° relative wind direction cause a tail rotor wake to be pushed back, and this turbulent airflow flows into the tail rotor causing the tail rotor thrust to vary and the nose direction to yaw to the right (see Figure 9, c.). If a tail rotor is in VRS and a right yaw rate is allowed to build, the helicopter can be brought into weathercock stability and then accelerate the right turn rate.

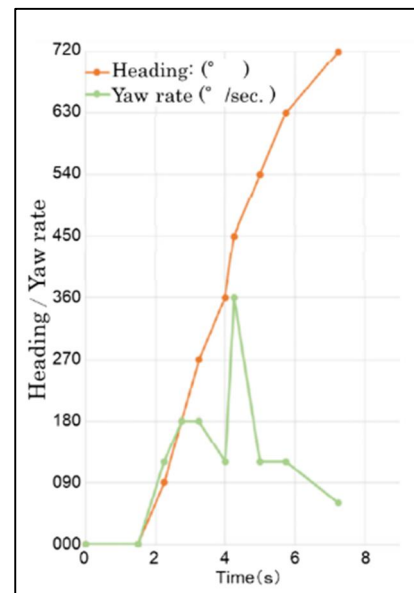
Figure 11: Heading and yaw rate from video analysis

- (c) Based on the heading changes obtained from the 10 images from (i) to (iii) above and the time differences, the yaw rate was calculated and plotted on a graph (see Figure 11). It can be seen that a duration from start of rotation until 360° of 2.5 to 3.0 seconds.
- (d) Based on (iv) above, it was estimated that the altitude gained during the turn was to have been about 5 m.
