**AIRCRAFT SERIOUS INCIDENT  
INVESTIGATION REPORT**

**KAWASAKI AIR Co., Ltd.**

**J A 3 8 1 8**

KAWASAKI AIR CO., LTD  
CESSNA TU206G, JA3818  
2,000 FT OVER THE BUILT-UP AREA  
2 KM SOUTHEAST OF YOKOTA AIRFIELD  
AT 14:12 LOCAL TIME, OCTOBER 23, 2010

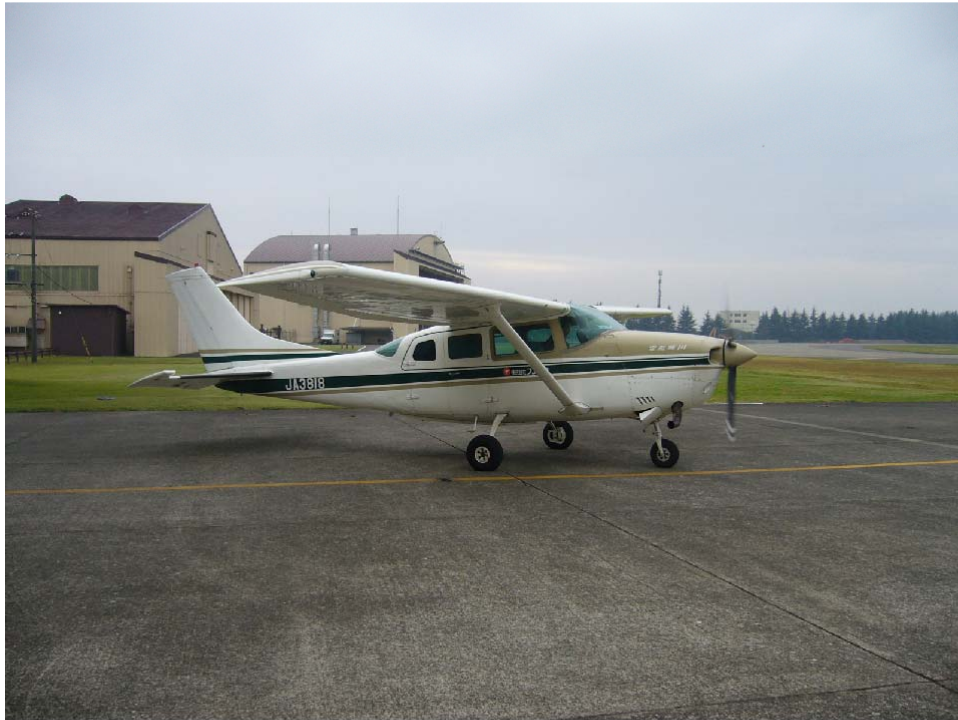
Photo 1: The Airplane

Two persons on board (the pilot in Command (PIC) and a cameraman) suffered no injuries. The airplane sustained no damage.
