**AIRCRAFT ACCIDENT
INVESTIGATION REPORT**

**PRIVATELY OWNED
JA 3825**

CESSNA 172N RAM, JA3825

MINAMIFURANO-CHO, SORACHI-GUN, HOKKAIDO

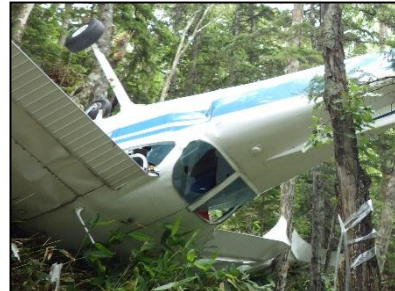
Figure 6: Upper fuselage

- (1) Extent of damage of the Aircraft: Destroyed
- (2) Damage to parts of the Aircraft
 - a. Fuselage
 - The spinner was crushed and deformed from the front.
 - The skin between the engine mounting area and cabin had been torn off.
 - The strut supporting the left main wing was fractured at its attaching point to the fuselage and tree chips were attached.
 - The cargo compartment of the aft fuselage had buckled.

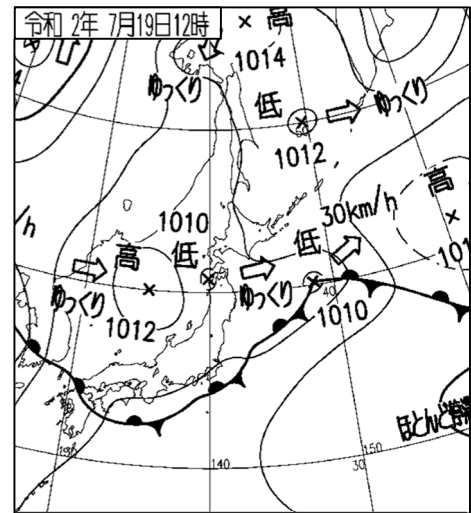
Figure 9: Weather maps

2.6 Meteorological Information	<p>(1) General weather outlook A weather outlook issued for the Hokkaido region by the New Chitose Aviation Weather Station at 05:00 on the day of the accident was as follows: It will be under a pressure trough through the night on July 19, bringing rain in some area in the Pacific side. In addition, low cloud cover will spread due to humid air current and temperature drops, bringing FG (fog) or BR (mist) in some places.</p>
