AA2016-2

**AIRCRAFT ACCIDENT
INVESTIGATION REPORT**

PRIVATELY OWNED CESSNA 172RG, JA3857 BELLY-LANDING AT KAGOSHIMA AIRPORT AT ABOUT 17:24 APRIL 26, 2015

February 26, 2016

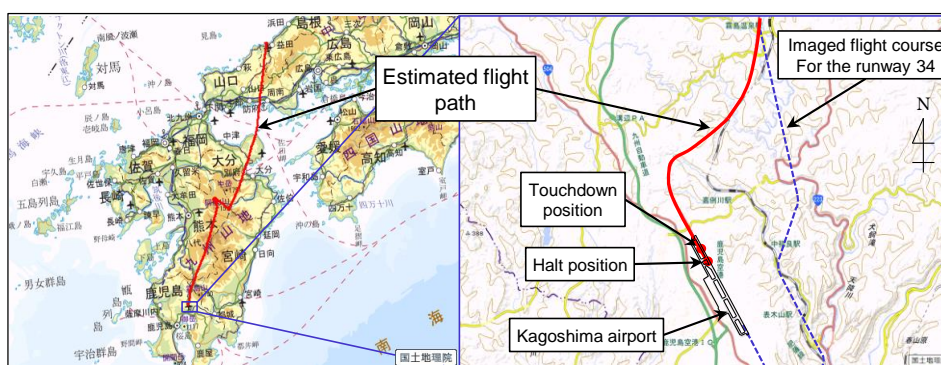
Estimated flight course

The captain once extended the landing gear to increase the descent rate for landing and retracted the gear to increase the airspeed. He planned to extend the gear on downwind before entering the base-leg. However, he directly entered the base-leg because he changed runway to land on, and worried about other traffic landing, he forgot that he retracted the gear once extended.
