**AIRCRAFT ACCIDENT  
INVESTIGATION REPORT**

**NAKANIHON AIR SERVICE CO., LTD.**

**J A 3 9 0 2**

NAKANIHON AIR SERVICE CO., LTD.  
CESSNA TU206G, JA3902  
IN THE MOUNTAINS EAST OF MT. IWABE-DAKE,  
FUKUSHIMA-TOWN, MATSUMAE-GUN,  
HOKKAIDO PREFECTURE  
AROUND 10:40 JST, JULY 28, 2010

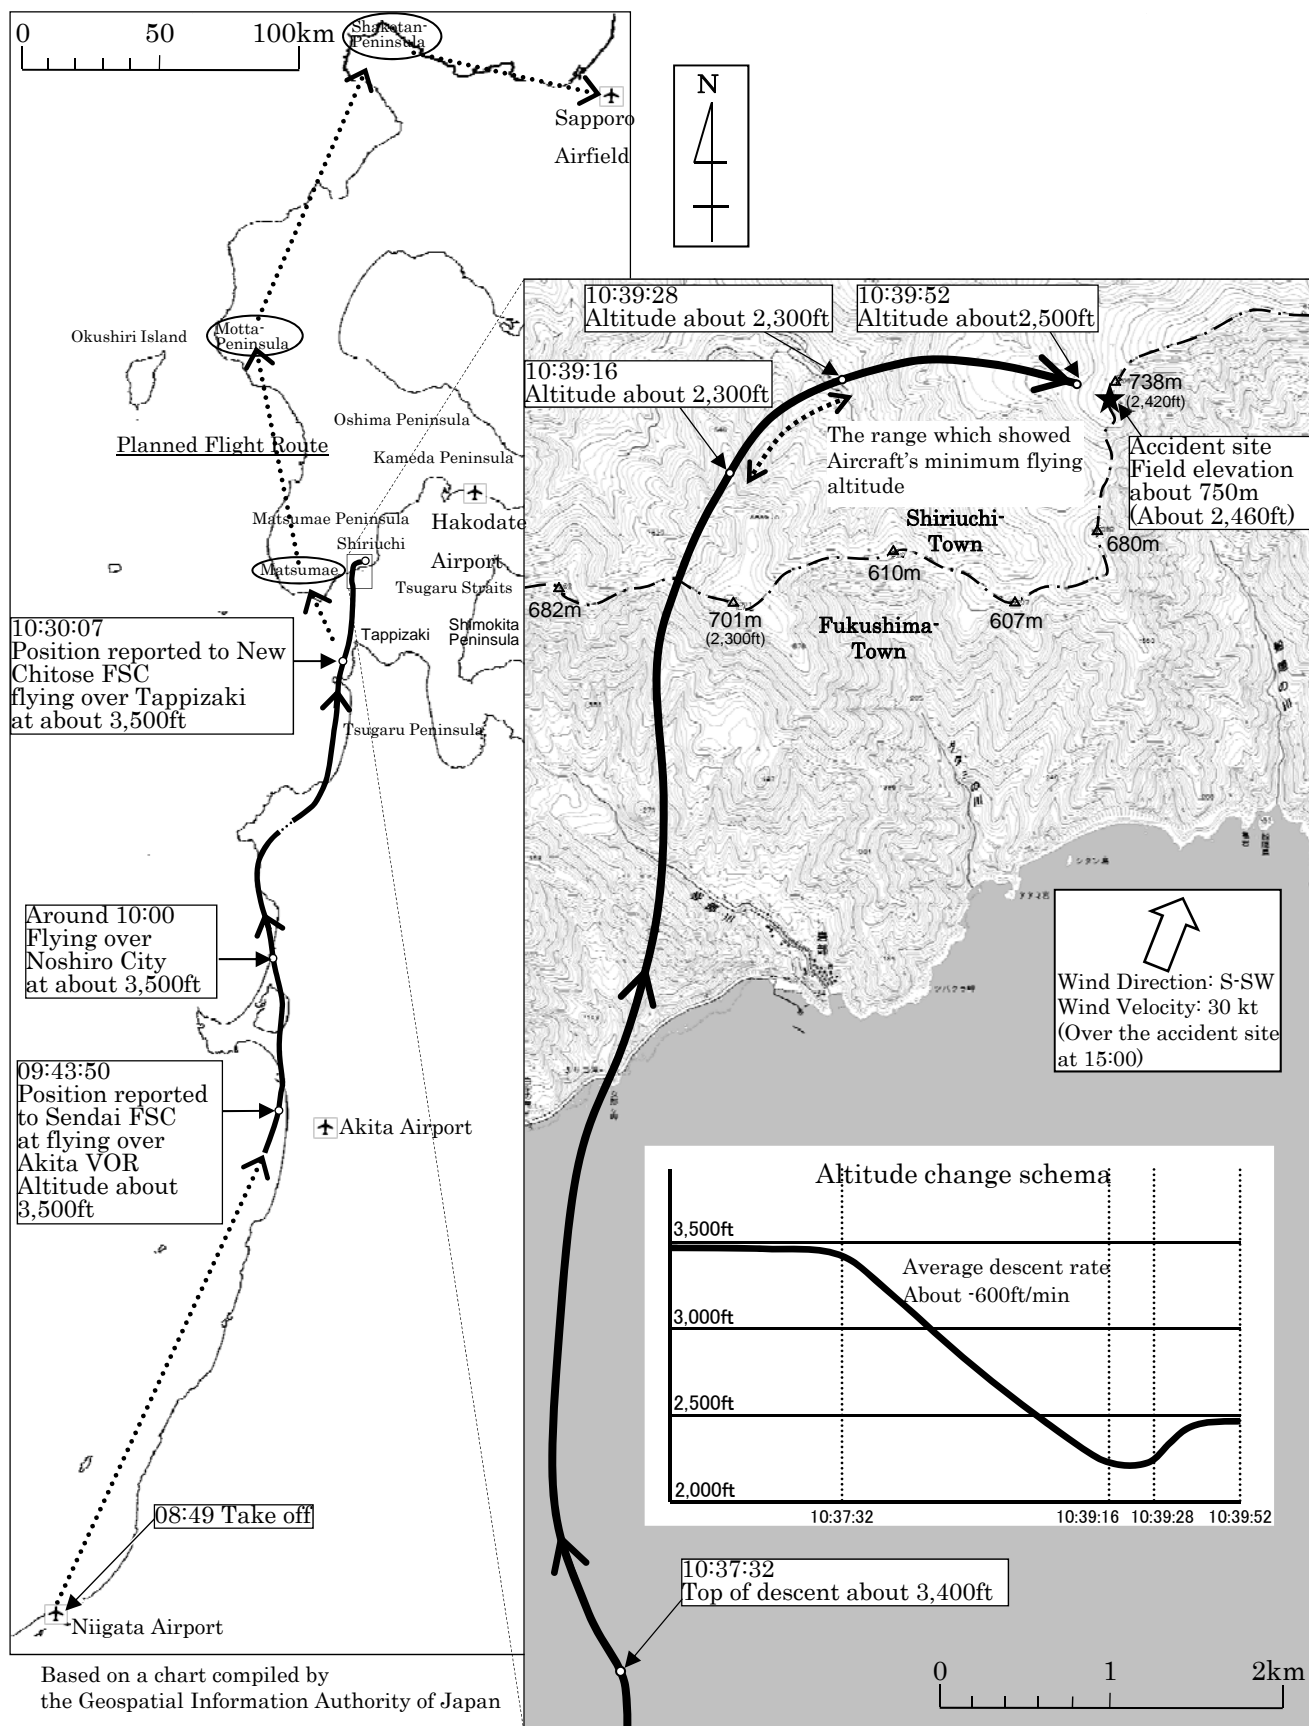
Figure 1 Estimated Flight Route

(See Figure 1 Estimated Flight Route, Photo 1 Accident Aircraft (Before Accident) )

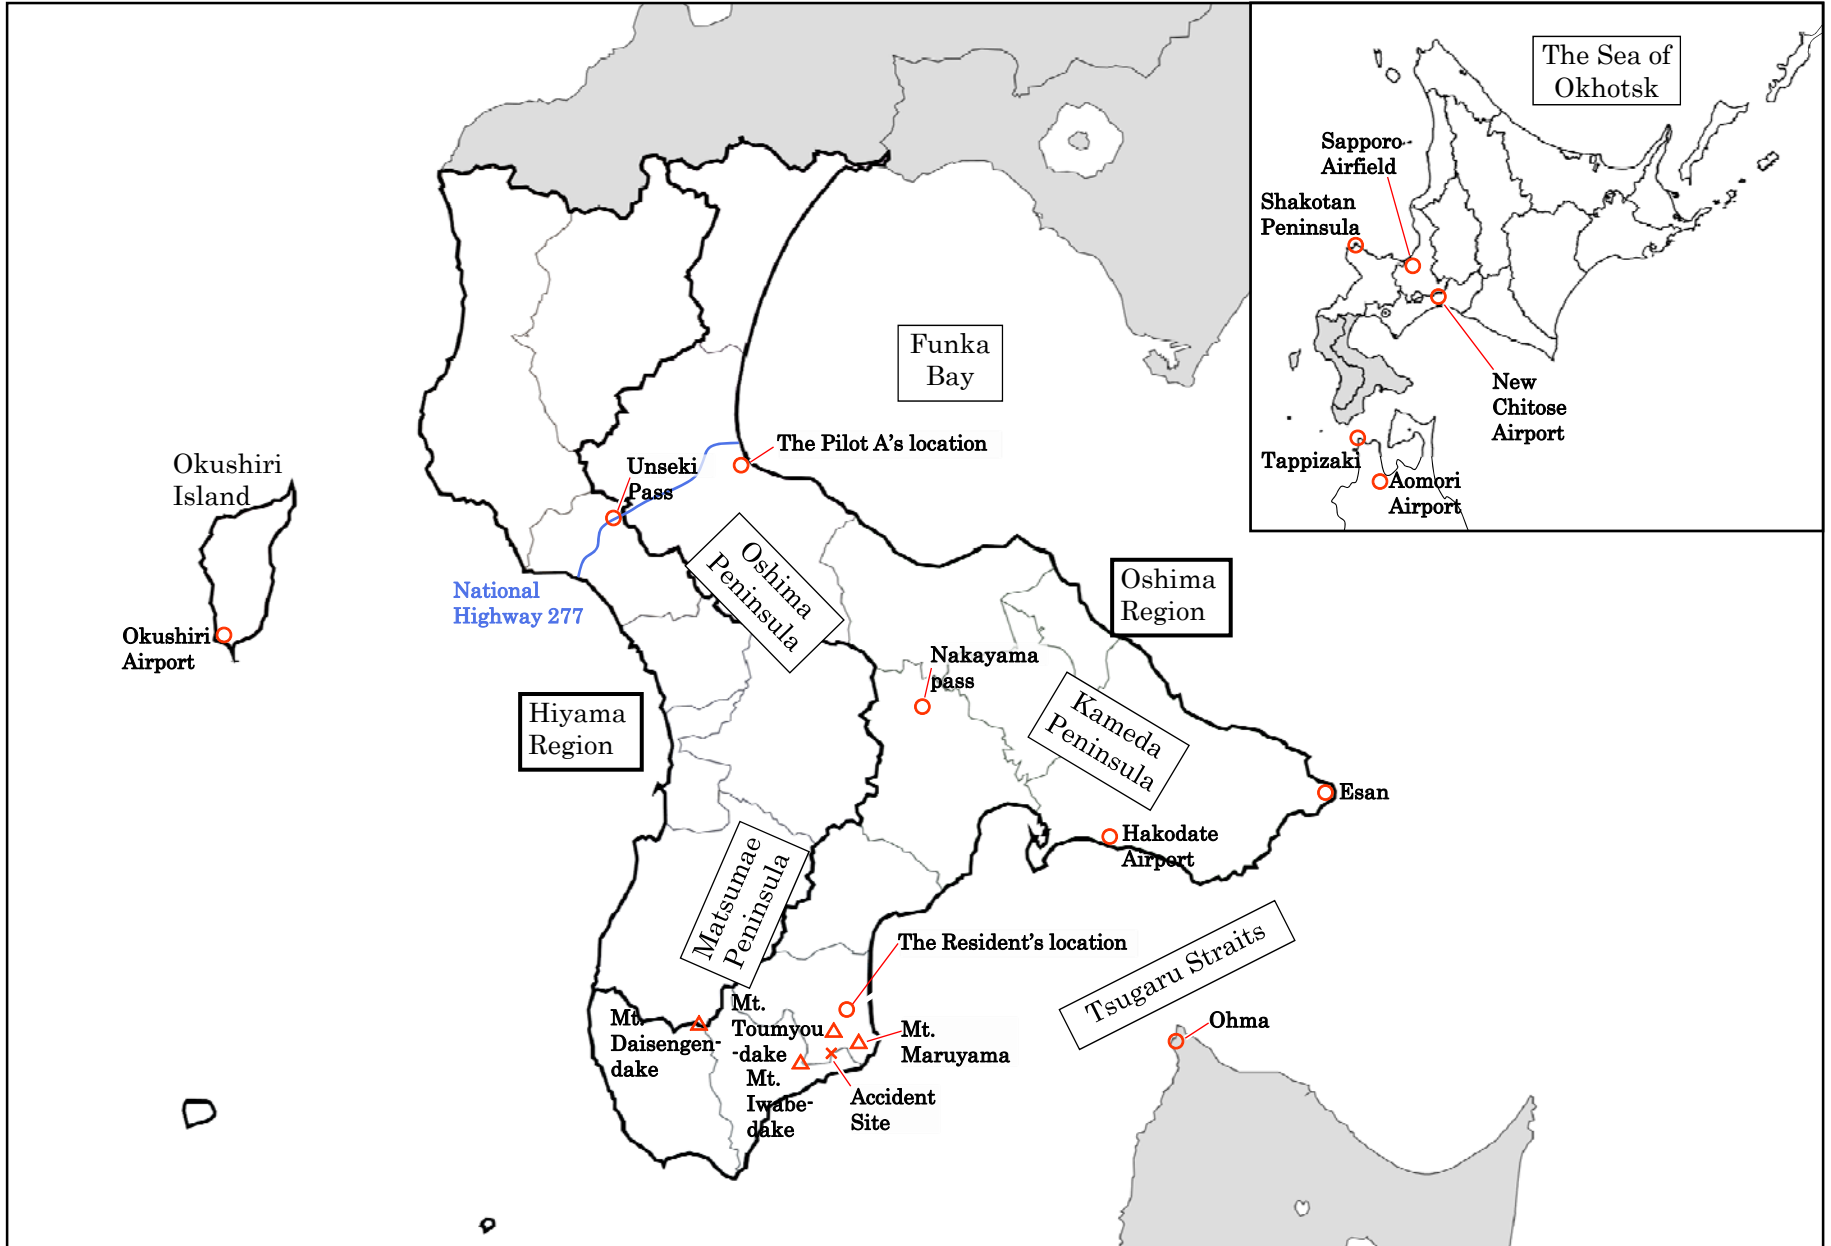
Figure 3 Oshima Peninsula Area Layout

was not bad and the coastline far ahead was visible.  
(See Figure 3 Oshima Peninsula Area Layout)

After arriving at Sapporo Airfield, the Aircraft was planned to do survey flights. But at the time of the accident there were no specific instructions for its flight when to start flying. There was no need for the Aircraft to arrive there hurriedly because there was no guarantee for favorable weather conditions even after the hurried arrival there. But because weather was relatively good at Sapporo Airfield, the PIC supposedly hoped to arrive at Sapporo somehow flying through a bad weather area over the Oshima Peninsula. (See Figure 3 Oshima Peninsula Area Layout)
