AIRCRAFT ACCIDENT INVESTIGATION REPORT

AIRCRAFT DAMAGE CAUSED BY FORCED LANDING

TEXTRON AVIATION 172S, JA395A

AT ABOUT 10:02 JST, APRIL 18, 2023

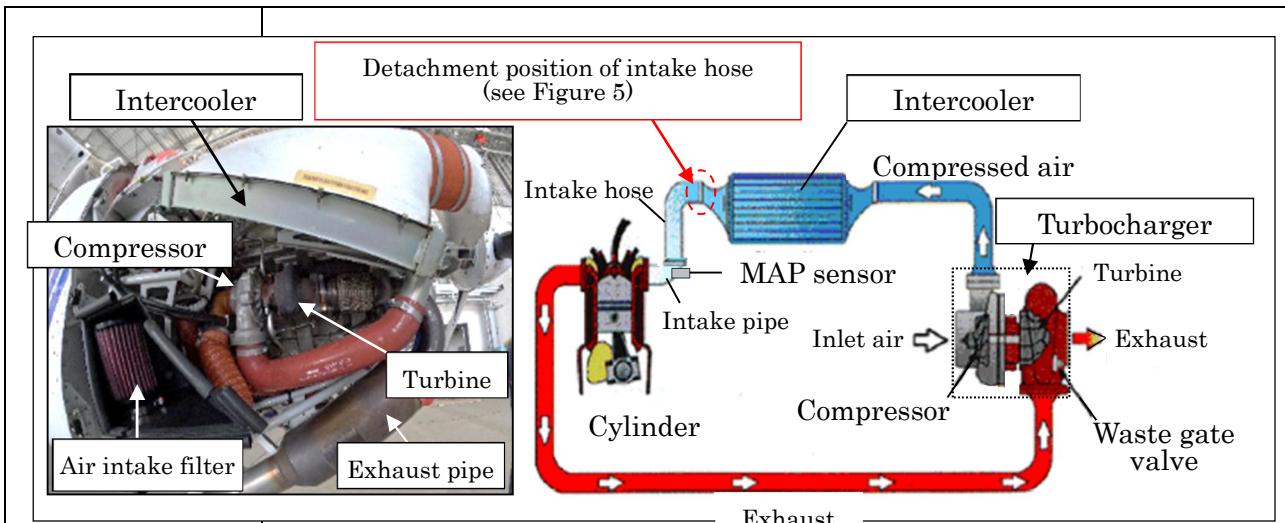
Figure 8: Turbo Diesel Engine System

In accordance with the Supplemental Type Certificate (hereinafter referred to as "STC") held by the aircraft engine's design and manufacturing company, the aircraft is equipped with a liquid-cooled in-line four-cylinder, diesel injection engine with common-rail technology and a turbocharger (Technify Motors TAE 125-02-114). The engine can be operated with JET A-1, and both the engine and the propeller pitch are controlled by the FADEC. With the exhaust gases, the turbocharger of the engine rotates a turbine and coaxial compressor, which compresses air to a maximum of 2,375 mbar. The air is then cooled in an intercooler before being delivered to the cylinders for the intake stroke. According to the engine's design and manufacturing company, the FADEC calculates the required amount of fuel based on the power lever position and engine RPM. It also controls the opening degrees of the Waste Gate Valve (WG valve) on the turbine side based on the information from the Manifold Air Pressure (hereinafter referred to as "MAP") sensor to adjust the compressed air pressure and prevent the turbocharger from over-speeding.

The JTSB concluded that the engine intake hose on the intercooler outlet side had most likely been disconnected, accompanied by a banging sound, at 09:53. At this time, the MAP value dropped from a maximum of 2,375 mbar to about 900 mbar, which is almost the same as the air pressure of 889 mbar. This most likely resulted in natural aspiration conditions, causing a significant decrease in the volume of air supplied to the engine.

During cruising flight with an engine output display value of 63%, the fuel flow was about 5.0 gph in normal operating conditions before disconnecting the intake hose. After disconnecting the intake hose, the fuel flow was 5.2 gph, which did not seem to be a significant difference. However, when the volume of intake air decreased significantly, about 5.2 gph of fuel was supplied, which most likely caused incomplete combustion due to the excessive fuel. In addition, as described in the Report, it is highly probable that WG valve was closed, resulting in increased exhaust pressure, decreased engine compression pressure, and reduced engine output, probably leading to "this condition in which the actual output would be around 35%" as stated by the engine's design and manufacturing company.

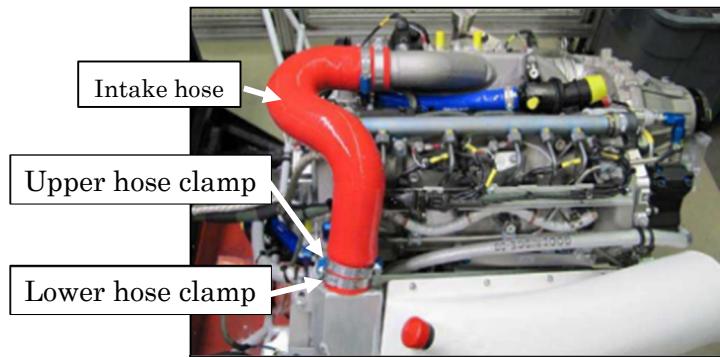
Figure 9: Normal Intake Hose Installation
(Extract from engine maintenance procedures)

The outside diameter on the aircraft's intercooler pipe was about 50.7 mm, and the intake hose was about 5 mm thick.

While it was still detached, the inside diameter of the lower hose clamp could be measured. However, it was not possible to measure the upper hose clamp, as it was difficult to detach the clamp, which remained installed even after the accident.

b. The detached lower hose clamp had corroded, but no cracks or damage were confirmed when its interior was scanned using a CT scanner. Another normal hose clamp with the same part number was installed in the position of the aircraft's lower hose clamp. The inside diameter was measured when tightened to the correct value and compared with that of the detached lower hose clamp. The results are shown in Table 1.
