**AIRCRAFT ACCIDENT  
INVESTIGATION REPORT**

**JAPAN COAST GUARD  
J A 3 9 5 A**

## DAMAGE TO AIRFRAME DURING LANDING JAPAN COAST GUARD TEXTRON AVIATION 172S, JA395A AT CHITOSE AIRFIELD, JAPAN AROUND 13:22 JST, AUGUST 21, 2018

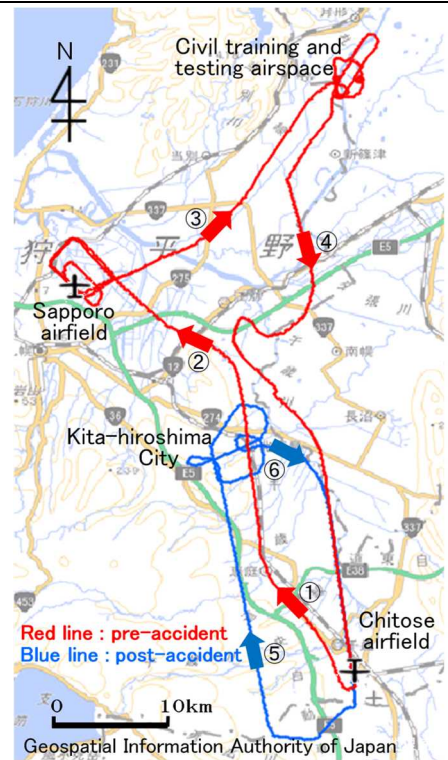
Then, the examinee requested air traffic control for radar vector and landed at Chitose airfield at around 13:58 by PAR RWY 18L approach again after holding over Kita-hiroshima City as instructed by air traffic control (see Figure 1).
