**AIRCRAFT ACCIDENT
INVESTIGATION REPORT**

**PRIVATELY OWNED
J A 4 0 1 7**

December 17, 2015

COLLISION WITH REVETMENT WALL DURING GO-AROUND A PRIVATELY OWNED MOONEY M20K, JA4017 KITAKYUSHU AIRPORT, JAPAN AROUND 17:22 JST, NOVEMBER 16, 2014

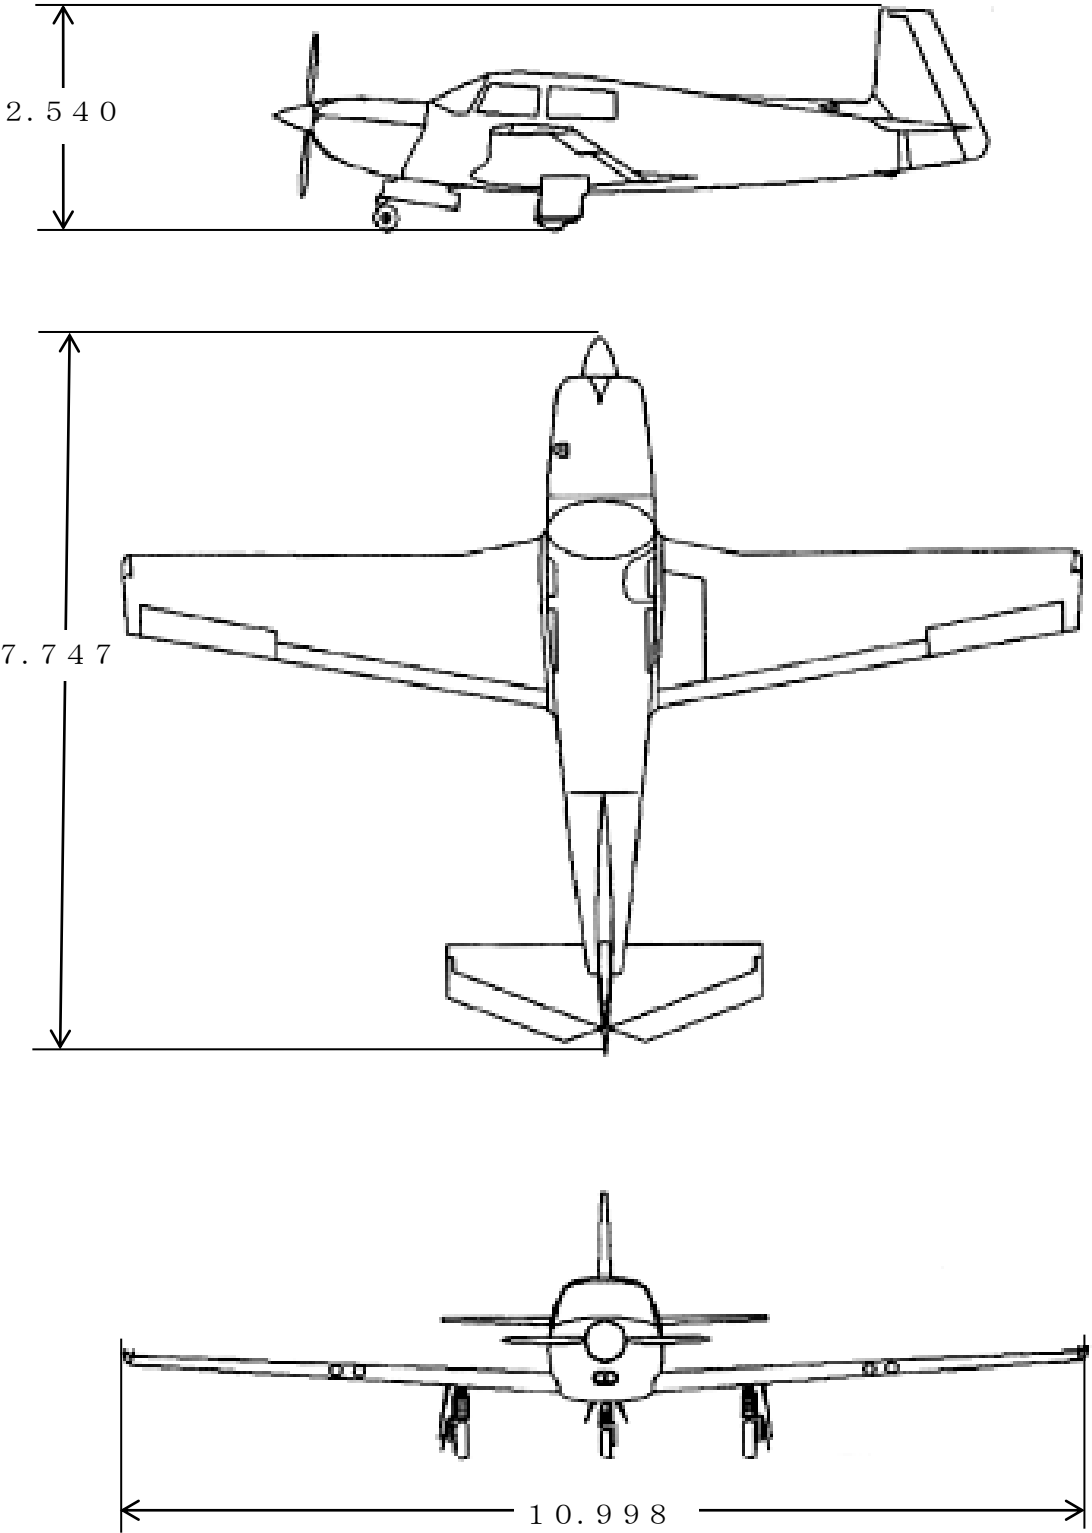
Photo 1: The Accident Aircraft

Entire fuselage:	Distorted and cracked
Front of fuselage:	Broken
Left main wing:	Broken off
Engine:	Mount broken
Propeller:	Detached
Right main landing gear:	Down lock mechanism damaged
Nose landing gear:	Down lock mechanism damaged
