# AIRCRAFT SERIOUS INCIDENT INVESTIGATION REPORT

April 4, 2025

Adopted by the Japan Transport Safety Board

Company	Privately owned
Type, Registration Mark	Cessna 172P, JA4059
Incident Class	The case where any component of the aircraft other than the landing gear had contact with ground surface during landing Item (iii), Article 166-4 of the Regulation for Enforcement of the Civil Aeronautics Act of Japan
Date and Time of the Occurrence	At about 13:54 Japan Standard Time (JST: UTC+9 hours), September 17, 2023
Site of the Incident	Bibai City Farm Road Airfield, Hokkaido Prefecture (43° 23' 33" N, 141° 51' 35" E)

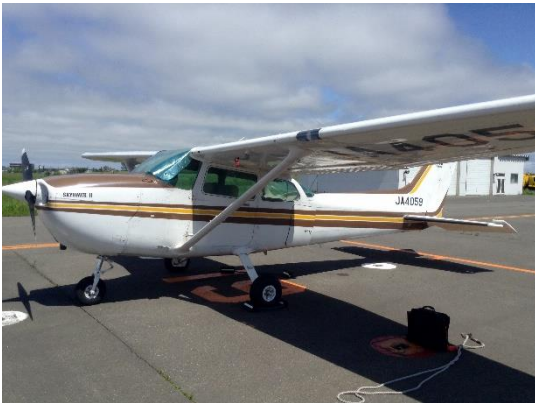
Summary of the Serious Incident	<p>On Sunday, September 17, 2023, the aft lower fuselage of the aircraft contacted with the airstrip (hereinafter referred to as “the runway”) when landing at Bibai City Farm Road Airfield (hereinafter referred to as “Bibai Airfield”), Hokkaido Prefecture.</p> <p>The aircraft was damaged, but the pilot in command (PIC) and other three passengers on board did not sustain any injuries.</p>
Outline of the Serious Incident Investigation	<p>On November 24, 2023, the Japan Transport Safety Board (JTSB) designated an investigator-in-charge and two other investigators to investigate this serious incident.</p> <p>Comments on the draft Final Report were invited from the parties relevant to the cause of the serious incident and the Relevant State.</p>
