AIRCRAFT SERIOUS INCIDENT INVESTIGATION REPORT

May 16, 2025

Company	Corporate body
Type, Registration Mark	Cessna 172P JA4101
Incident Class	Dragging during landing of any other part of the aircraft other than the landing gears Item (iii), Article 166-4 of the Regulation for Enforcement of the Civil Aeronautics Act
Date and Time of the Occurrence	At about 10:14 Japan Standard Time (JST: UTC+9 hours), July 7, 2024
Site of the Serious Incident	Fukushima City Temporary Operation Site (for agricultural use) (Fukushima Sky Park), Fukushima City, Fukushima Prefecture (37° 49' 24N, 140° 23' 26E)

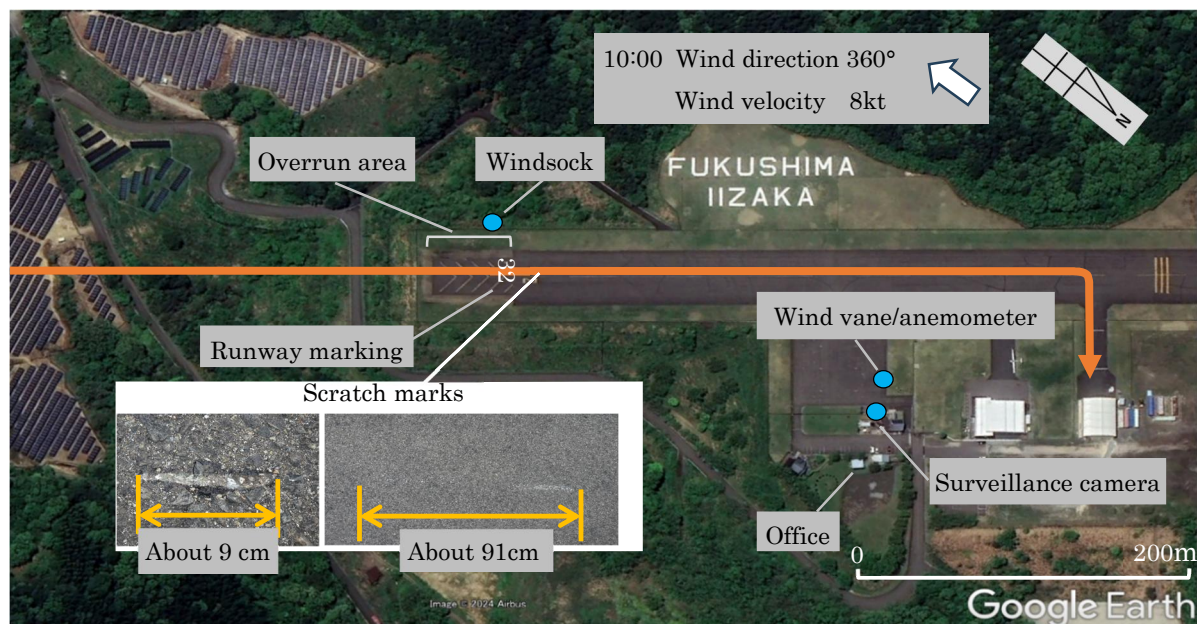
Figure 1: Estimated Flight Route (Orange Line) of the Aircraft and Layout of Fukushima Sky Park

At about 10:14, the aircraft passed the south end of the overrun area*³ short of Runway 32 at a velocity of about 65 kt*⁴ (about 111 km/h) with flaps 30° in a generally stable state. Based on the appearance of the windsock, the student pilot recognized that the wind direction was from the front and that the wind velocity was about 3 to 5 kt (1.5 to 2.6 m/s). The student pilot set the engine power to idle as usual before the aircraft crossed over the runway marking indicating “32” on the runway, and began to flare*⁵. Immediately afterwards, the three people on board the aircraft felt a loud bang and a strong impact, different from a normal landing, as the rear of the aircraft lowered, therefore, the captain took control of the aircraft from the student pilot. After the bounce*⁶, the aircraft, piloted by the captain, landed, taxied to the apron under its own power and came to a stop. After the aircraft stopped, the captain and the student pilot visually inspected the aircraft and confirmed that there

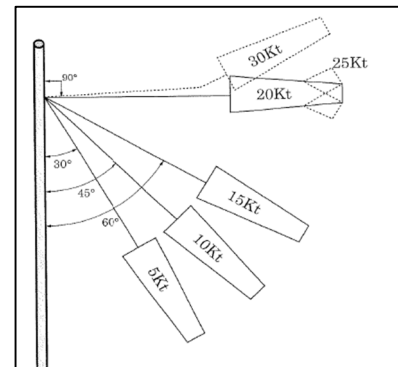
Figure 4: Estimated Wind Velocity based on Windsock
(Source: AIM-J)

- b. Four seconds before touchdown, the aircraft was just short of the south end of the runway, and compared to the wind conditions in a., the change in the wind direction was smaller, but the windsock indicated that the wind velocity had dropped to about 5 kt (2.8 m/s).

It is difficult for a pilot to observe the movement of the windsock and understand the change of wind direction from that movement just before landing. It is effective for the pilots to obtain information from the Operations Assistants and others about the wind conditions in the circumstances of the change in wind direction in order for the pilots to understand the change in wind direction.
