**AIRCRAFT ACCIDENT  
INVESTIGATION REPORT**

## PRIVATELY OWNED BEEHCRAFT A36, JA4159 DAMAGE DURING LANDING ON THE RUNWAY AT MATSUYAMA AIRPORT AT AROUND 18:27, OCTOBER 26, 2013

June 5, 2015

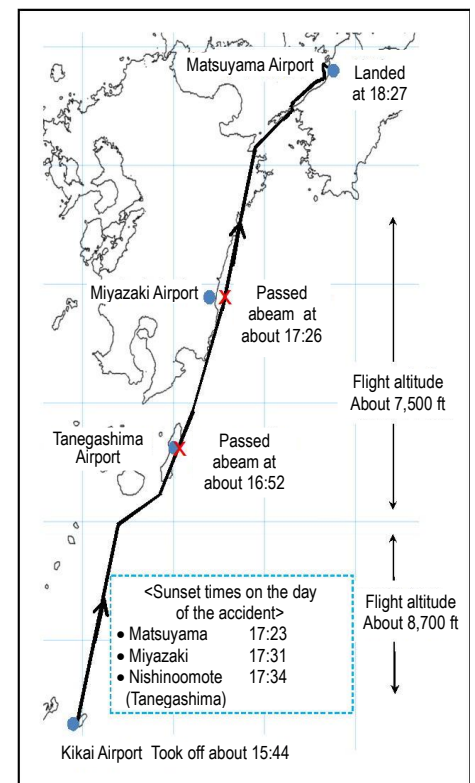
**Estimated Flight Route**

As described in his statement, it is probable that the Captain intended to enter the downwind leg at an altitude of about 1,500 ft. However, as shown in Figure 1, the Aircraft's altitude, which shown about 1,800 ft near South Point, was increasing little by little and climbing to about 2,100 ft at 18:24:33. It is somewhat likely that this gradual increment of the Aircraft's altitude was caused by the Captain's unintentional pulling of the control wheel, not only because he would not afford to check the altimeter using the Waterproof Portable Light, but also because he wanted to confirm the position of the Runway at this time.

As described in 2.1.1, at 18:24:37, the Captain said to the Tower, "Excuse me, but I have not confirmed yet and I will fly a bit further away. Is that OK?" As described in the statement, it is probable that the Captain at this time wanted to extend the downwind leg in order to confirm the position of the Runway exactly. An example of estimated flight route imaged by the Captain at that time is shown by the broken line in Figure 1.

As shown in Figure 1, it is probable that the Aircraft started to descend at around 18:25:27 when an altitude of about 2,350 ft was recorded, however, it descended and reached about 350 ft by 18:26:27. It is probable that the Aircraft dived by about 2,000 ft in about one minute in the base leg. Accordingly it was probable that the Aircraft made a steep descent equivalent to an average descent angle of about 10°.

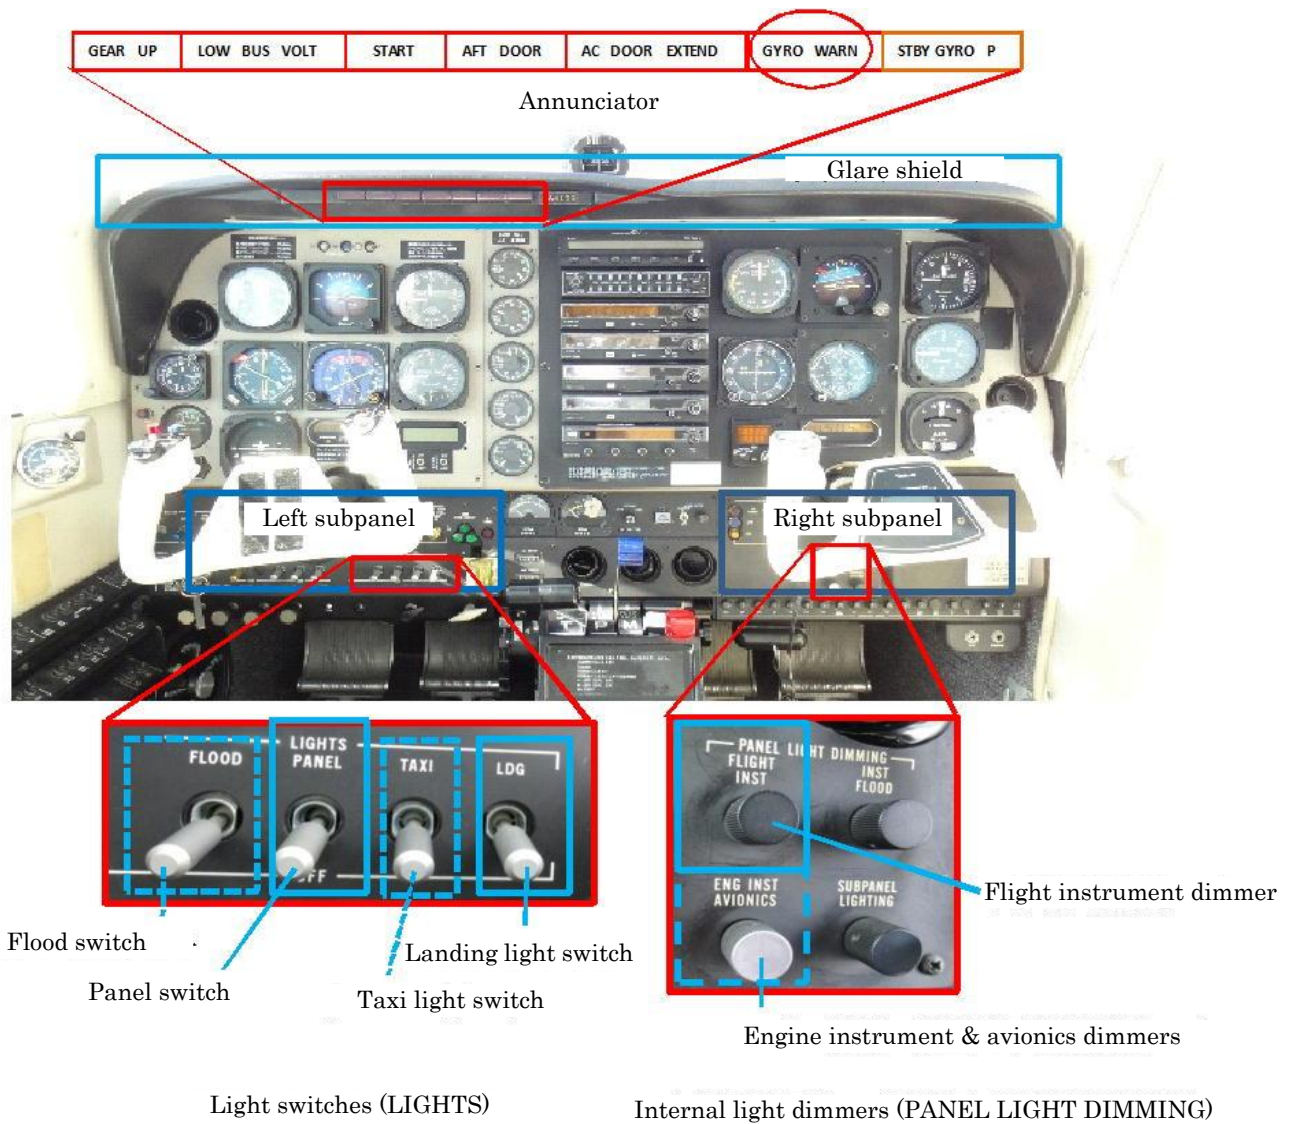
### Layout of Switches in the Aircraft's Cockpit

Pilots can adjust the brightness of internal lights (instrument lights) of the flight instruments, the engine instrument and avionics by using the flight instrument dimmer (FLIGHT INST) at the upper left of internal lights dimmers (PANEL LIGHT DIMMING) and the engine instrument and avionics dimmer (ENG INST / AVIONICS) at the bottom left respectively, following turning on the panel switch described above. Even if Pilots turn on the panel switch, the instrument lights won’t illuminate when these dimmers are turned down to the off position.

Pilots also can adjust the brightness of the lighting from the glare shield by using the instrument flood dimmer (INST FLOOD) at the upper right of internal light dimmers (PANEL LIGHT DIMMING), following turning on the flood switch (FLOOD) described above. In the same manner mentioned above, the floodlight won’t illuminate when this dimmer (INST FLOOD) is turned down to the off position. Additionally, pilots could adjust the brightness of internal lights in the right-and-left subpanel by using the dimmer at the lower right (SUBPANEL LIGHTING).

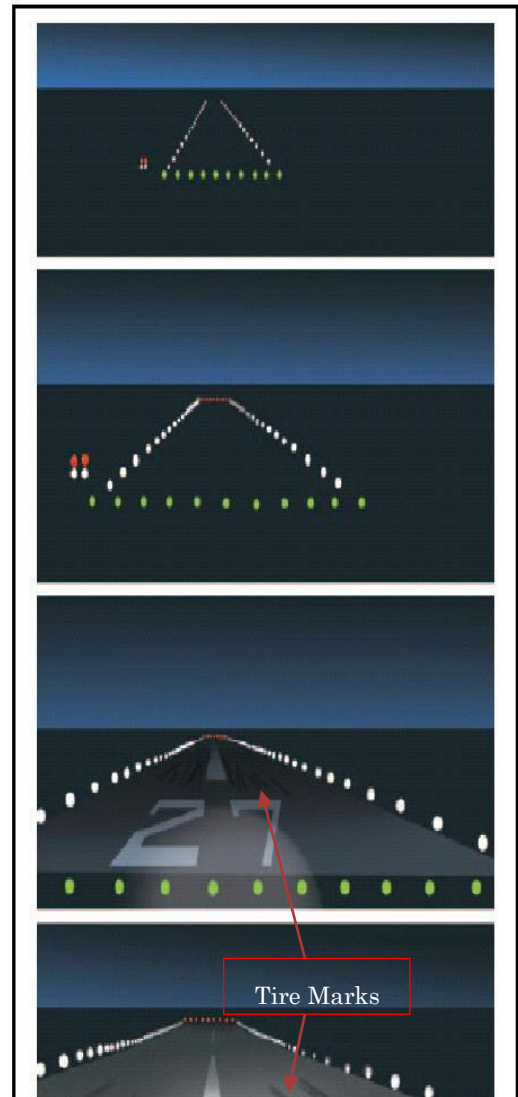
### **Reference Example of Flare with Tire Marks Visible**

*To aid in determining the proper flare point, continue a constant approach descent until landing lights reflect on the runway and tire marks on the runway surface or joint lines of the pavement can be seen. Upon reaching this point, the flare should be started smoothly, and then the throttle should be gradually reduced to the idle as the aircraft is touching down. (please refer to an example image on the right)*
