**AIRCRAFT SERIOUS INCIDENT
INVESTIGATION REPORT**

**PRIVATELY OWNED
J A 4 1 7 8
JAPAN AIR COMMUTER CO., LTD.
J A 8 4 7 C**

April 26, 2013

BOMBARDIER DHC-8-402, JA847C

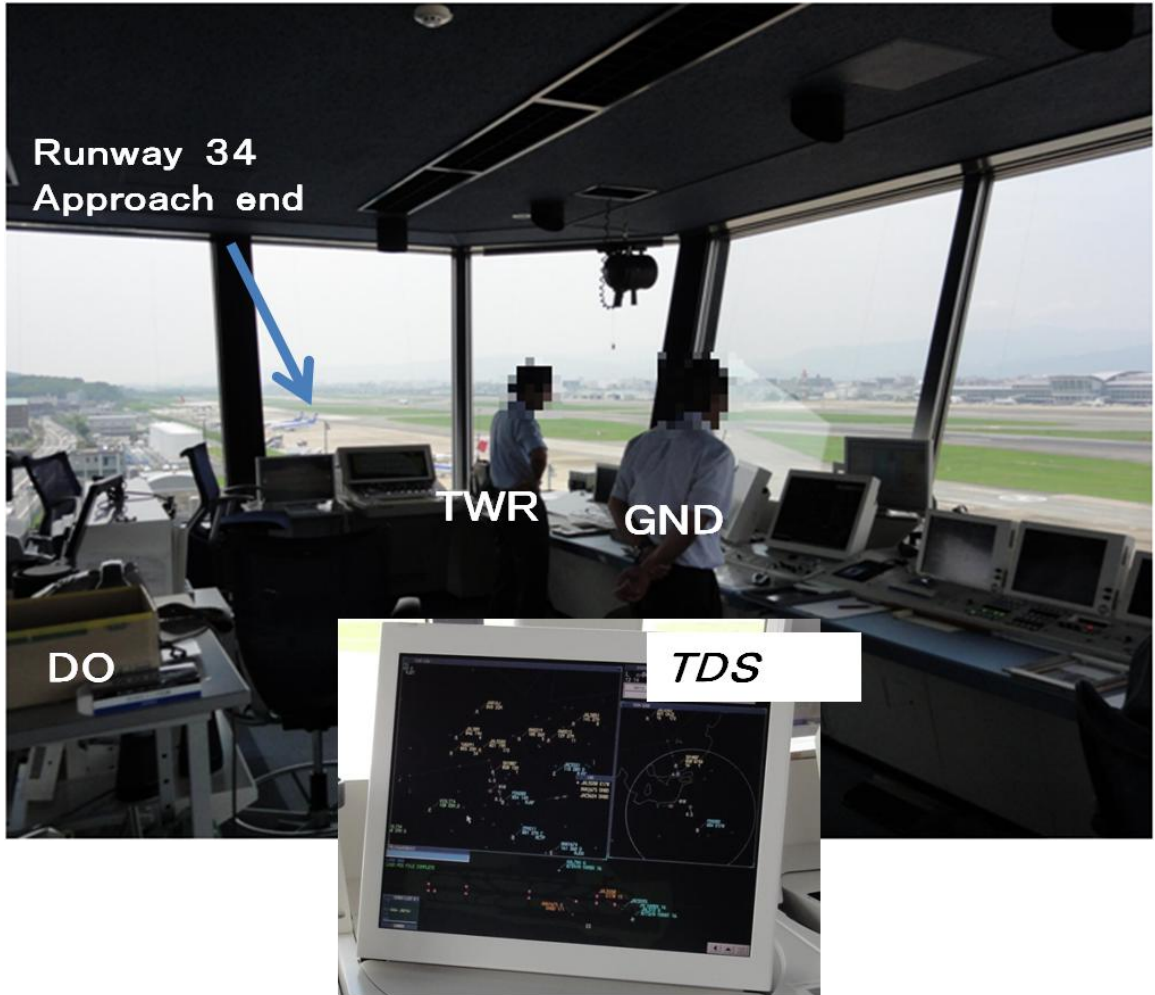
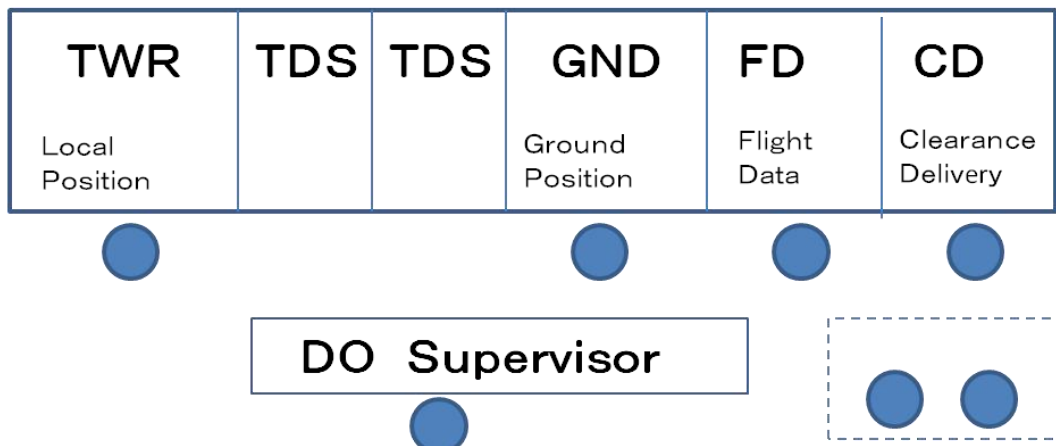
Figure 3 Layout of the Control Tower and View of the Runway

(See Figure 3 “Layout of the Control Tower and View of the Runway.”)
