**AIRCRAFT SERIOUS INCIDENT  
INVESTIGATION REPORT**

**ANA WINGS CO., LTD.**

**February 22, 2018**

OVERRUNNING  
ANA WINGS CO., LTD.  
BOMBARDIER DHC-8-402, JA461A  
NEAR THE END OF THE RUNWAY 01R  
AT NEW CHITOSE AIRPORT, HOKKAIDO, JAPAN  
AT ABOUT 11:58 JST, JANUARY 19, 2017

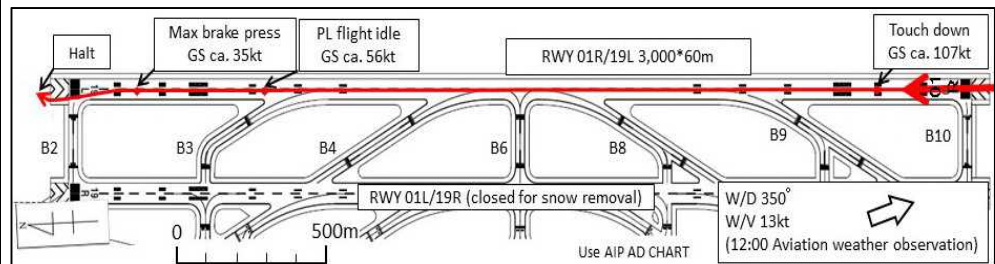
**Figure 1 - Estimated flight route**

The PIC remembered that he started to step on the brake from near Taxiway B4 considering the remaining distance, but the braking pressure actually started to rise as passing through Taxiway B3. The PIC did not feel the effect of braking, so he stepped on with maximum braking pressure, still he did not feel the deceleration, therefore he thought that the braking action was not good. However, because the warning light was not turned on, he did not think that equipment caused malfunctions. The braking pressure started to rise from 11:57:29 and became the maximum (3,000 psi) at about 35 kt for GS at about 200 m before the end of the runway. Because the co-pilot felt the braking of the aircraft, he judged that the PL was at Disc position and braking was operated and did not assist the brake. He thought that the weak deceleration was caused because the anti-skid system for braking did not work.

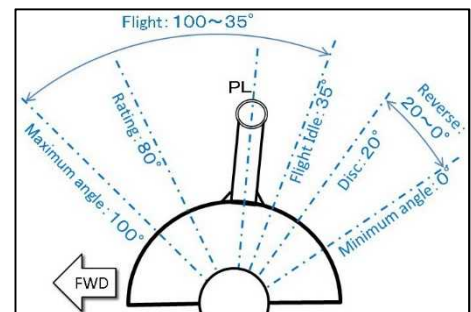
Figure 2 - PLA

The propellers increase air resistance and obtain the braking force by overriding Flight Idle position with pulling triggers attached on PL and moving to Disc position having soft detent. In case that more braking force are required, it could decelerate by moving PL to Reverse position in order to generate backward thrust. When PL is between Flight Idle and Disc position and the blade angle is at 16° or less, the Propeller Ground Range Advisory light would be turned on.

Regarding why the aircraft overrun, it is highly probable that because the aircraft could not obtain the braking force due to the delay of braking operation start by the PIC and PL was not set at the Disc position during the time from braking operation start to the aircraft stop. Moreover, it is probable that the bad conditions with snow fall around the end of the runway and the overrunning zone contributed to the aircraft overrunning.
