**AIRCRAFT ACCIDENT  
INVESTIGATION REPORT**

UNCONTROLLED CRASH INTO THE GROUND

EUROCOPTER AS350 B3, JA508A

APPROXIMATELY 12:17 JST, OCTOBER 3, 2011

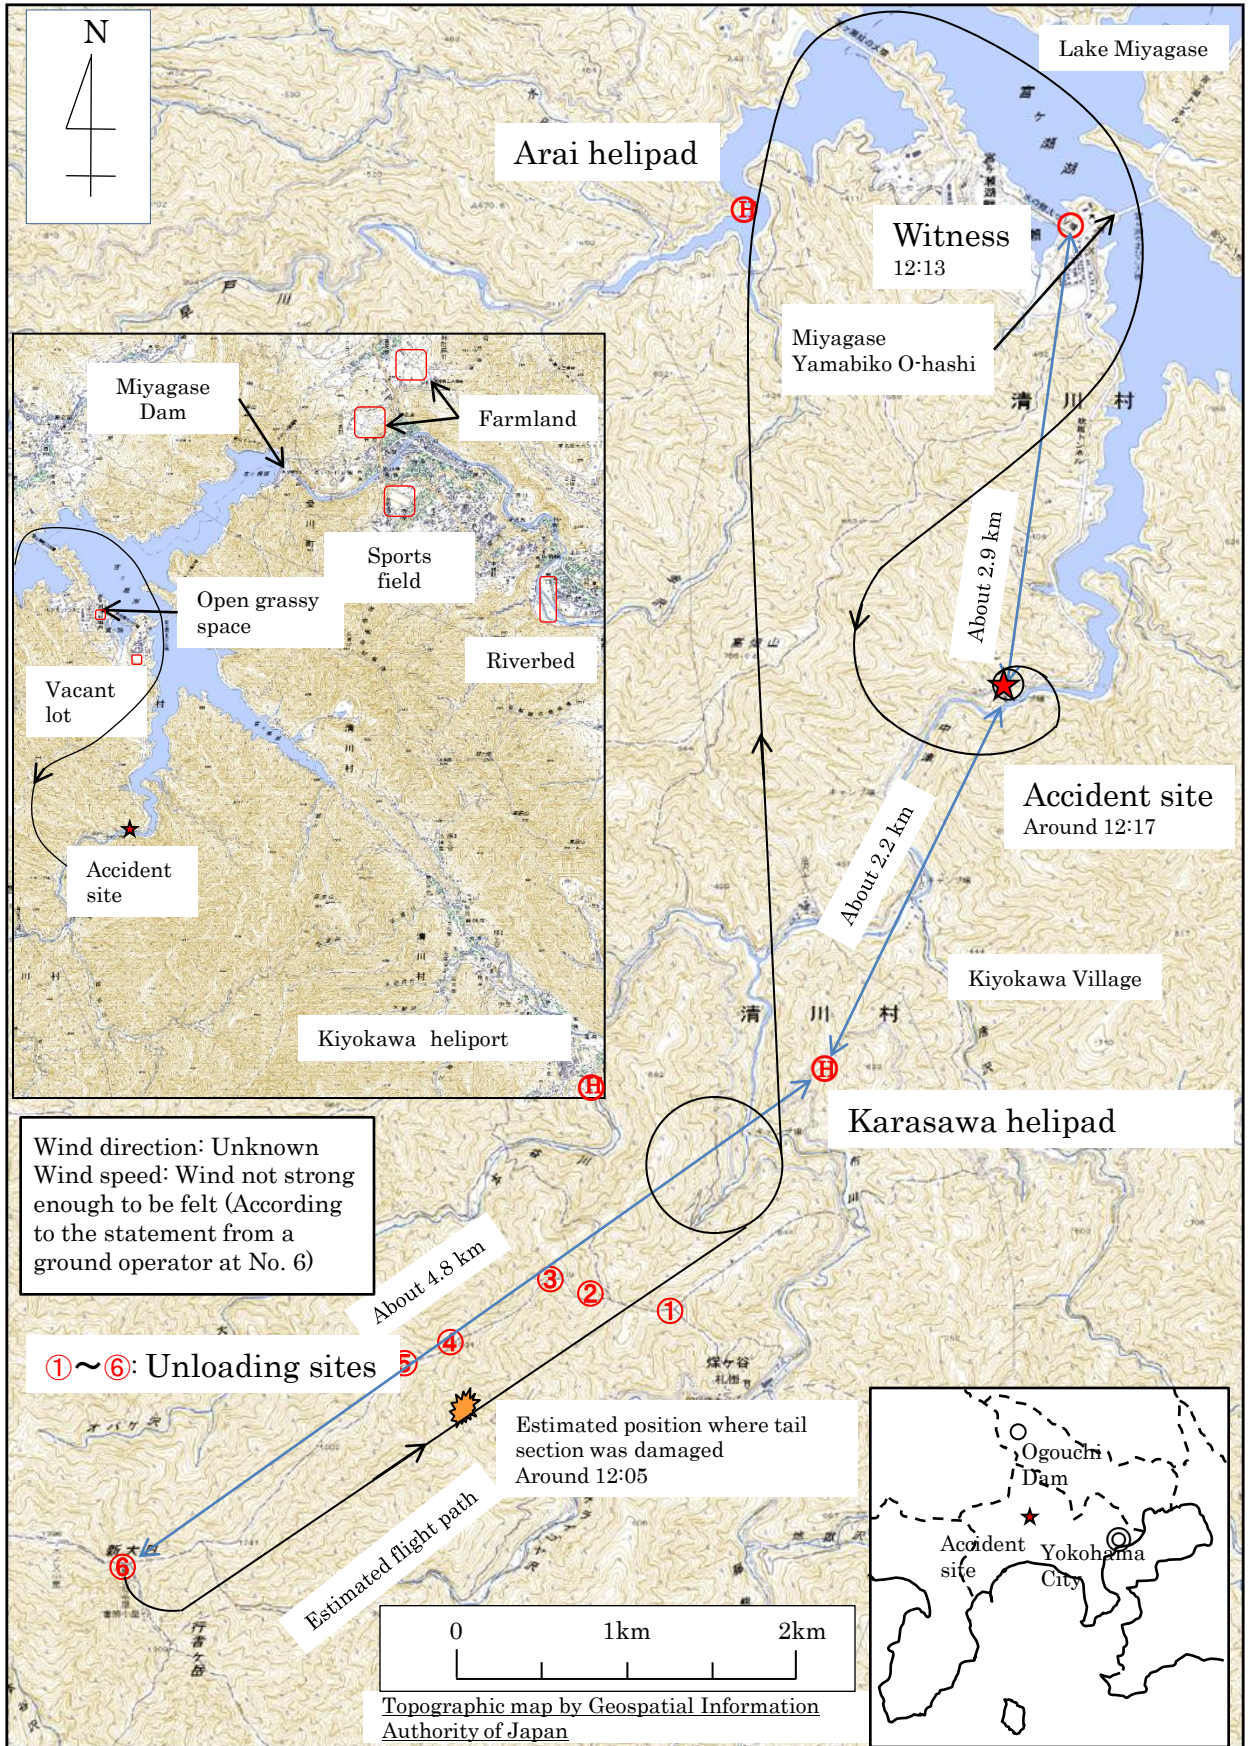
Figure 1 Estimated Flight Path

Before transporting cargoes, the Pilot had a meeting with those involved in the construction to map the locations of unloading sites No. 1 to No. 6 (hereinafter referred to in the text and in Figure 1 simply as "No.1" to "No. 6"), which are situated along the mountain ridge, to confirm the number of times transport was required, and to discuss other details. At around 09:20, the Pilot, who occupied the front right seat, took off on a flight for about ten minutes to observe and check these sites along with the onboard mechanic, who was in the back left seat, and the person who ordered the construction work (hereinafter referred to as "the Customer"), who was in the front left seat. During the flight, they were not able to approach close to No.6 due to the presence of gas<sup>\*1</sup>.

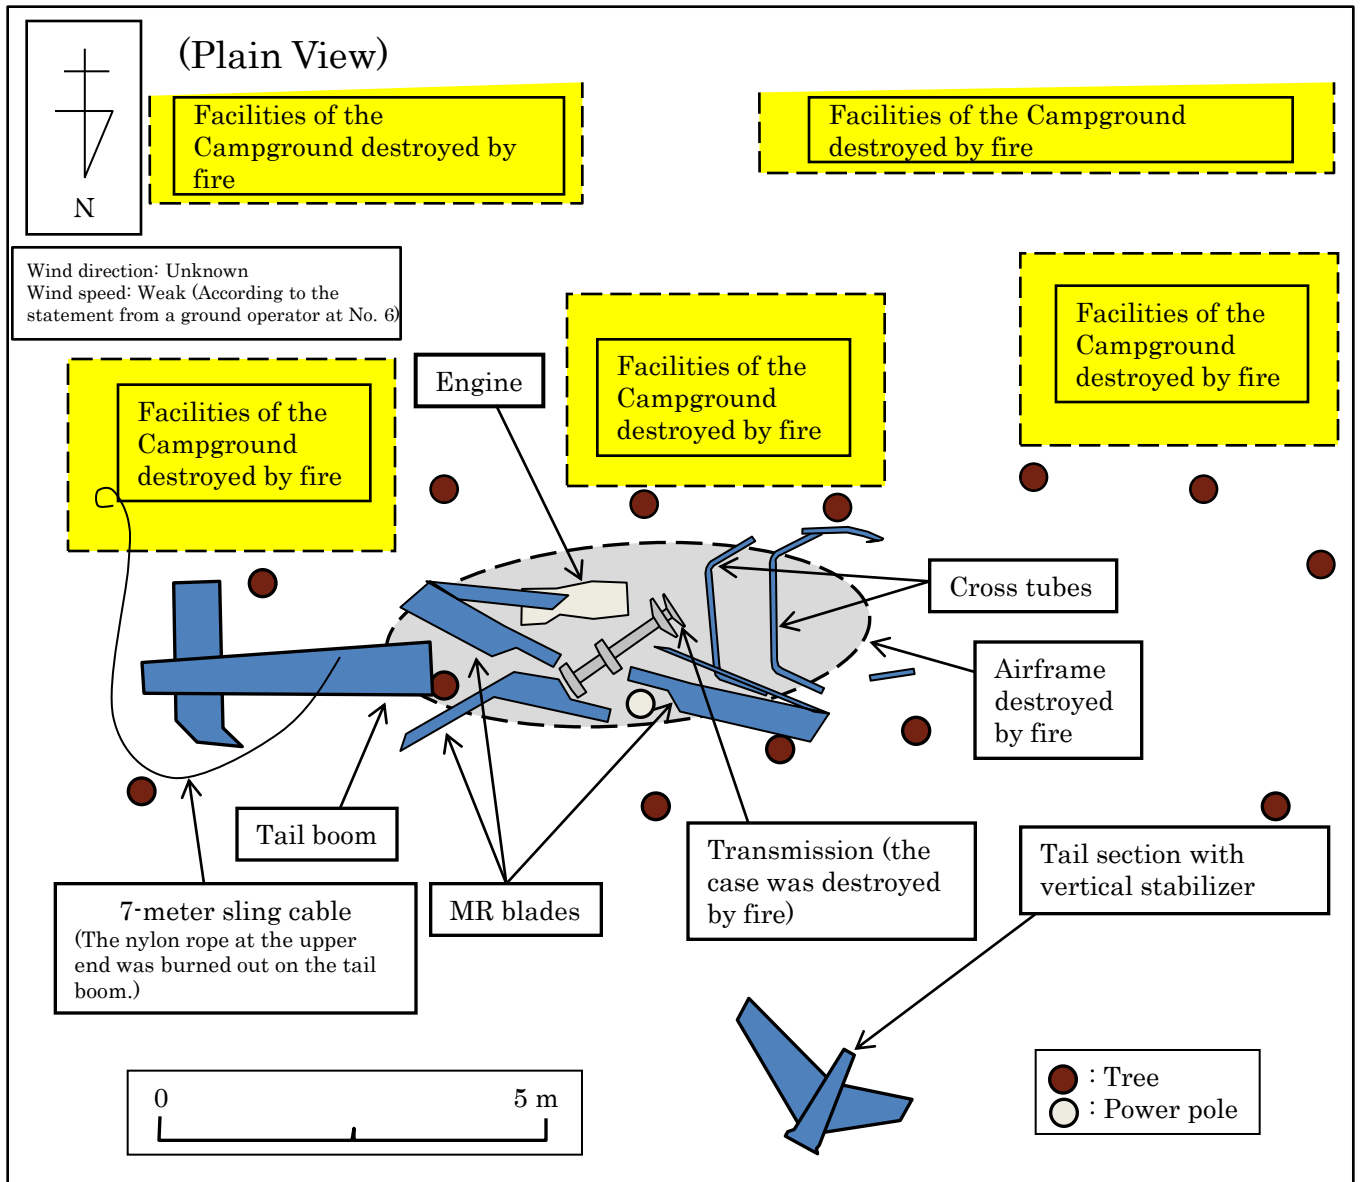
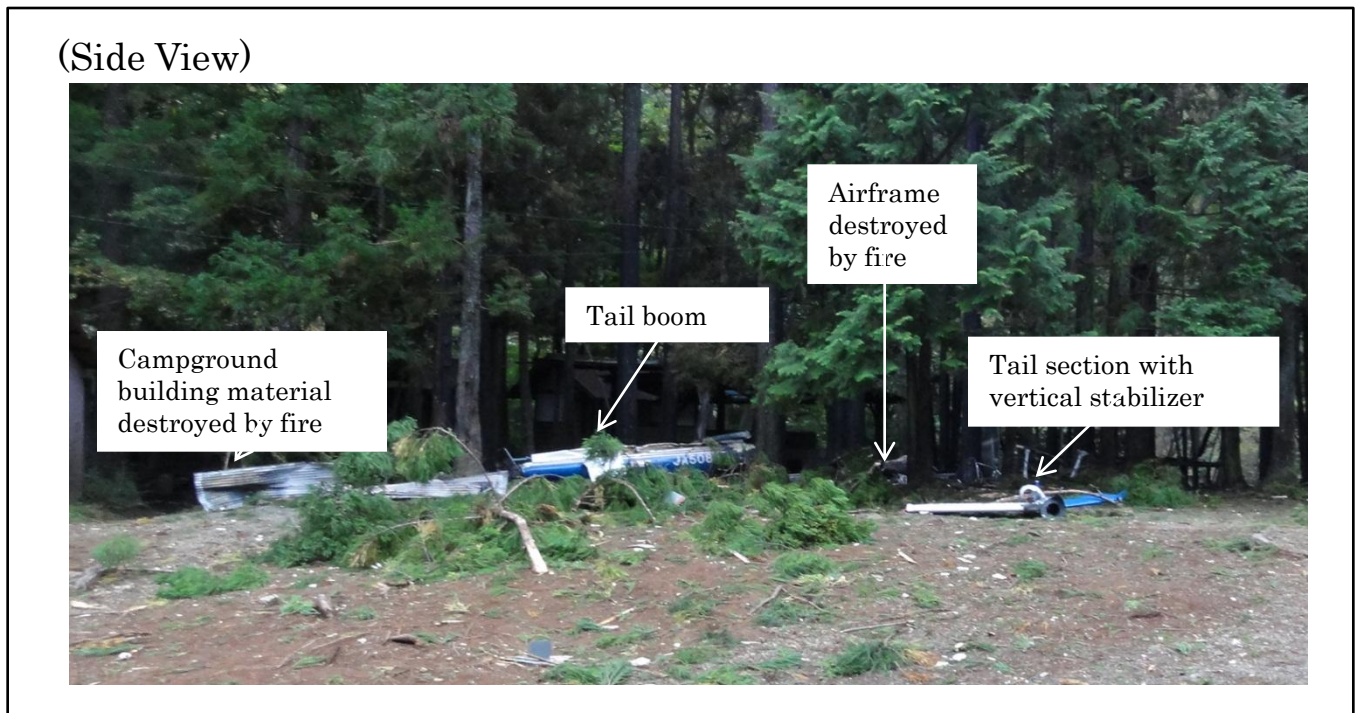
Figure 2 Accident Site

(See Figure 1 "Estimated Flight Path" and Figure 2 "Accident Site.")

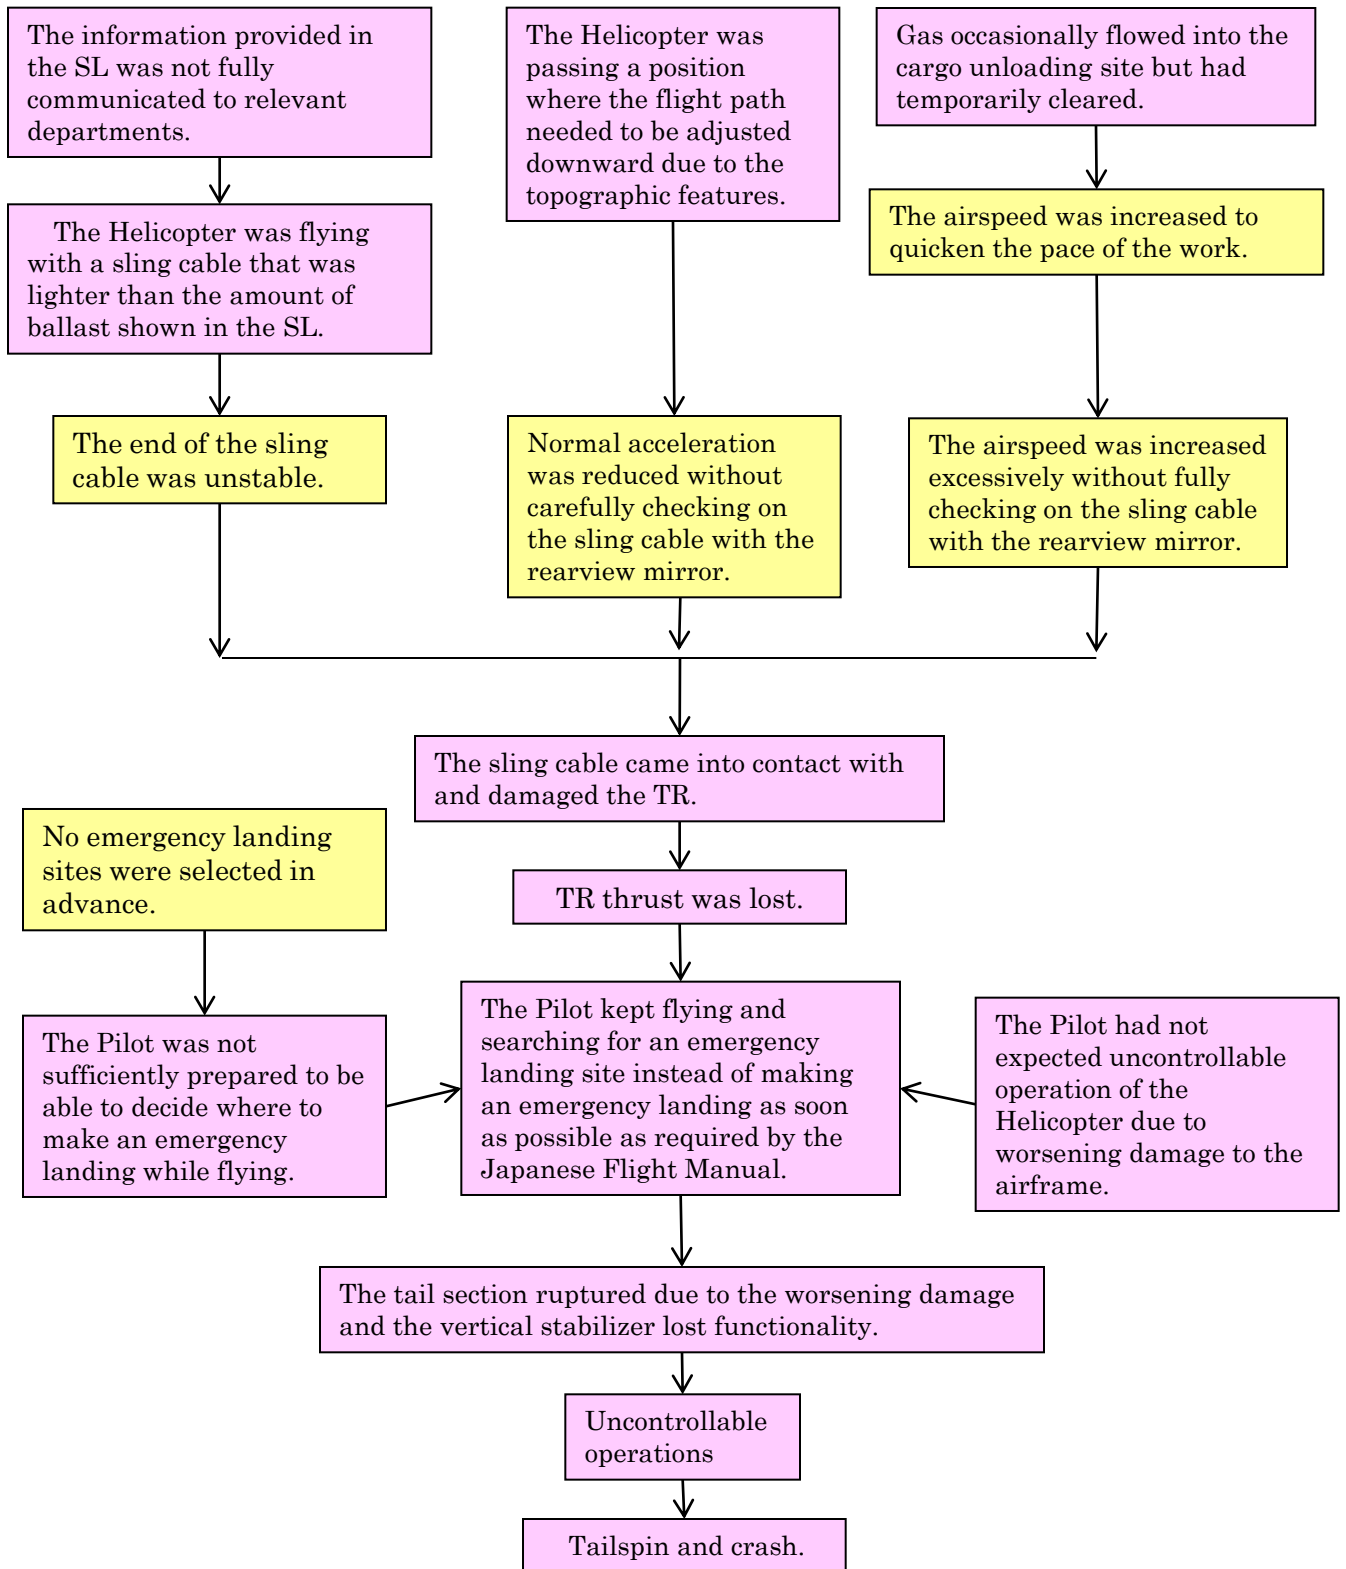
# Figure 5 Chain Reaction of Contributing Factors to the Accident

It is probable that the accident occurred as follows: The Helicopter sling cable contacted the TR, damaging the tail section and resulting in a loss of TR thrust. The Pilot, however, did not make an emergency landing as soon as possible as stipulated in the Japanese Flight Manual, but instead continued to search for a suitable emergency landing site, during which time the damage to the tail section, including the vertical stabilizer, was exacerbated leading to its rupture, and the Helicopter became uncontrollable and crashed into the ground.

It is probable that the Pilot failed to make an emergency landing as soon as possible as stipulated in the Japanese Flight Manual because he had not selected appropriate emergency landing sites before flight and was not prepared for emergency, including which landing site to choose in a given situation; and because the Pilot continued flying without anticipating the possibility that the damage to the Helicopter could worsen making the Helicopter uncontrollable.

- b. Amendment to the Procedures for Training and Assessment
  - (1) Special training on emergency procedures for TR failures and procedures for selecting emergency landing sites was provided to all pilots. Training on TR failures, which was formerly one of the elective subjects in a periodic training program, is now a mandatory subject.
