**AIRCRAFT ACCIDENT
INVESTIGATION REPORT**

SHIN NIHON HELICOPTER CO., LTD.

J A 6 0 5 5

SHIN NIHON HELICOPTER CO., LTD.
BELL 206L-3 (ROTORCRAFT), JA6055
MINAKAMI-MACHI, TONE-GUN, GUNMA PREFECTURE,
AROUND 9:53 JST, FEBRUARY 10, 2009

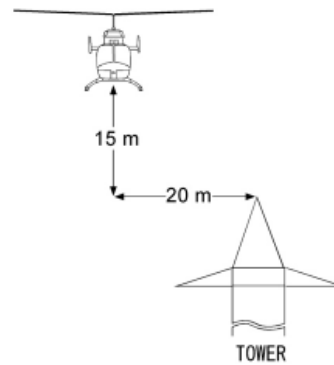
(7) *Position of a helicopter to transmission lines*

(Relative position of the Aircraft for Grid A inspection is shown here)

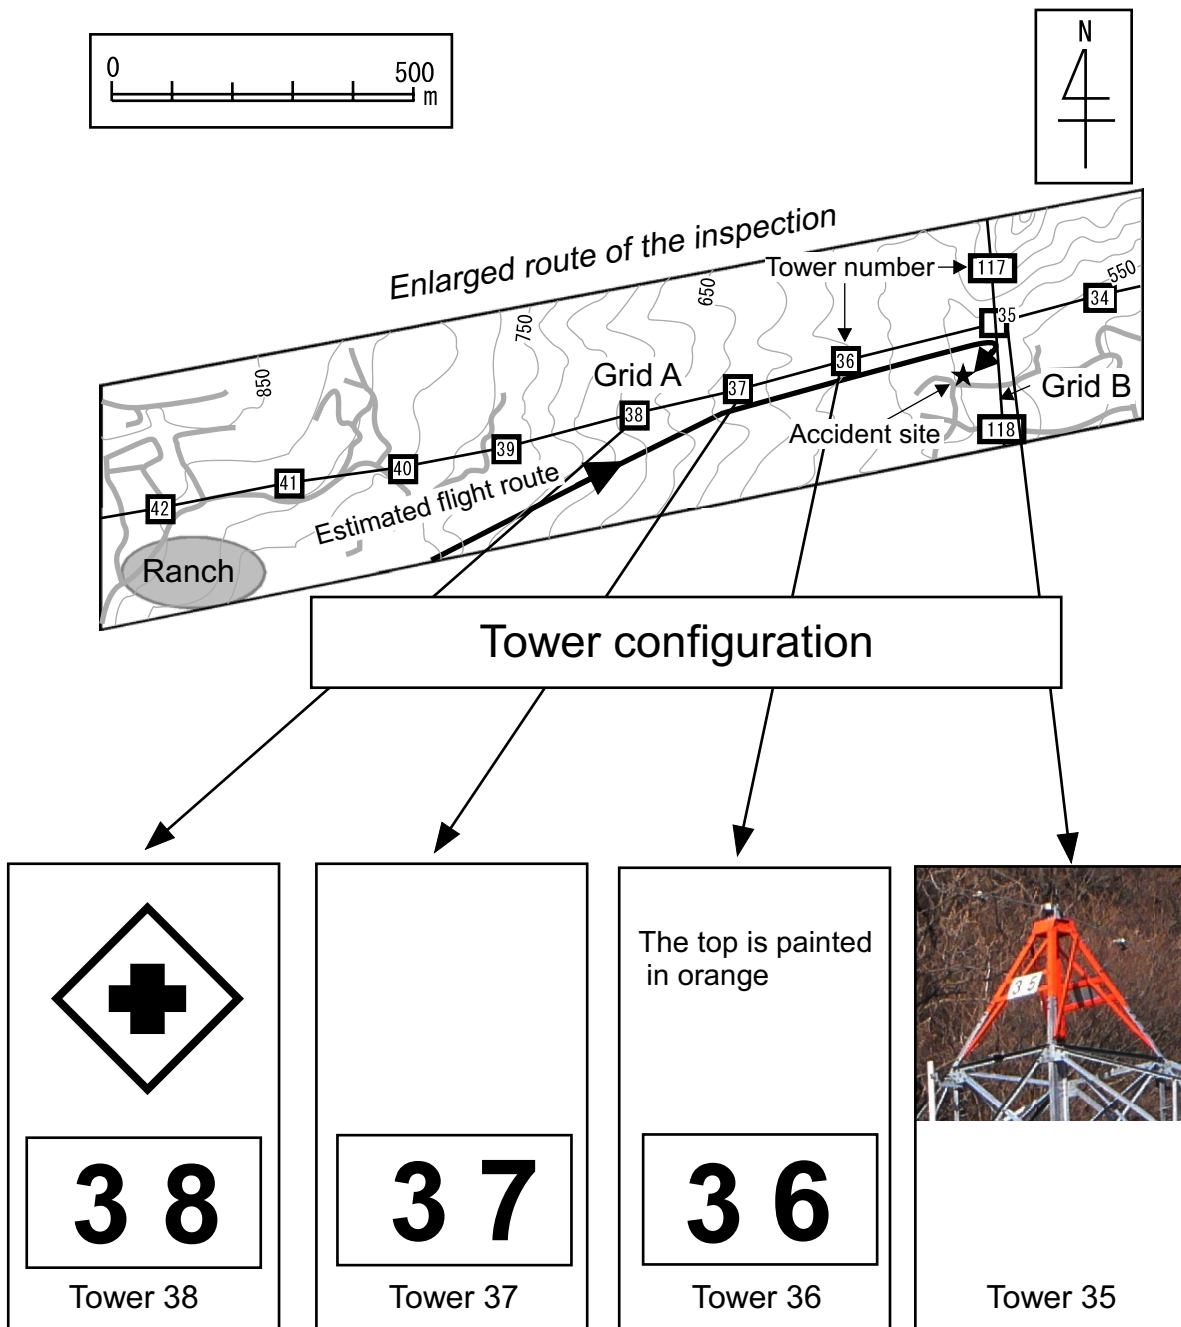
Figure 3 Inspection Route and Tower Configuration

As shown on Figure 3, the slope east of tower 42 descends to the east and the Overhead Intersection is located in lower part of the slope. As shown on Figure 1, from tower 36 one can see the west slope of Mitsumine mountain range. The upper part of the west slope is higher than tower 36 by 200 – 400 m.
