AIRCRAFT ACCIDENT INVESTIGATION REPORT

CRASH

AKAGI HELICOPTER CO., LTD.

KAMAN K-1200 (ROTORCRAFT), JA6200

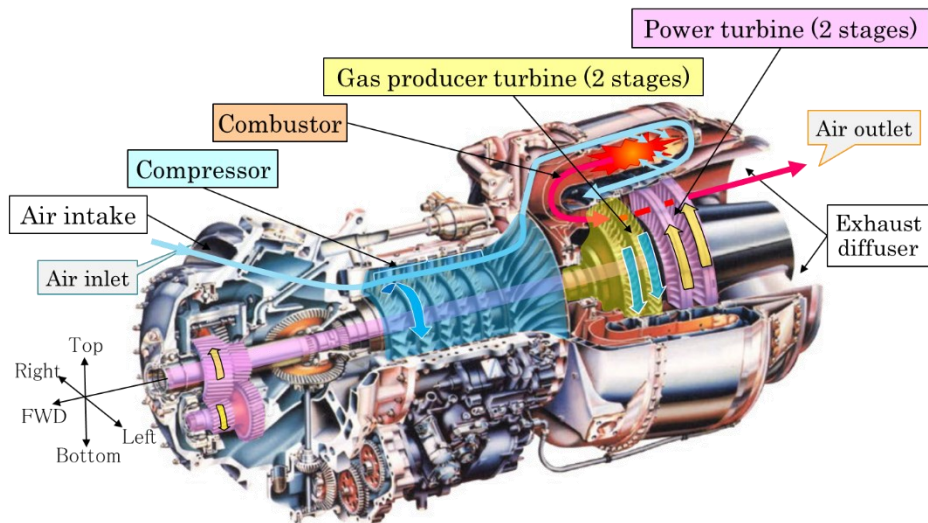
Figure 4: Names of Engine Parts

The engine of the helicopter is a turboshaft engine, which is composed of air intake, compressor, combustor, gas producer turbine (two stages), power turbine (two stages) and exhaust diffuser, from the fore (see Figure 4).

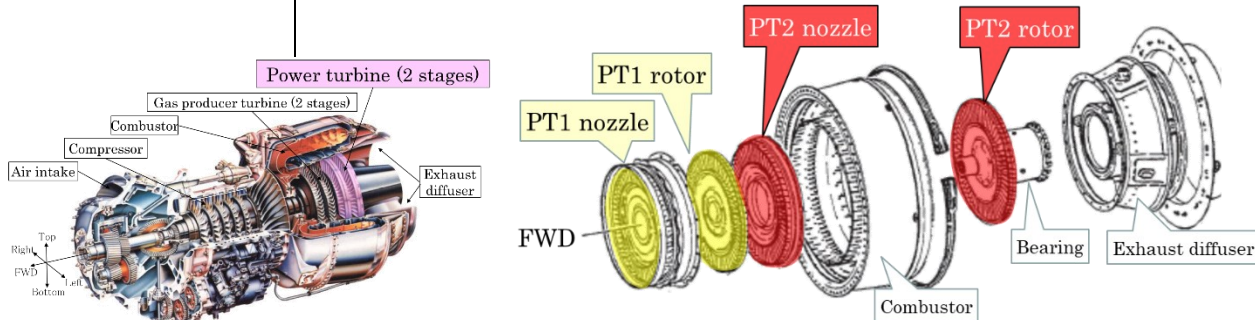
Figure 5: PT Configuration

The PT configuration consists of two stages such that one stage is formed by a pair of a non-rotating PT nozzle and a rotating PT rotor. (Hereafter, the forward stage is referred to as "PT1" and the backward stage as "PT2.") (See Figure 5.)
