**AIRCRAFT ACCIDENT  
INVESTIGATION REPORT**

**SHIKOKU AIR SERVICE CO., LTD.**

**J A 6 5 2 2**

FIRE FROM REAR HOLD  
SHIKOKU AIR SERVICE CO., LTD  
EUROCOPTER AS350B3 (ROTORCRAFT), JA6522  
HIKETA, HIGASHIKAGAWA CITY, KAGAWA PREFECTURE  
AT ABOUT 10:10 JST, SEPTEMBER 22, 2011

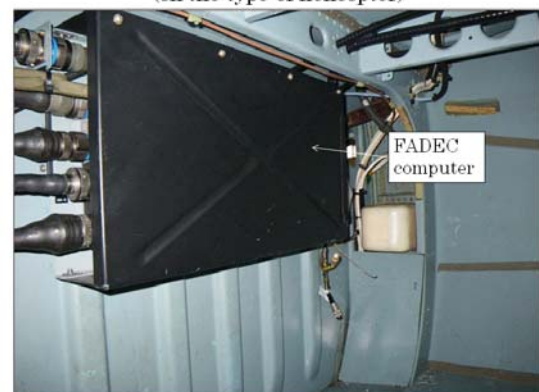
Installation of the FADEC computer (on the type of helicopter)

equipment, was installed at the other side of the floor of the rear hold.

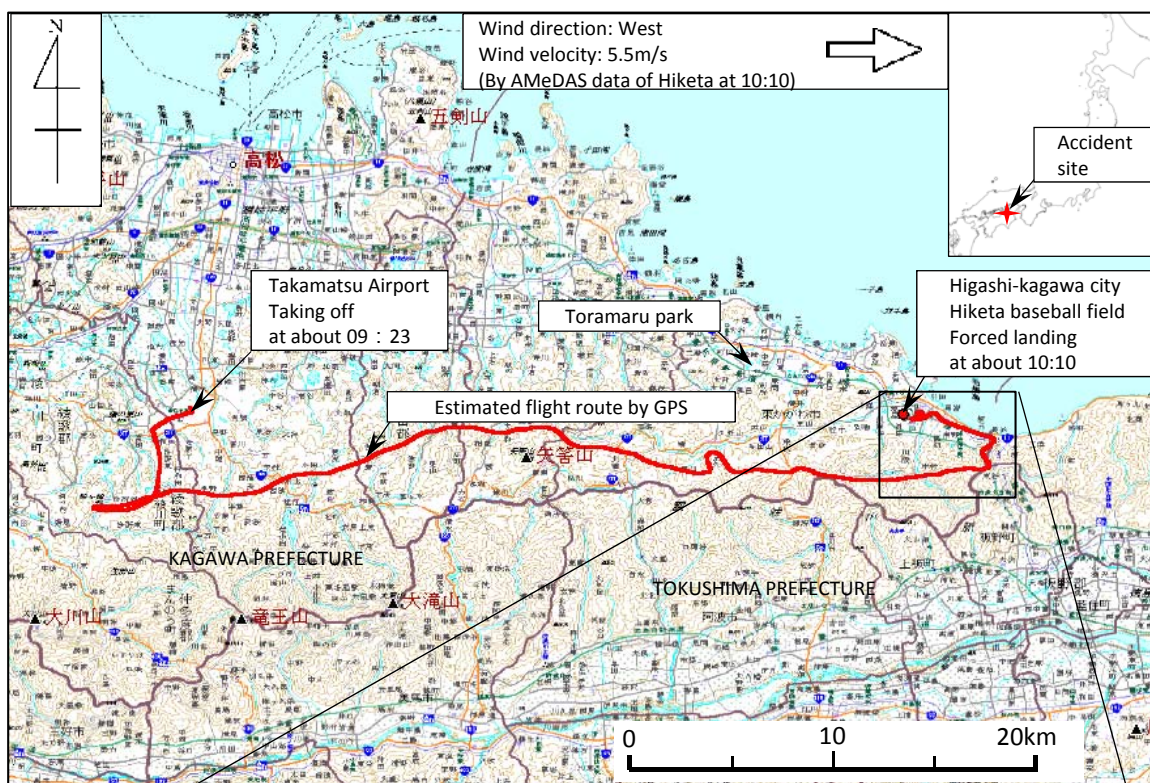
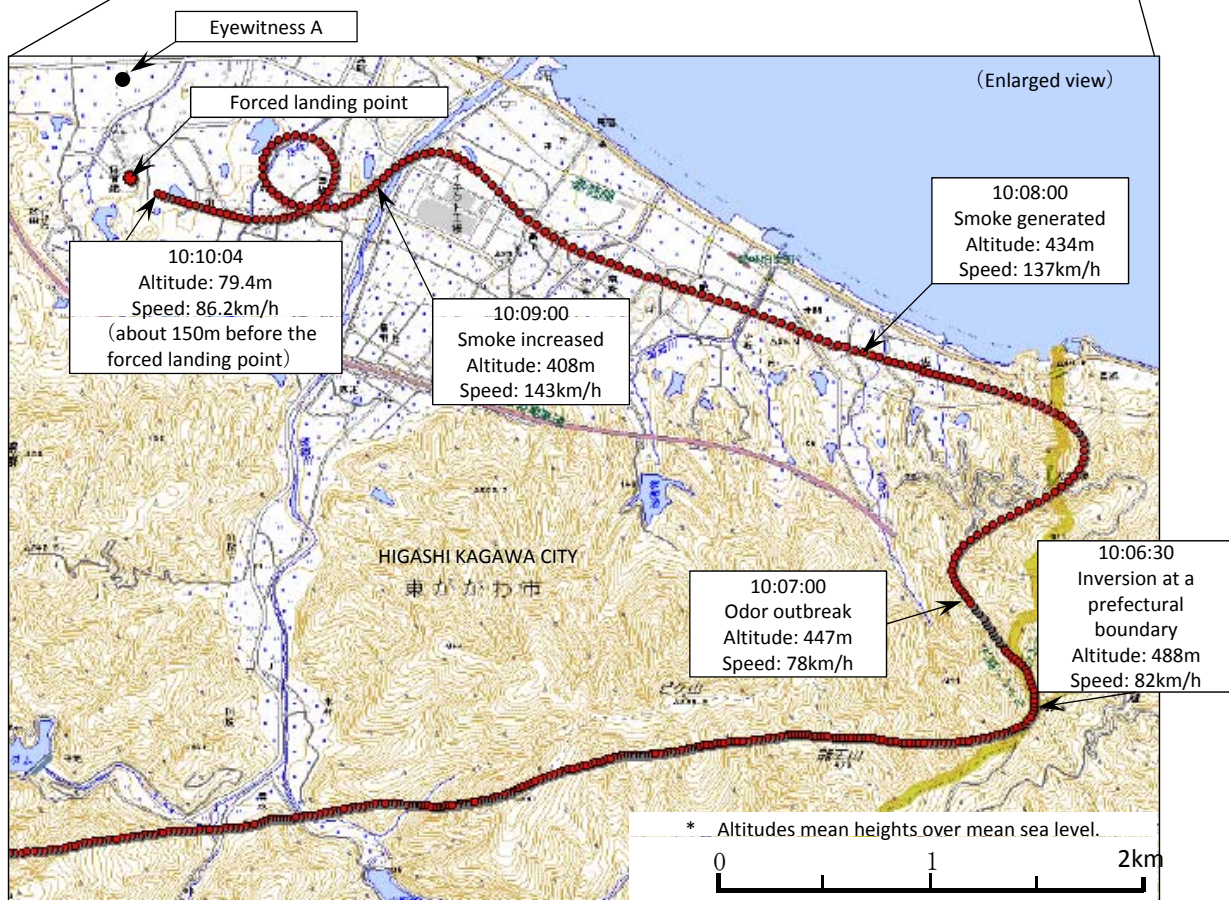
Figure 1: Estimated Flight Route

The Helicopter equipped with had a device called the "Power Transmission Line Route Mapping System" with a built-in GPS receiver, which electronically recorded its location and altitude every second, and the data were retrieved from the system. The retrieved data recorded all locations and altitudes from the time when the Helicopter was parked at the Airport to 10:10:04 when it was flying at a location about 150 meters before the place where it made a forced landing (as shown in Figure 1, "Estimated Flight Route" based on the Radar data) ).

This accident occurred at the baseball field in Hiketa, Higashikagawa City, Kagawa Prefecture (34°12'56" N, 134°23'38" E) at about 10:10. (See Figure 1: Estimated Flight Route)

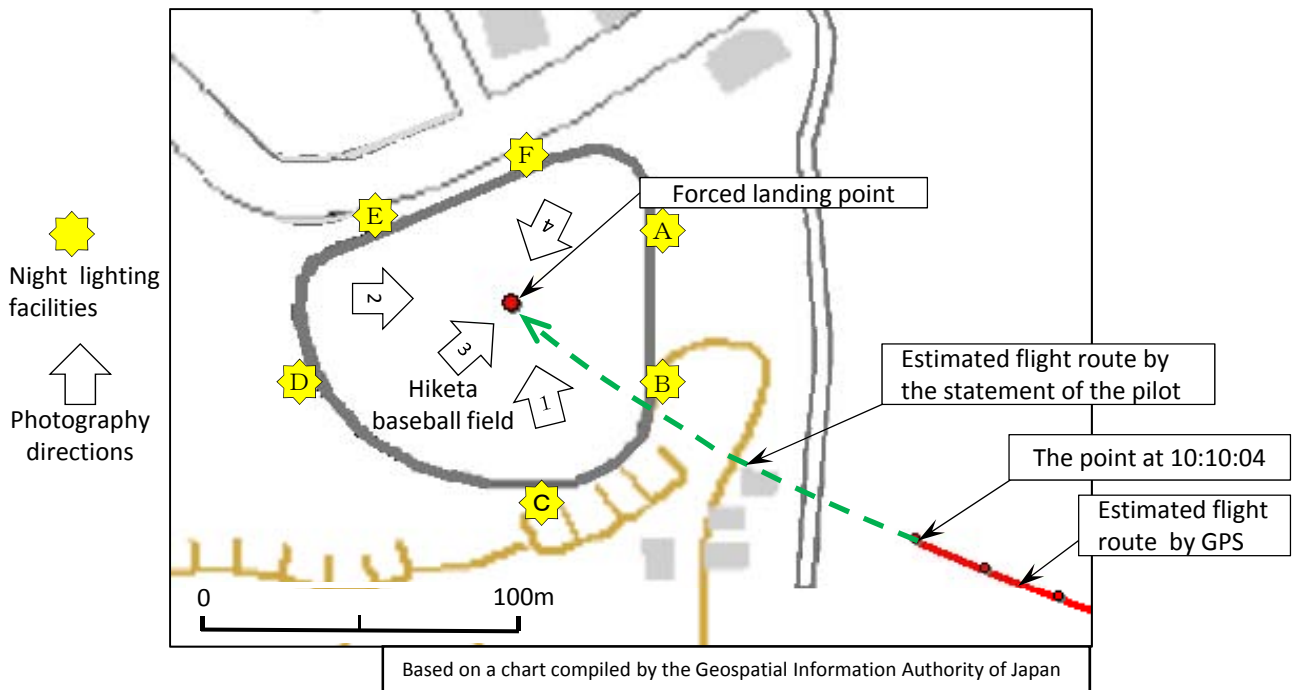
Figure 3: Accident Site Layout

(See Figure 3: The Condition of the Accident Site)
