**AIRCRAFT ACCIDENT
INVESTIGATION REPORT**

**JAPAN AIRLINES CO., LTD.
J A 6 5 4 J**

CABIN ATTENDANTS INJURIES
BY THE SHAKING OF THE AIRCRAFT
JAPAN AIRLINES CO., LTD., BOEING 767-300, JA654J
AT AN ALTITUDE OF APPROXIMATELY 16,000 FT
ABOUT 95 KM SOUTHEAST OF
GIMPO INTERNATIONAL AIRPORT (KOREA)
AT 17:33 JST, SEPTEMBER 12, 2014

April 24, 2015

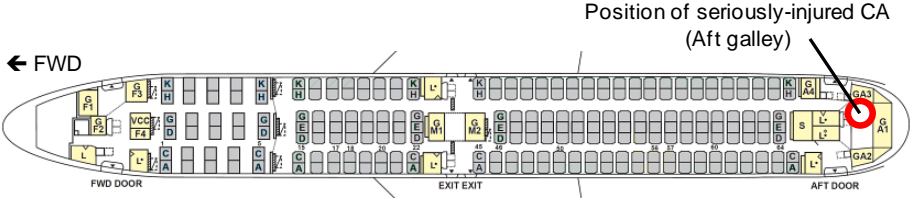
<p>preparing for landing. Since shaking of the aircraft gained its momentum from around 17:28, CAs and interpreters in the aft galley took their seats temporarily although the seatbelt sign was not lit on. When they resumed their work after the shaking subsided, they suddenly encountered a violent vertical shaking, by which cabin crewmembers were thrown into the air to hit the ceiling and one of them fell onto the floor on her back. As a result, she was seriously injured.</p> <p>The atmosphere being stabilized after clearing clouds, the PIC turned on the seatbelt sign at 10,000 ft as usual and continued descent. The aircraft landed at Gimpo International Airport at 17:51.</p> <p>The accident occurred at 17:33 on September 12, 2014, near GUKDO, about 95 km southeast of Gimpo International Airport (37°01'43" N, 127°38'05" E), at an altitude of approximately 16,000 ft.</p> <p>(See figure 1 and 2)</p>
