# AIRCRAFT SERIOUS INCIDENT INVESTIGATION REPORT

October 09, 2025

Adopted by the Japan Transport Safety Board

<b>Company</b>	Shin Nihon Helicopter Co., Ltd.
<b>Type, Registration Mark</b>	Aerospatiale AS332L1 (Rotorcraft), JA6686
<b>Incident Class</b>	Case where a slung load carried external to the aircraft was released unintentionally Item (xvi), Article 166-4 of the Regulation for Enforcement of the Civil Aeronautics Act of Japan.
<b>Date and Time of the Occurrence</b>	At about 12:21 Japan Standard Time (JST: UTC+9 hours), July 2, 2025
<b>Site of the Incident</b>	At about 150mt above the ground over Hamamatsu City, Shizuoka Prefecture (35° 02' 32" N, 137° 55' 45" E).

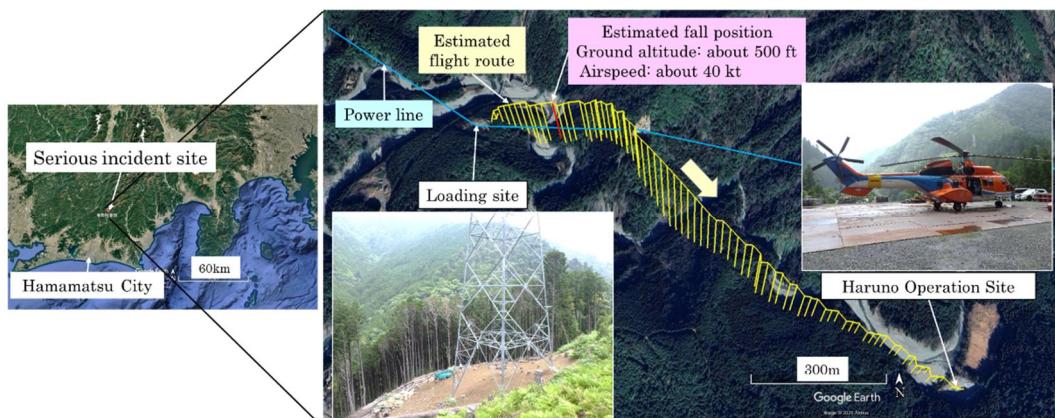
Figure 1: Estimated Flight Route (FDR)

At about 12:20, with the captain sitting in the right pilot seat, a mechanic (trainee) in OJT sitting in the cockpit rear left seat, and a mechanic (instructor) sitting near the left cabin door, the helicopter lifted the total cargo weight of about 800 kg (Cargo A and Cargo B) from a load site near a steel tower in Haruno Town, Tenryu Ward, Hamamatsu City, Shizuoka Prefecture (hereinafter referred to as “the load site”) for material transport involving steel tower construction, and started to fly towards Haruno Operation Site (see Figure 1 and Figure 2).
